Operator: Extraction Oil and Gas
Location Name: GREEN-61S68W 17SESE
Loc ID: 321507
Inspection: 697505089

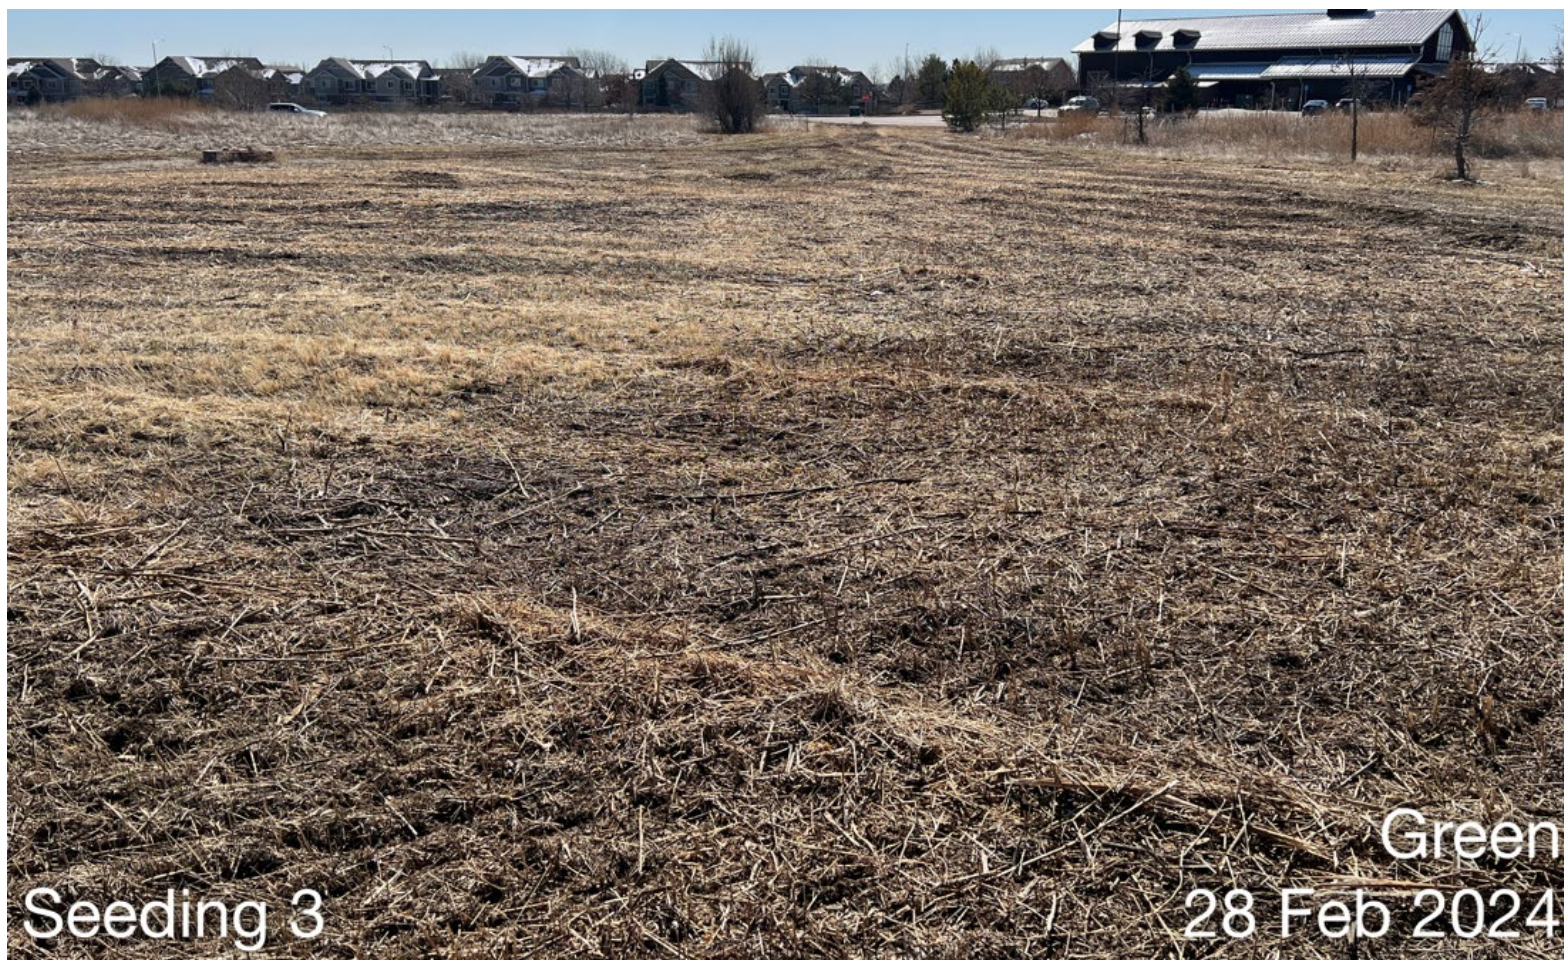
Exhibit D

CA: This location does not comply with Rule 1004. The access road, well and tank battery location have mostly annual, weedy vegetation, which is not reflective of reference area vegetation. Also, there appears to be subsidence at the wellhead. There has been some land use change along a portion of the access road that is not the responsibility of the Operator. The surface owner has a fire pit that is being accessed via a portion of the access road. Operator is responsible for the red outlined area shown in Photo #4.

CA Resolution: This location has been reclaimed to comply with Rule 1004.
