Inspection Photos

Operator: TEP ROCKY MOUNTAIN LLC #96850

Location ID: 335174

Inspection Doc: 696205667

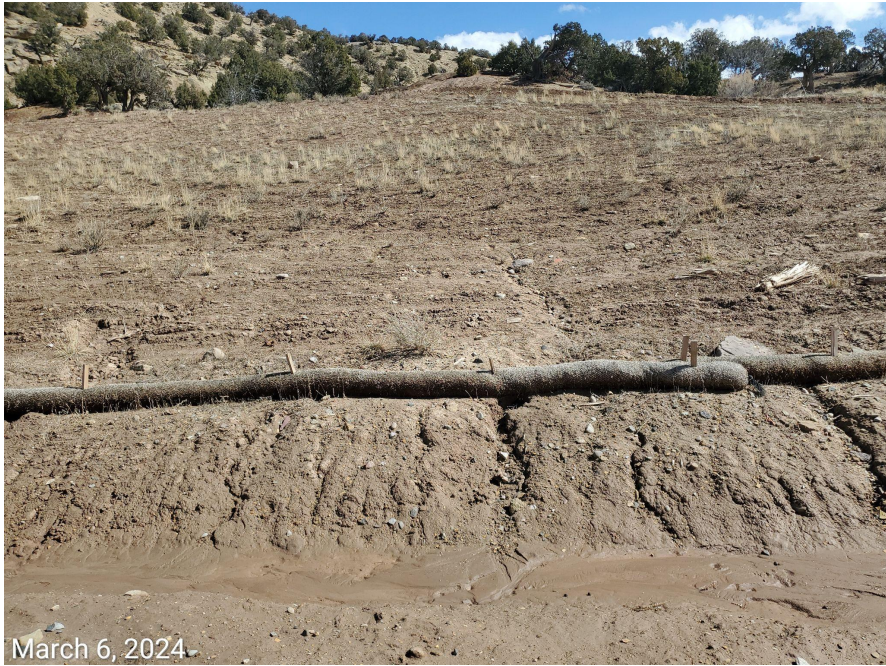
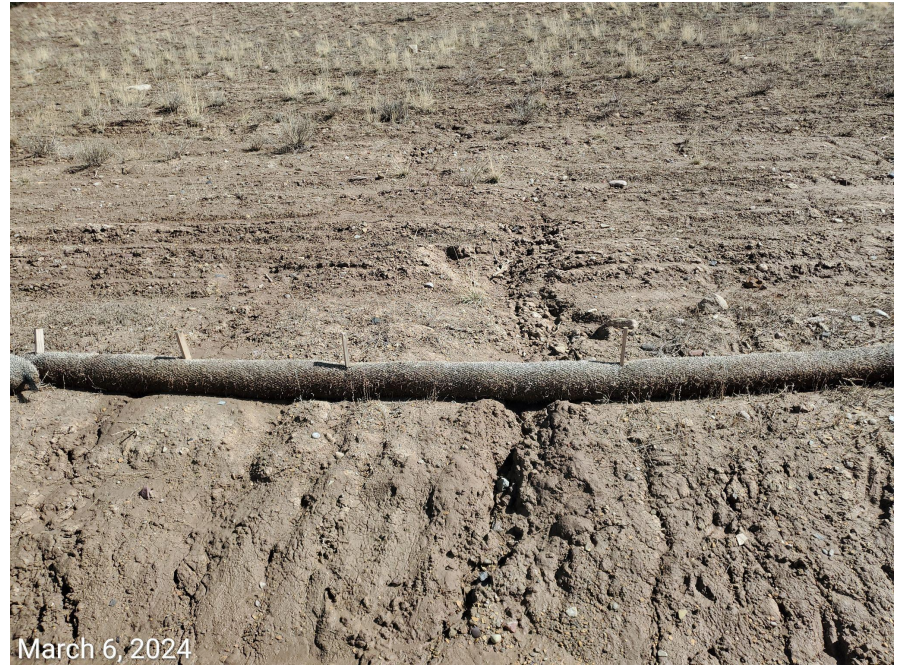
Photo 1: Photos taken from the eastern interim areas. Stormwater and erosion control BMPs remain missing or insufficient; erosion logs remain inadequate and not in proper functioning condition. Erosion degradation persists. CA regarding interim reclamation remains outstanding.

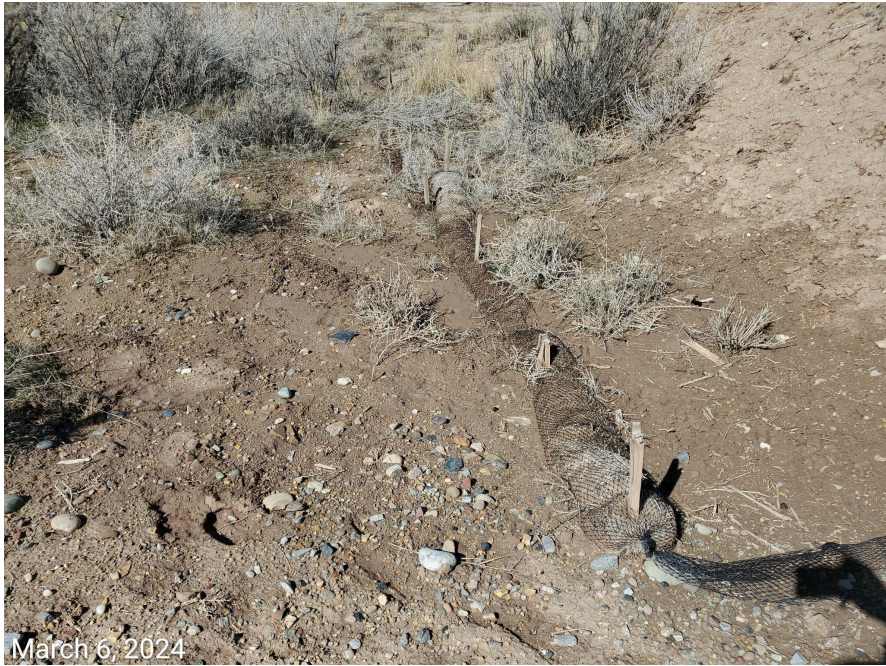
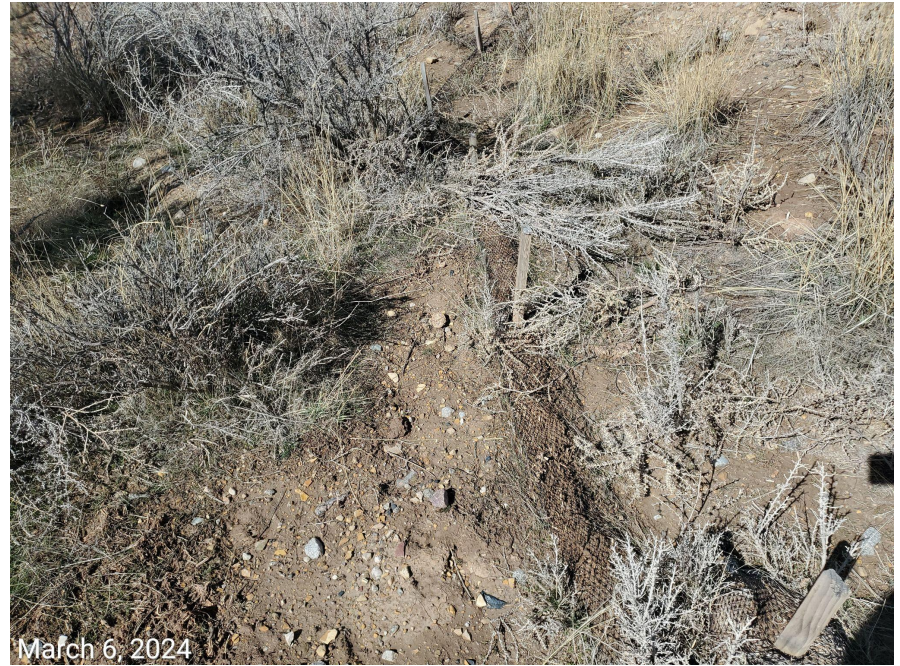
Photo 2: Erosion logs remain in disrepair and is considered debris; erosion logs have not been removed per 606 requirements. Photo also examples showing erosion logs on Location appear to have been constructed with a plastic material.

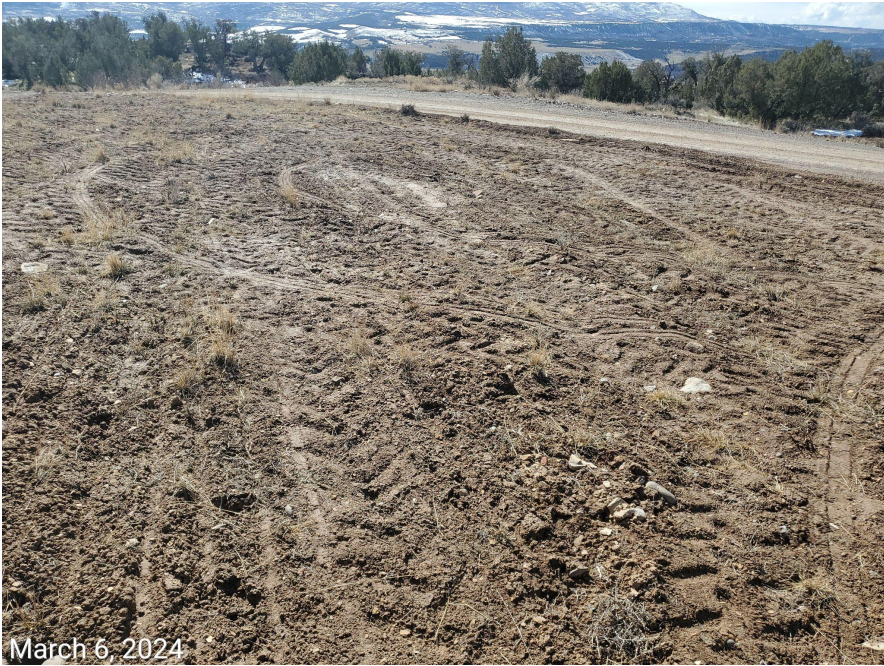
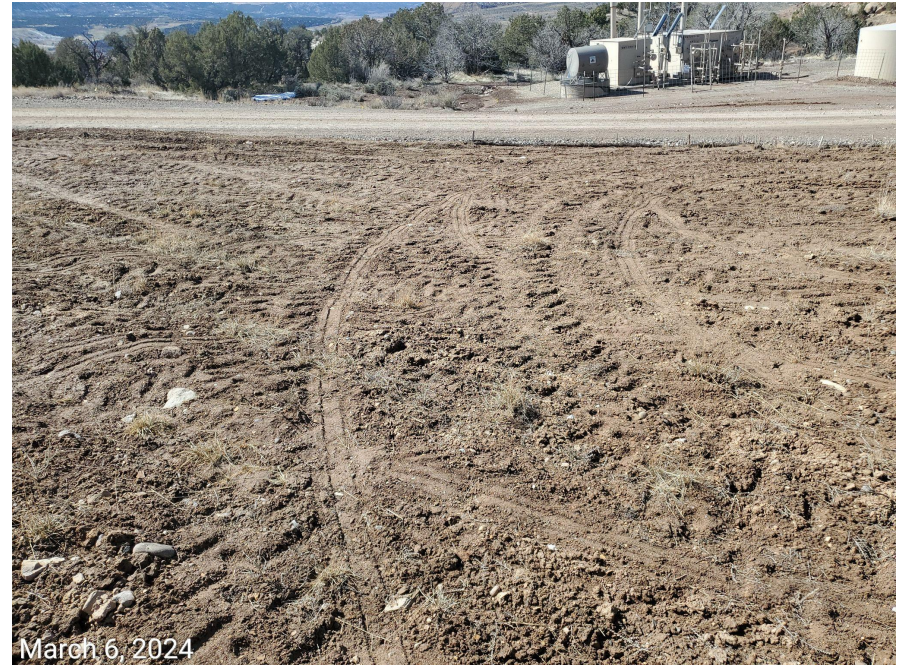
Photo 3: Photo taken from the western interim areas. Operator appears to have conducted additional work in these areas, however, stormwater and erosion control BMPs remain missing or insufficient; CA regarding interim reclamation remains outstanding.

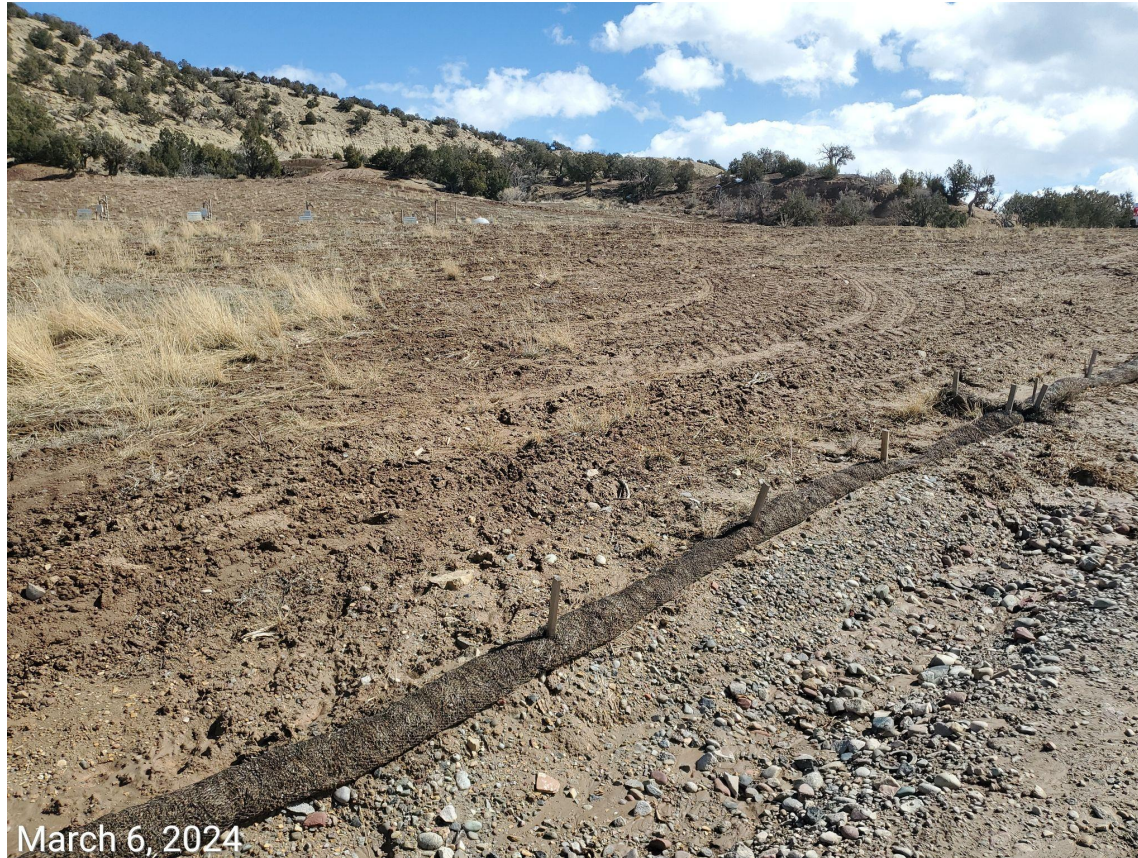
Photo 4: Photo taken from the western interim areas. Operator appears to have conducted additional work in these areas, however, stormwater and erosion control BMPs remain missing or insufficient. Erosion logs remain in disrepair. Photo also examples showing erosion logs on Location appear to have been constructed with a plastic material.
