Big Run Production Company
Argenta Fee 18 & Argenta Fee 19
Location ID 333079
Inspection #700300642 Remediation

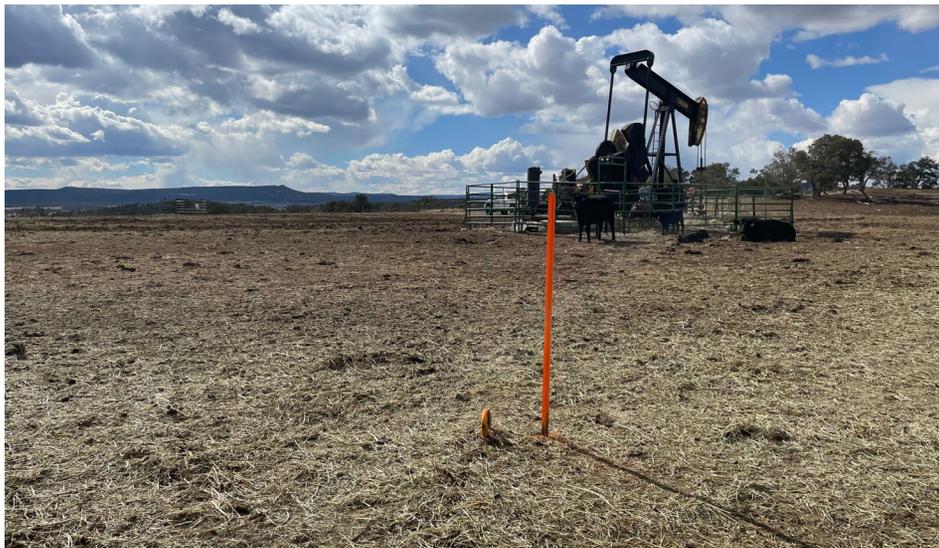
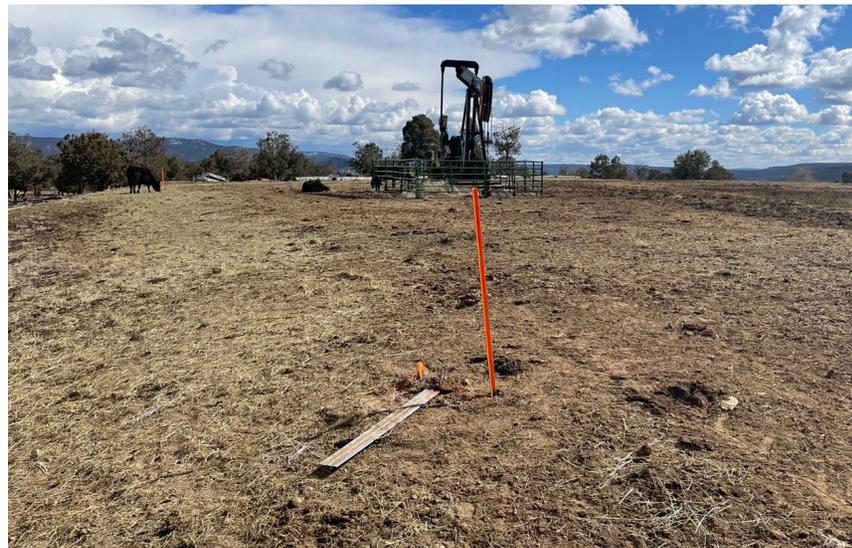
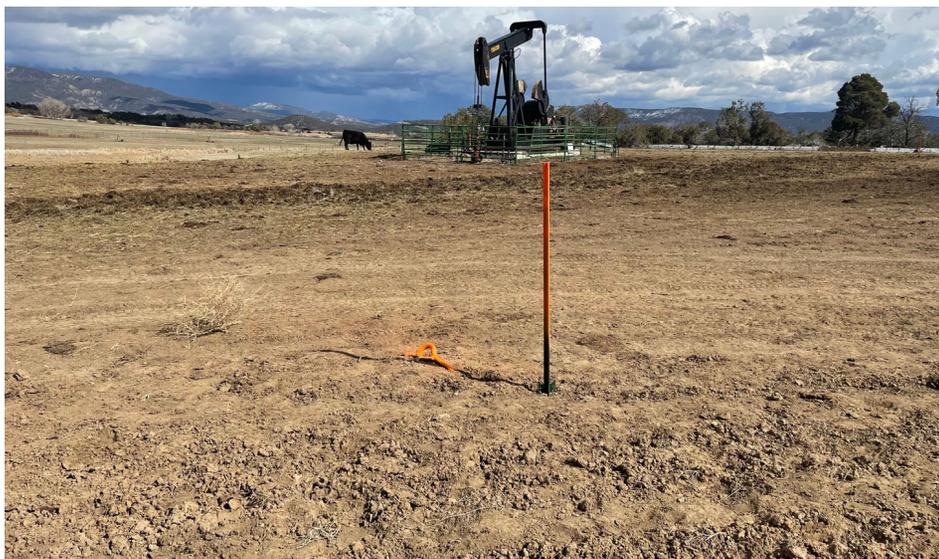
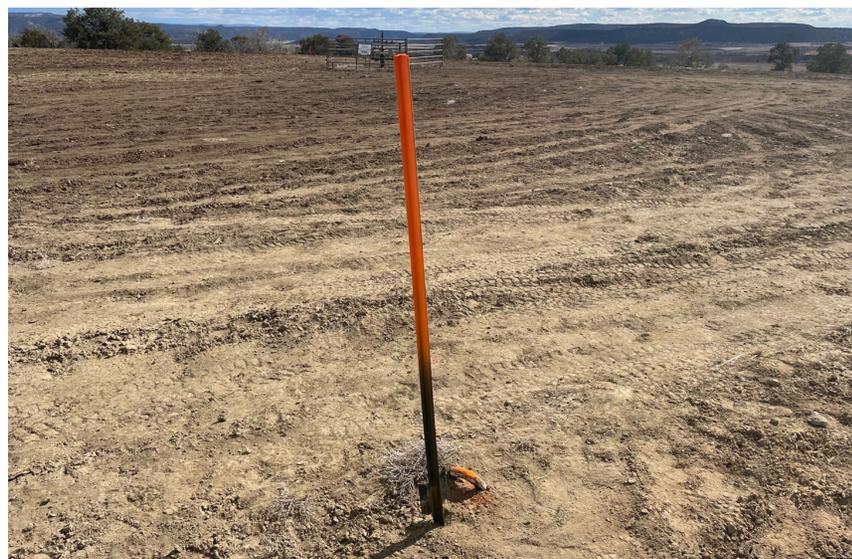
Corrective Action: Mark all rig anchors per Rule 1003

Action Taken: Located and Marked all rig anchors

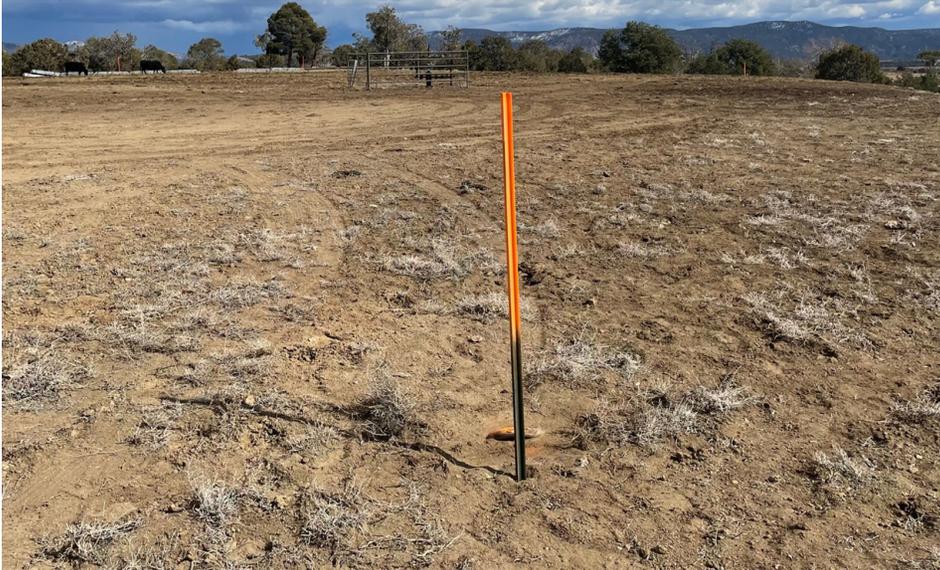
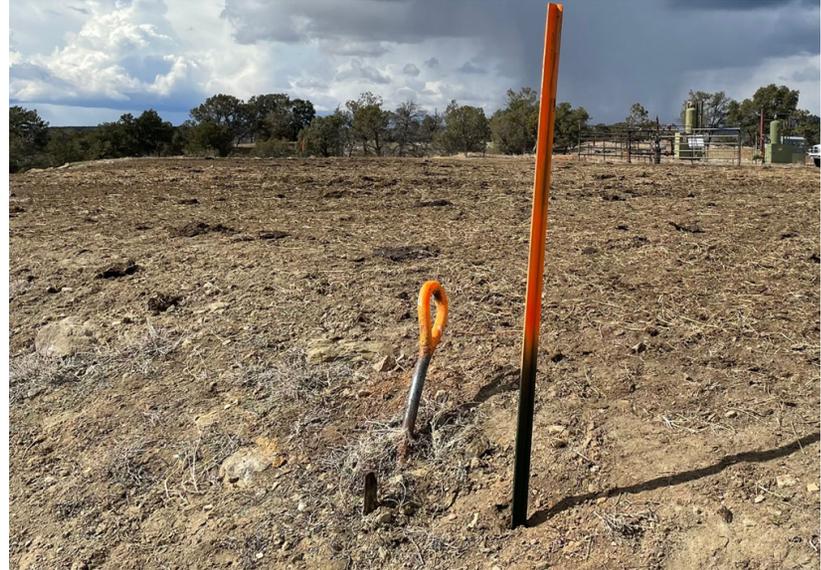
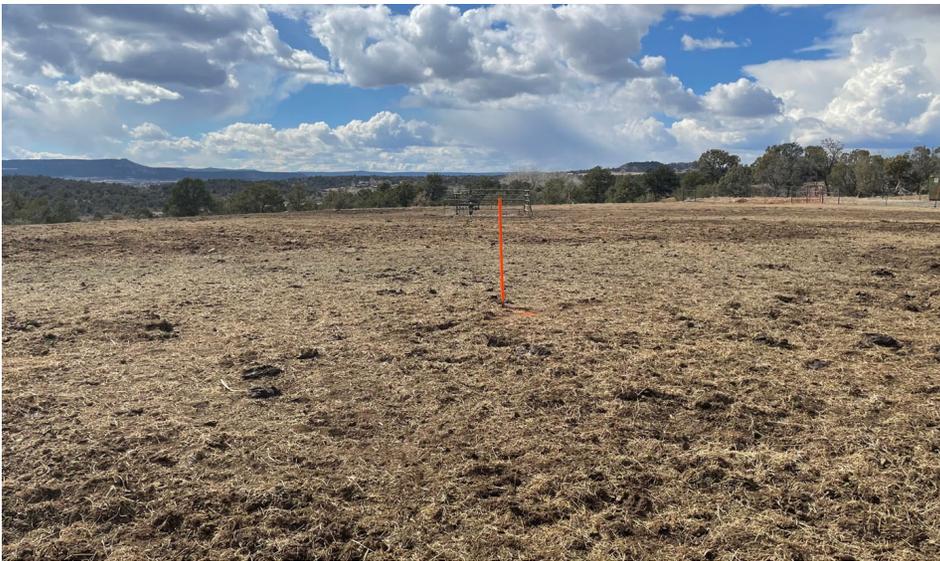
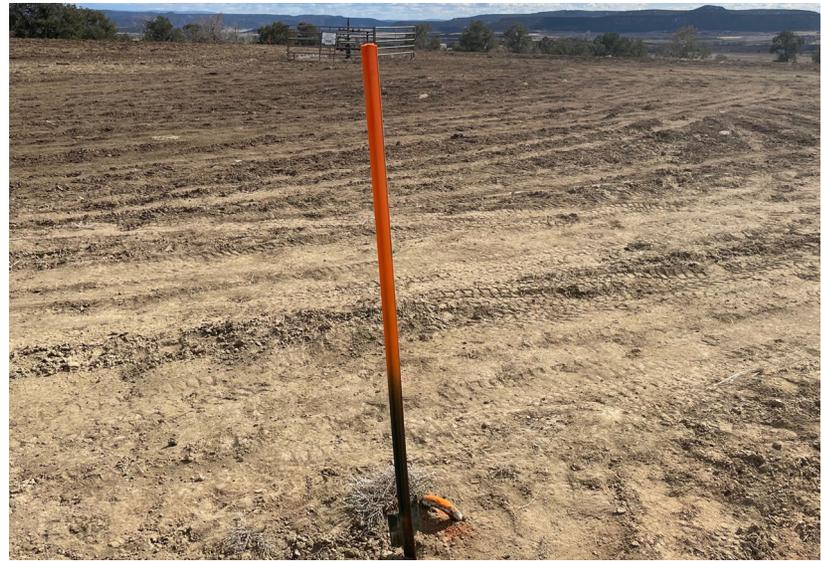
Corrective Action: Mark all rig anchors per Rule 1003

Action Taken: Located and Marked all rig anchors

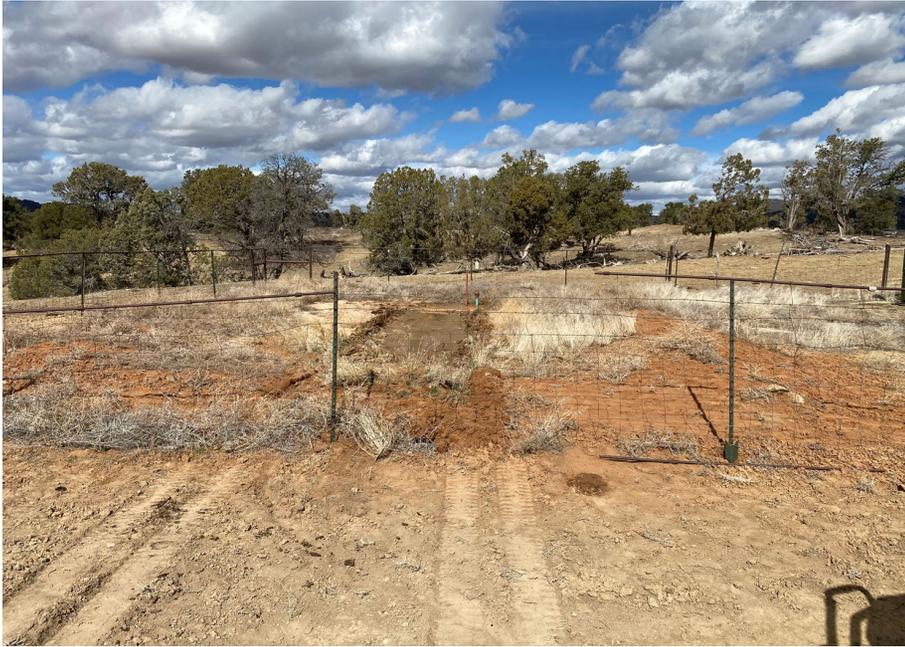
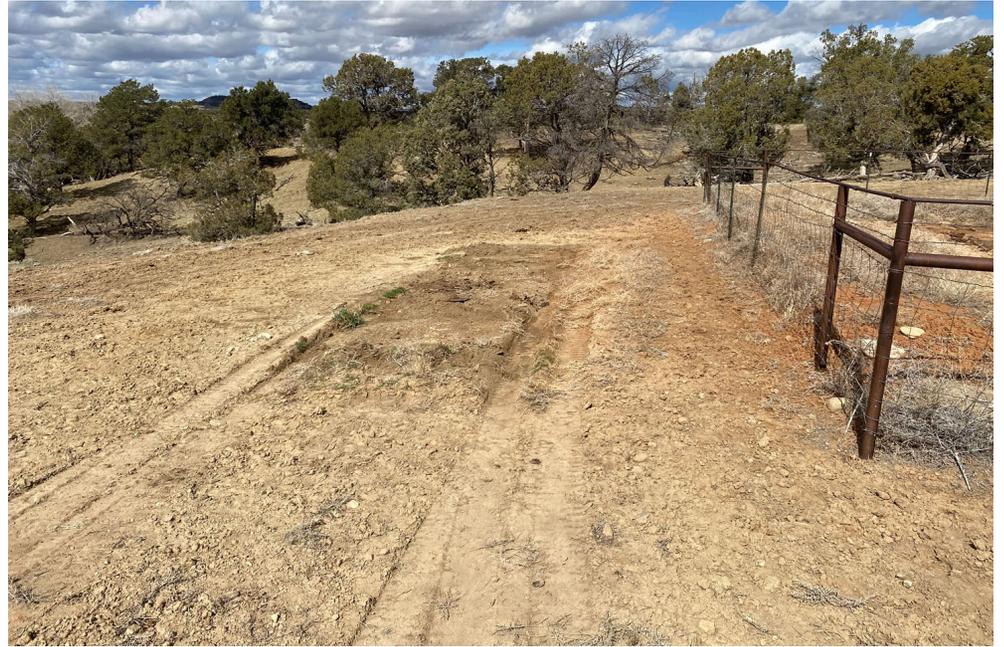
Corrective Action: ~400 bbl (not in use produced water tanks) are corroded, have holes and are nonservicable. Remove per Rule 606
Action Taken: Removed Tanks

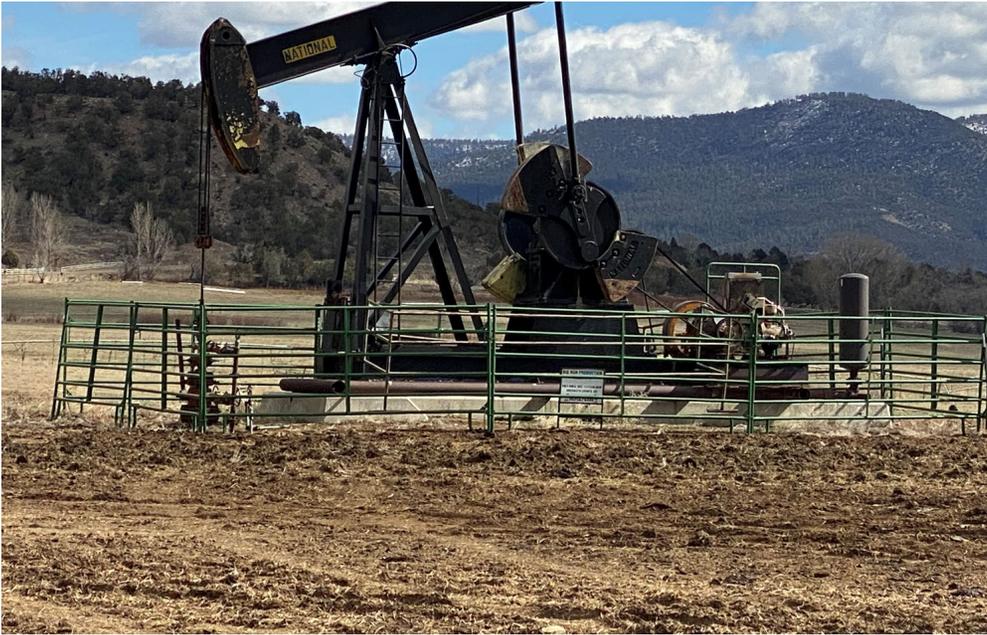
Corrective Action: Clean up area around Argenta 18 well, remove unused equipment, self inspect for impacted material and remove. Repair wildlife screen at Argenta 19 well and install plug on top of chemical barrel. Per Rules 1002.f and 602.c

Action Taken: Removed barrels and cleaned up area around Argenta 18
