WELL NAME: BOOF 12-2 TR, API #: 071-09754, INSP. # 695109268

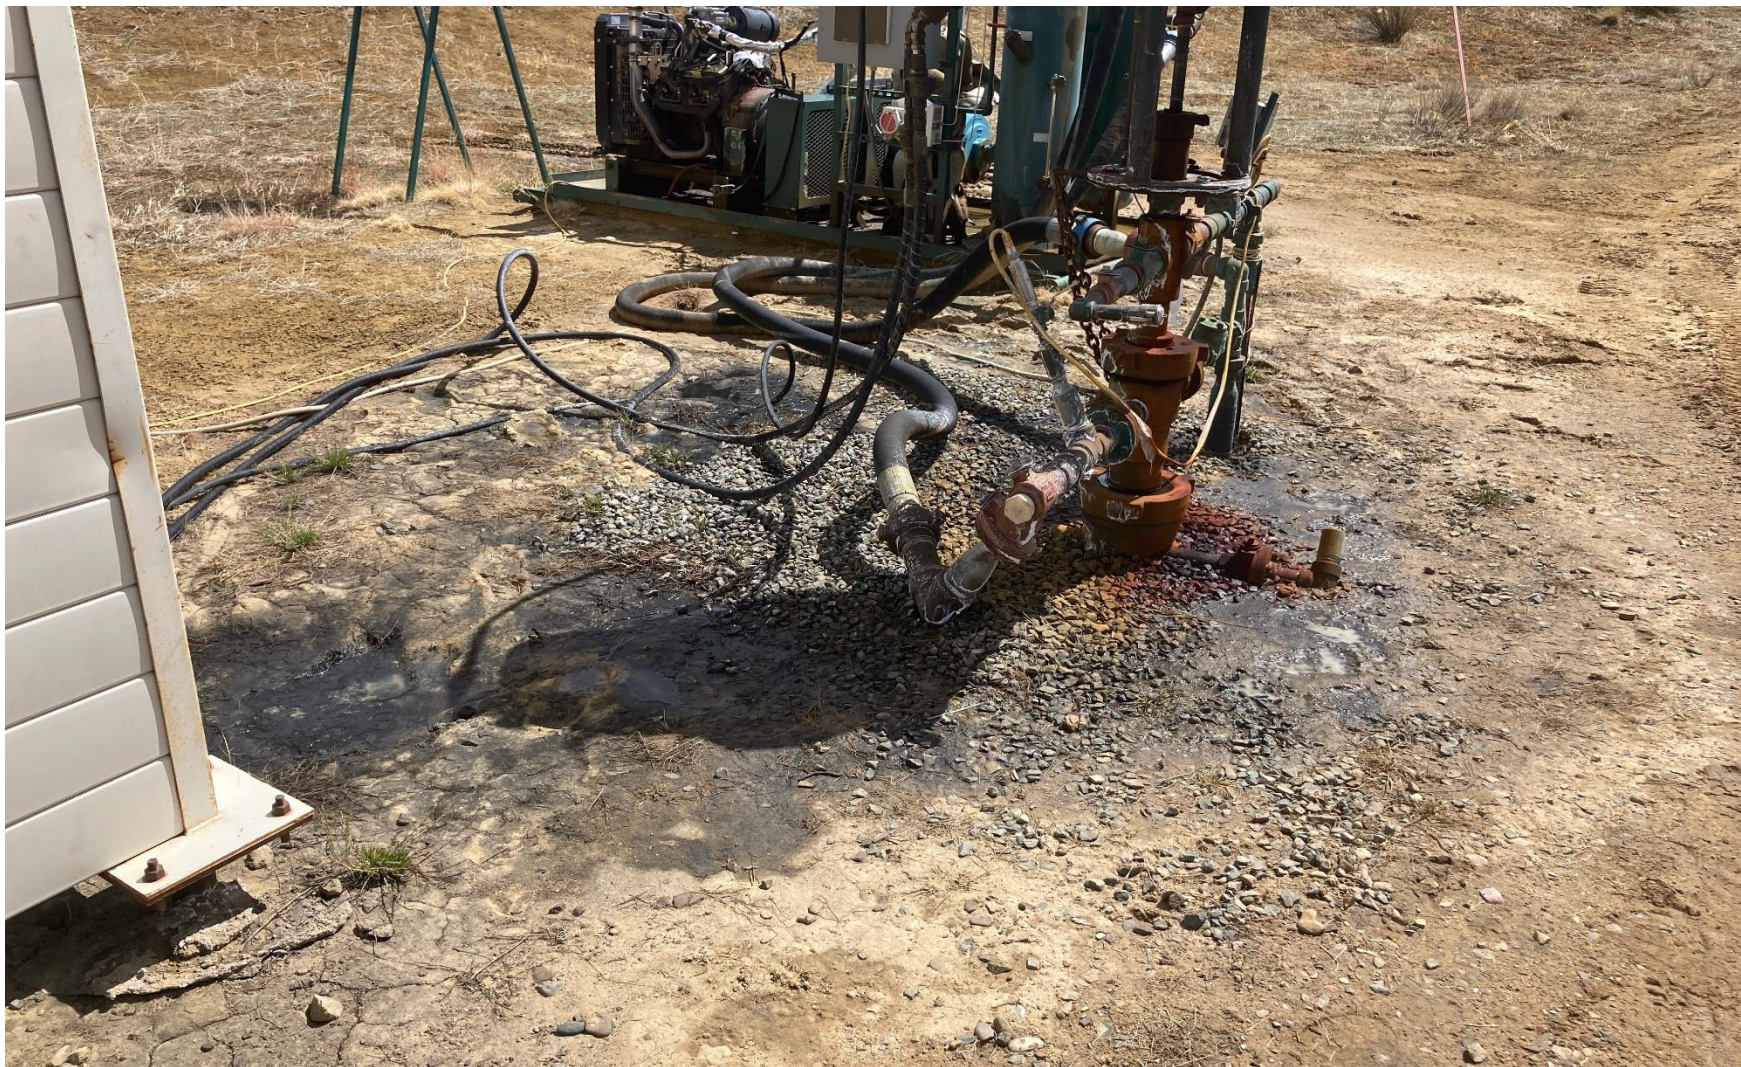
PHOTO 4: Signs of recent slow leak from wellhead has left a Salt/black mineral buildup around the wellhead. Securely fasten all valves, pipes, fittings, and Production Facilities to ensure good mechanical condition, inspect at regular intervals and maintain in good mechanical condition remove and dispose of impacted material per Rule 608.e. ca date 4-27-2024.
