Operator: CRESTONE PEAK RESOURCES OPERATING LLC

Location Name: BEEBE DRAEW-64N65W 26SWSW

Loc ID: 319335

Inspection: 714200777

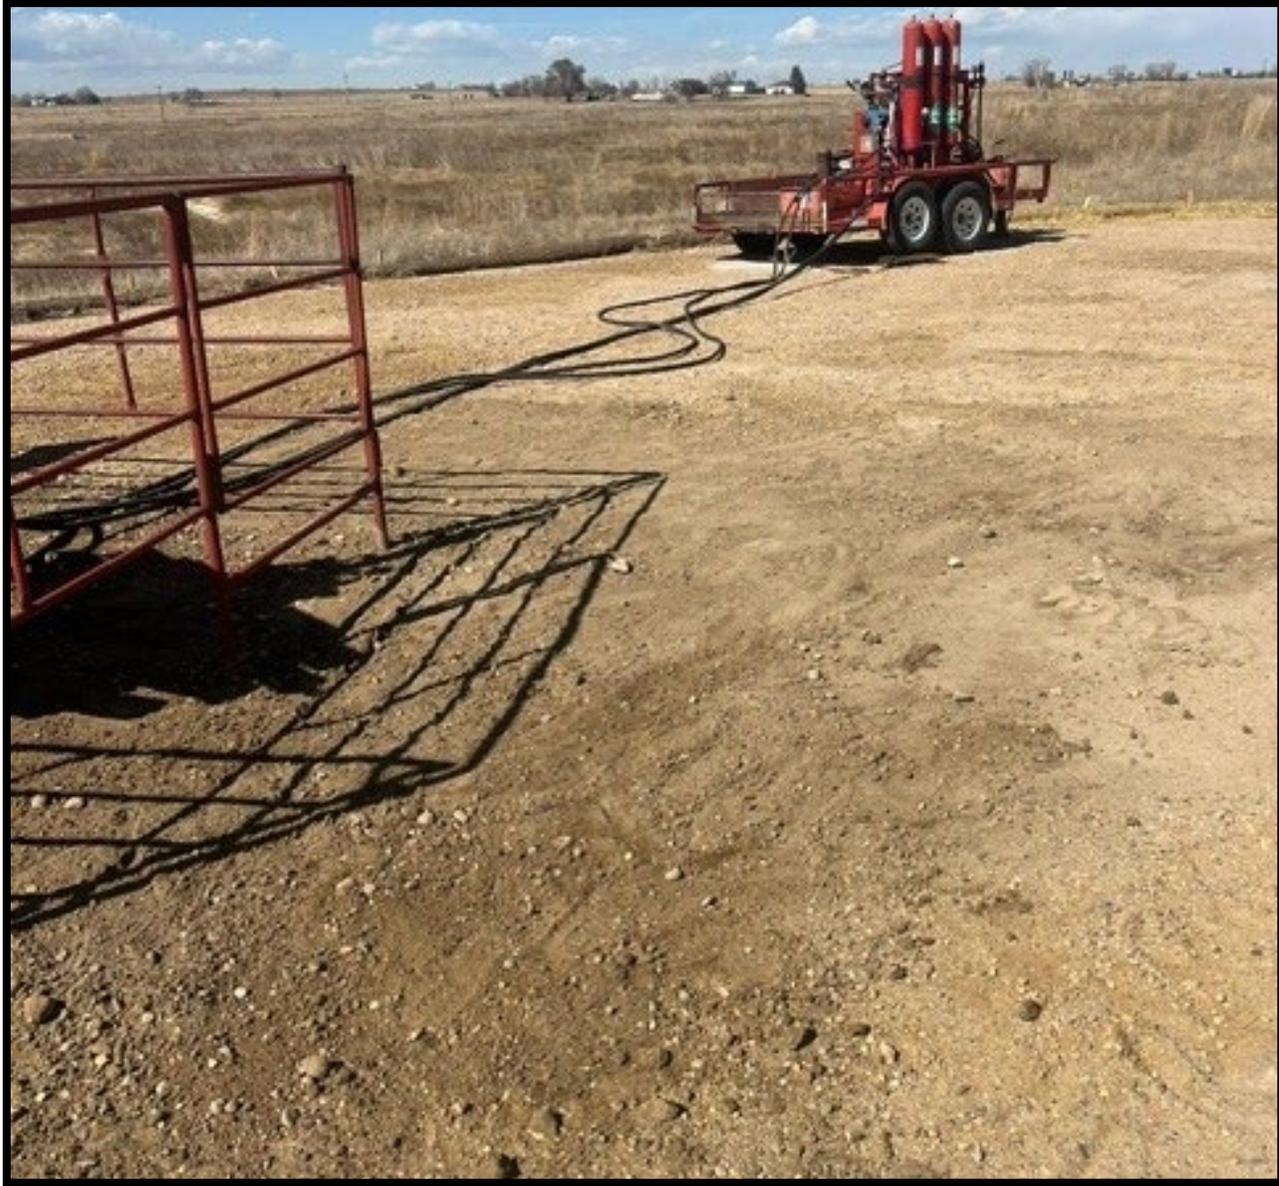
Exhibit A

CA: Unused equipment on various areas of location. See attached photos. Comply with Rule 606.

CA Resolution: Operator has removed the unused equipment from the location to comply with Rule 606.

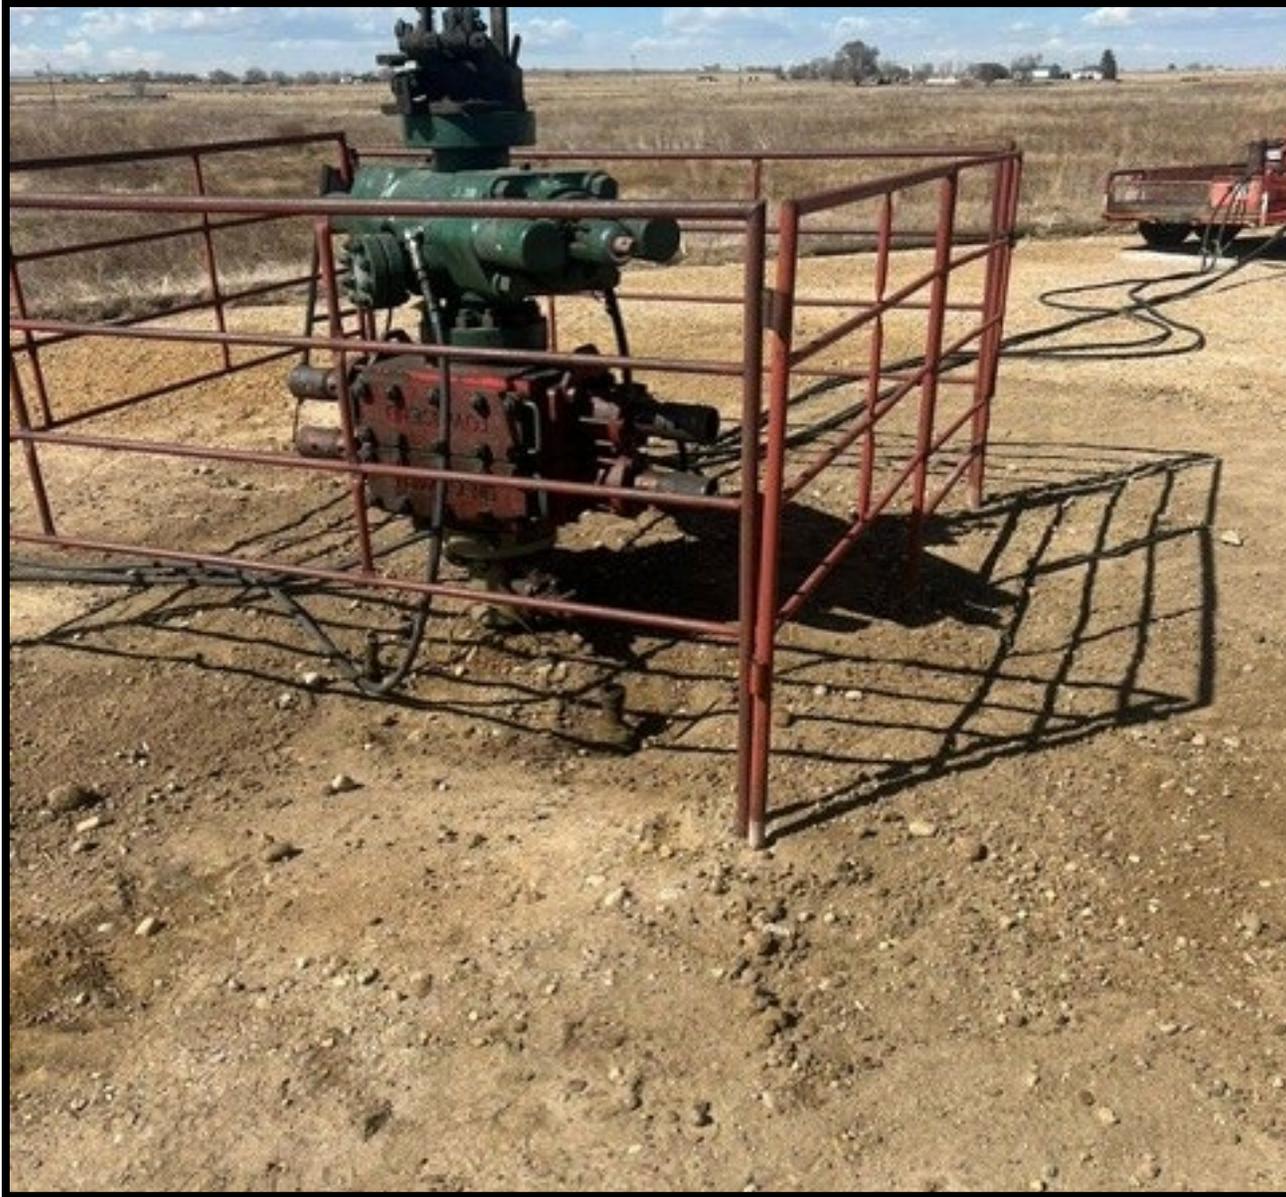
Exhibit C

CA: Stained soil at wellhead and surrounding area. See attached photos. Conduct maintenance on equipment, cleanup stained material and review self inspection processes per Rule 1002.(2).d.

CA Resolution: Operator addressed and appropriately removed identified stained soil. Equipment has been reviewed to help address/prevent leaks.
