Final Reclamation Inspection

Operator: Epic Energy LLC - 10684

Location ID: 306967

Inspection Photos
Location Name: Bondad 33-9 33A
Location ID: 306967

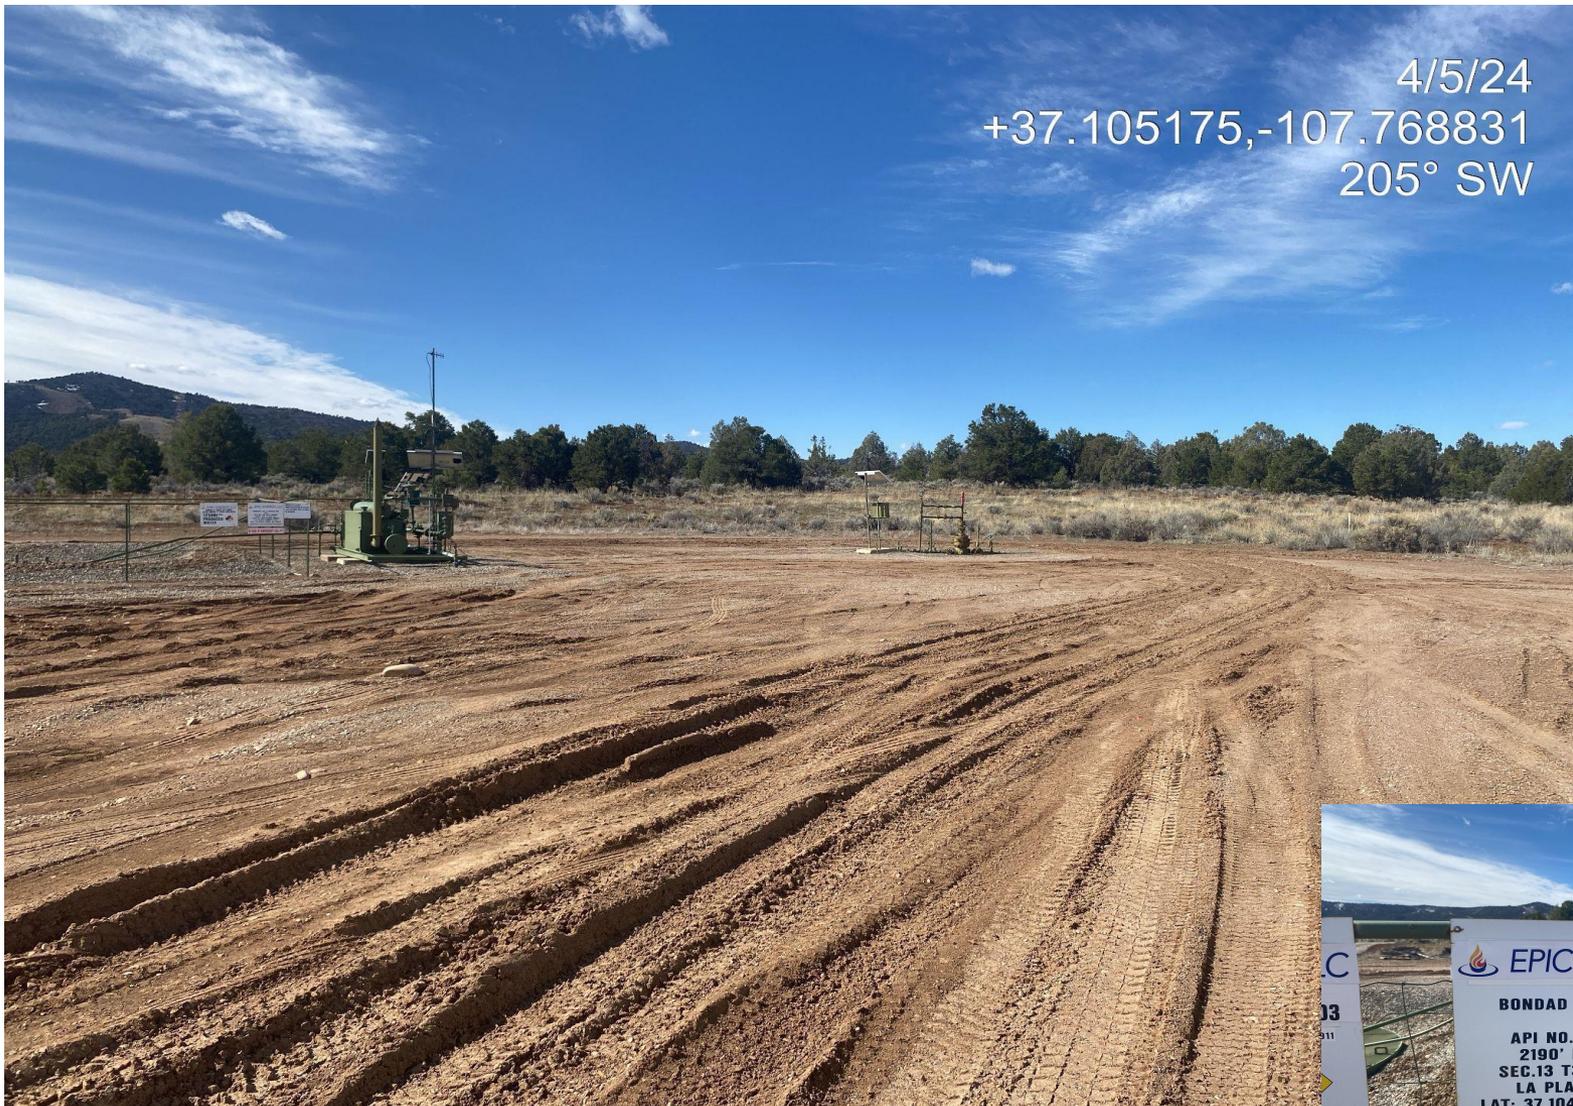
Photo 1. Overview of the well pad disturbance the access point facing center.

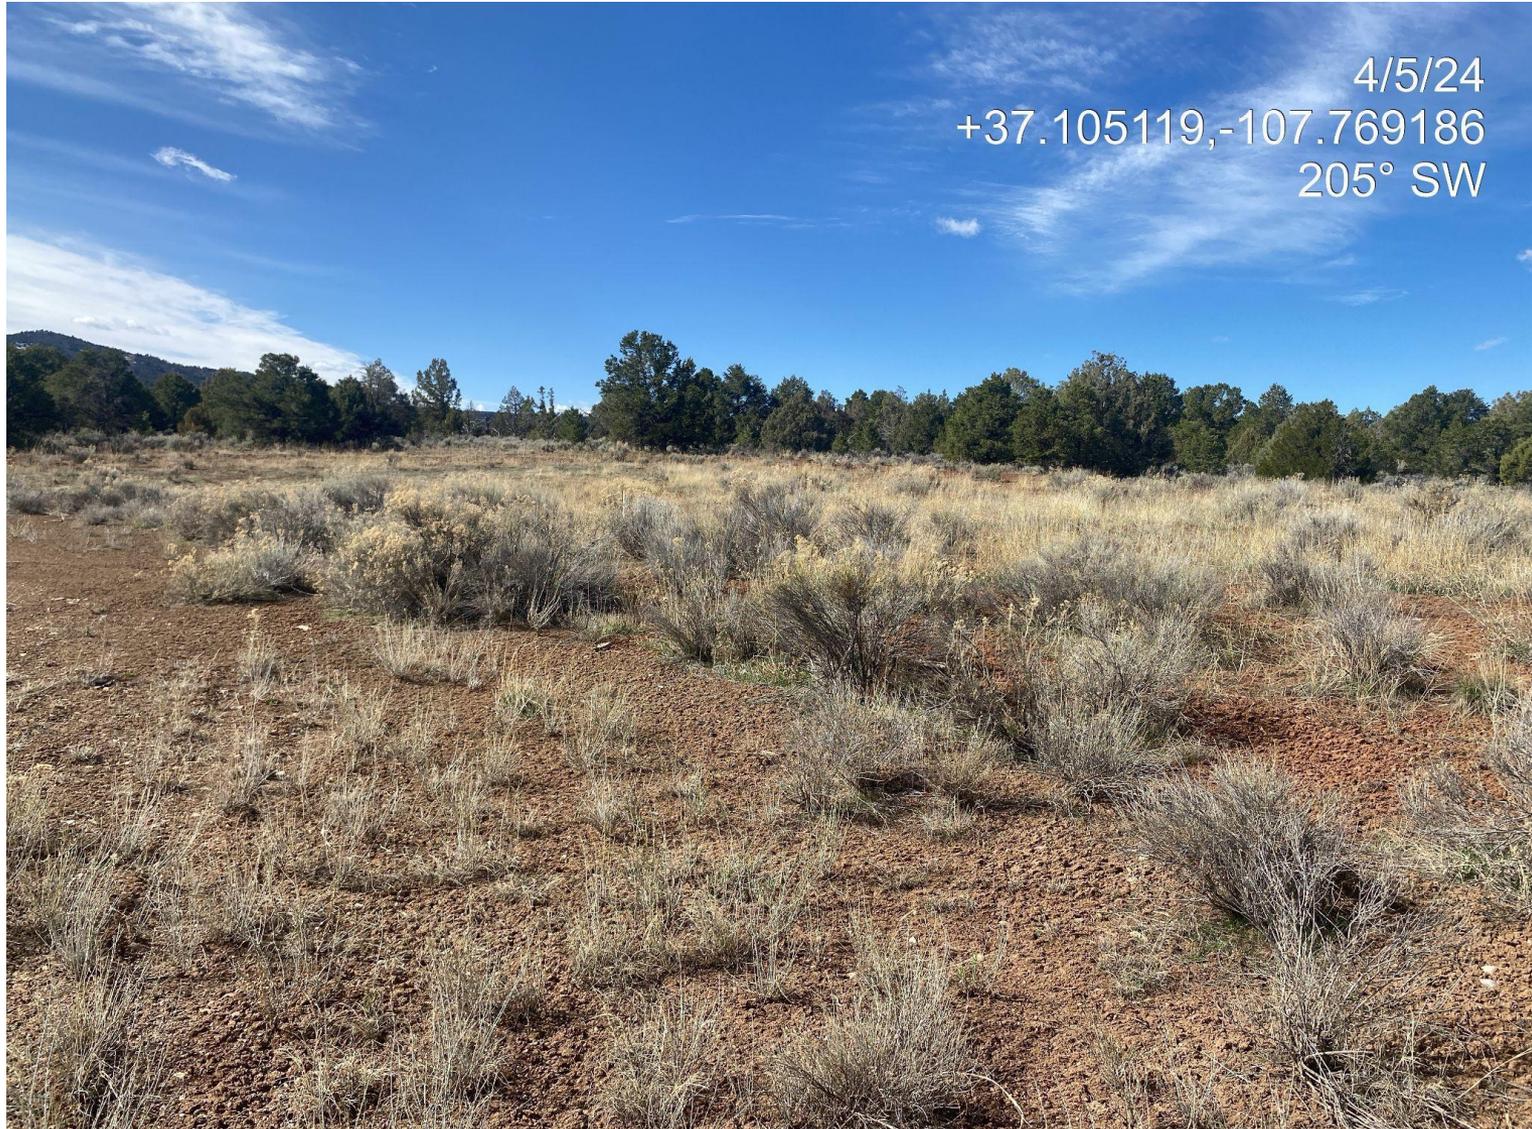
4/5/24
+37.105119,-107.769186
205° SW

Photo 2. View of the western interim reclamation area facing southwest. Vegetation comprised of crested wheatgrass, smooth brome and rabbitbrush.

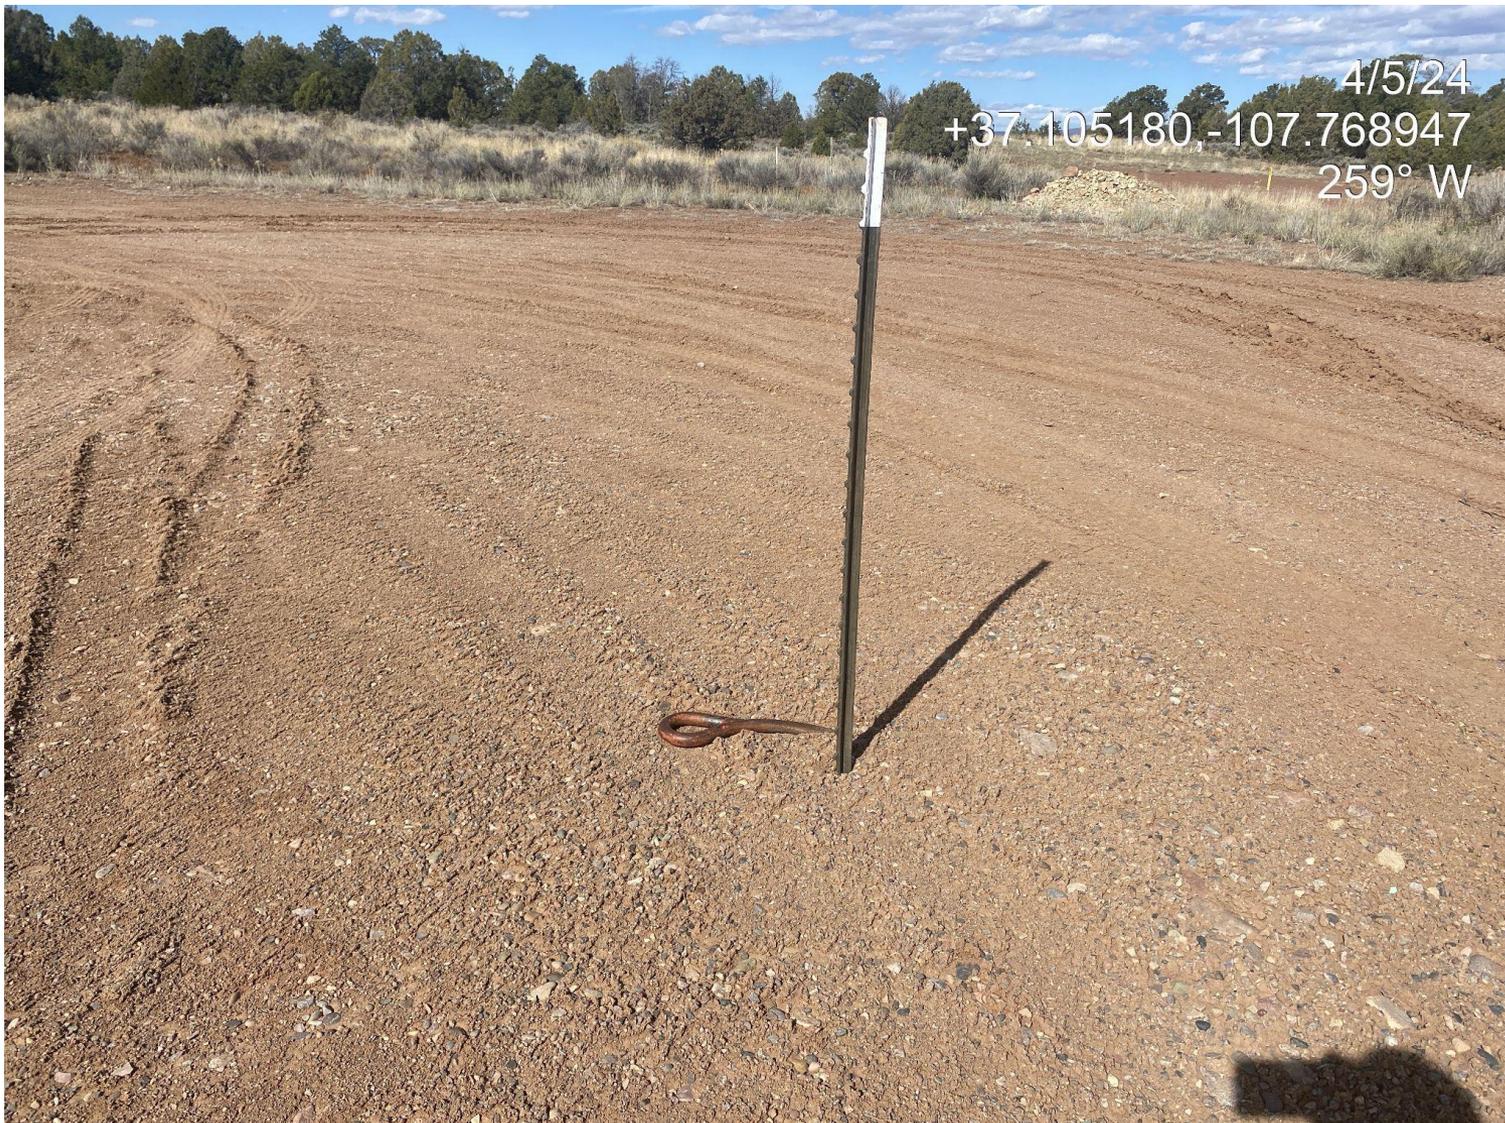
Photo 3. Unmarked guy line anchor corrective action identified in the previous inspection doc #712700710 has been addressed/resolved.

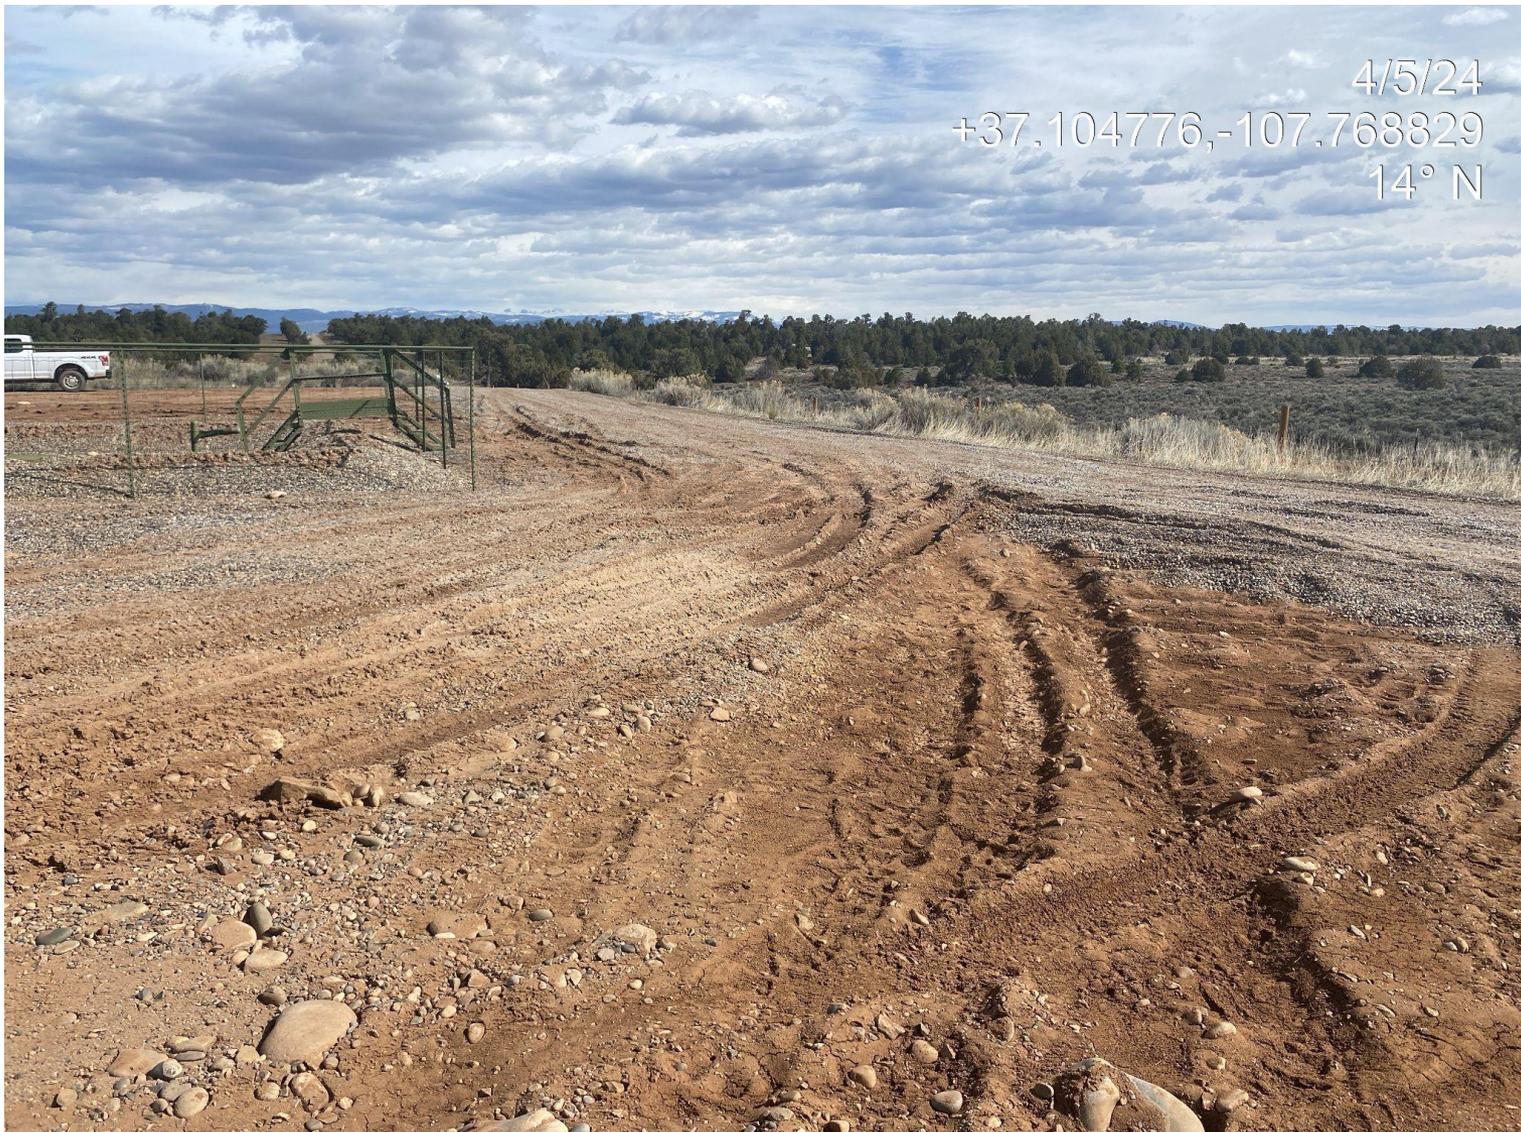
4/5/24
+37,104776,-107,768829
14° N

Photo 4. Rutting observed location wide. Additional stabilization is needed to minimize site degradation.

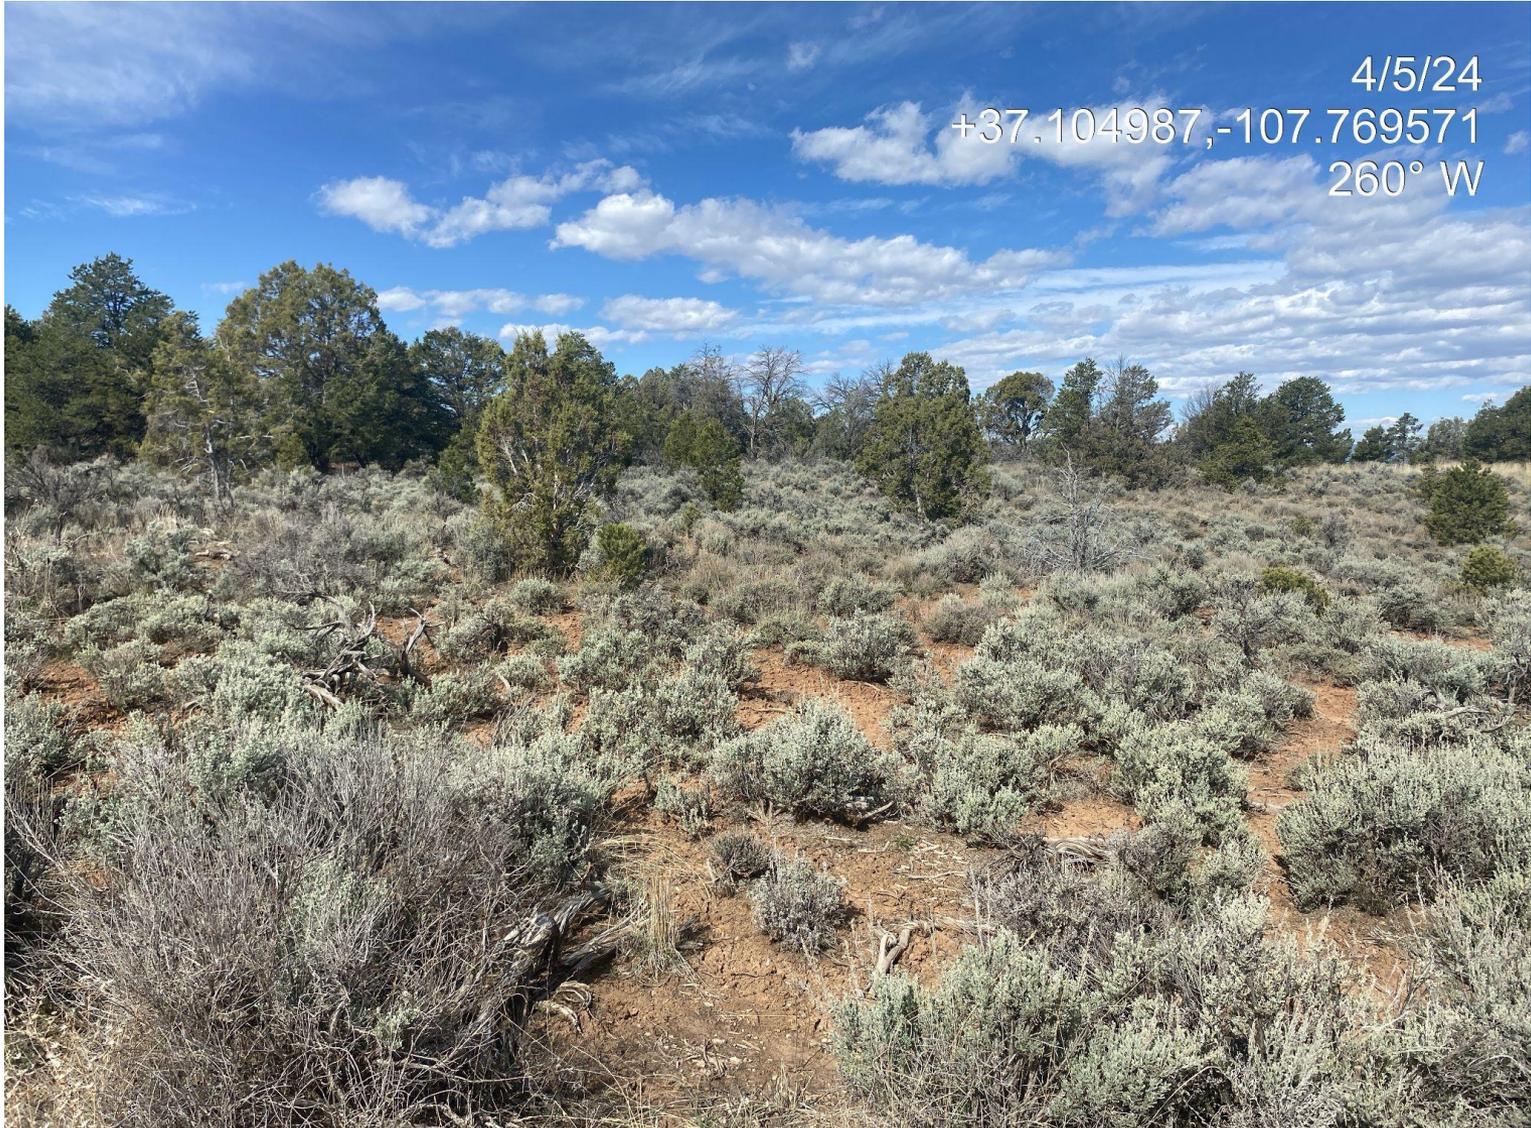
4/5/24
+37.104987,-107.769571
260° W

Photo 5. Reference area comprised of crested wheatgrass, smooth brome and sagebrush.
