**Operator:** *Bonanza Creek Energy*  
**Location Name:** *Pronghorn D-28 Pad*  
**Loc ID:** *441005*  
**Inspection:** *708201158*

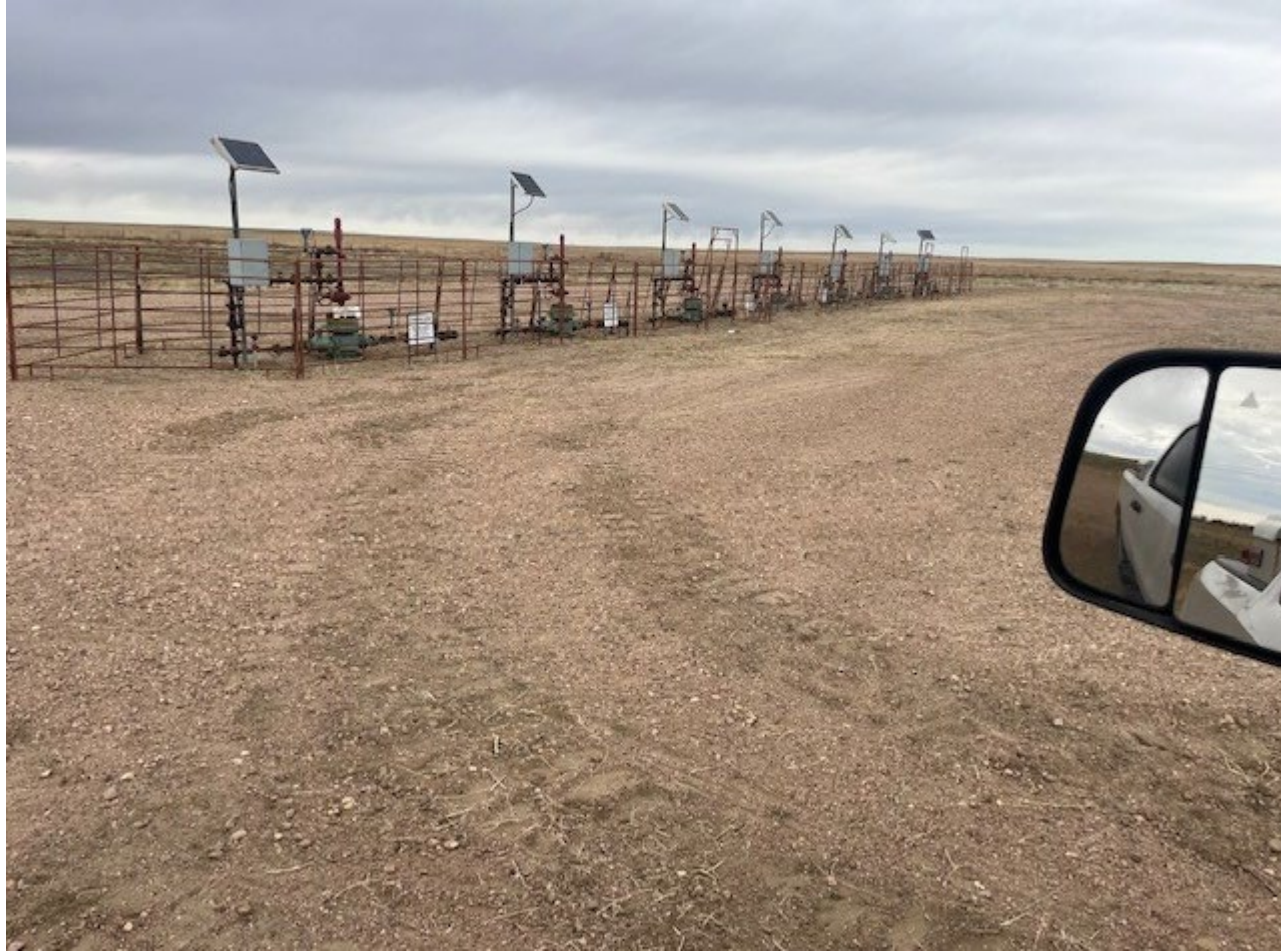
Exhibit A

**CA:** *Tumbleweed accumulations observed throughout the location and within equipment. Degraded straw wattles at SE sediment trap need to be removed as they are not intact. Comply with Rule 606 and remove all debris on location.*

**CA Resolution:** *Debris has been removed to comply with Rule 606.*
