# Final Reclamation and Stormwater Inspection

Operator: Noble Energy Inc - 100322

Location ID: 326991

Location Name: Daniels PM K-64N66W 5SWSW

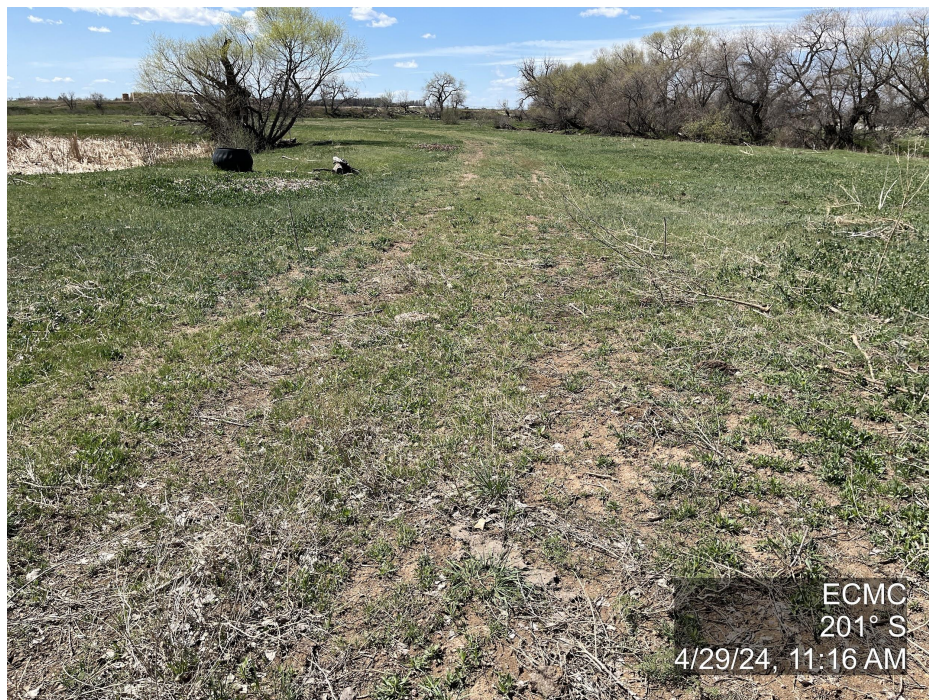
**Photo 1.** The photo was taken at the entrance to the well location facing South. The photo illustrates the access road is still apparent.

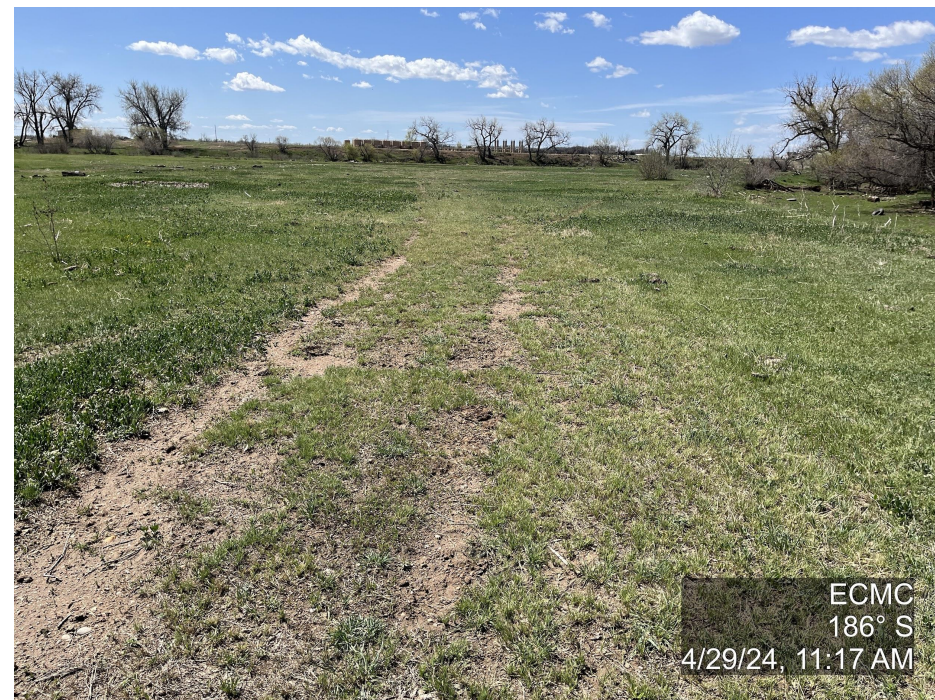
**Photo 2.** The photo was taken along the access road facing South. Refer to the comment for photo 1.

Note - Bare soil was also apparent along the access road.

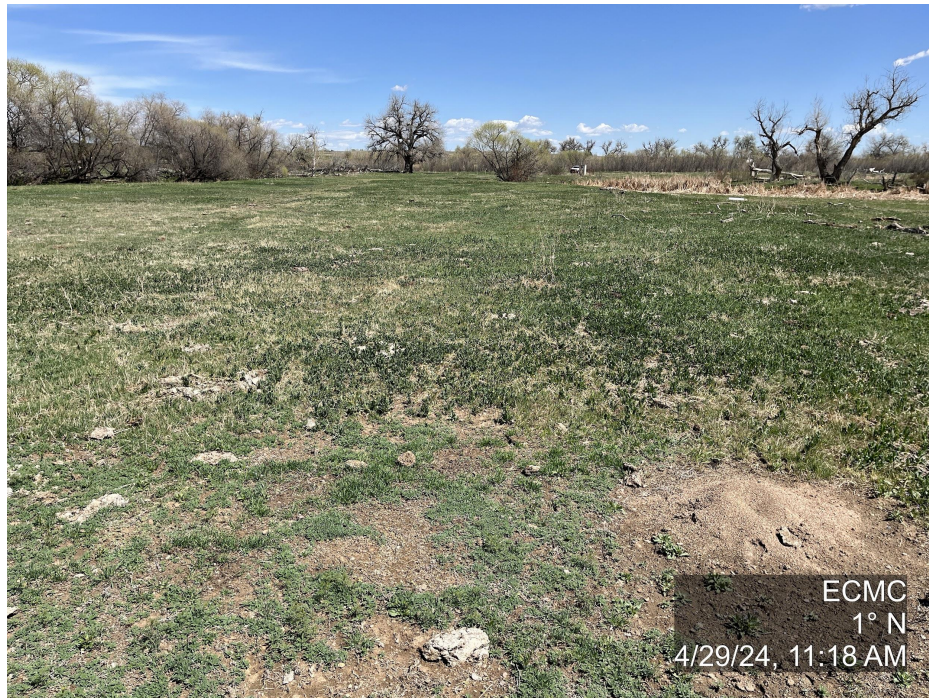
**Photo 3.** The photo was taken at the well location facing North. The photo illustrates the well location is dominated by Hoary Cress, Kochia and bare soil.

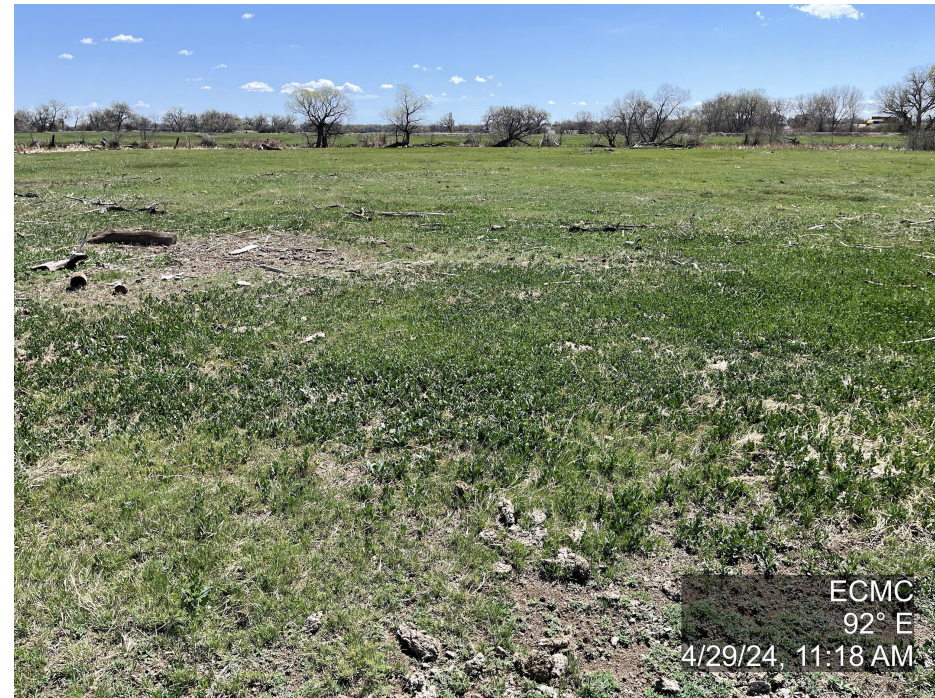
**Photo 4.** The photo was taken at the well location facing East. Refer to the comment for photo 3.

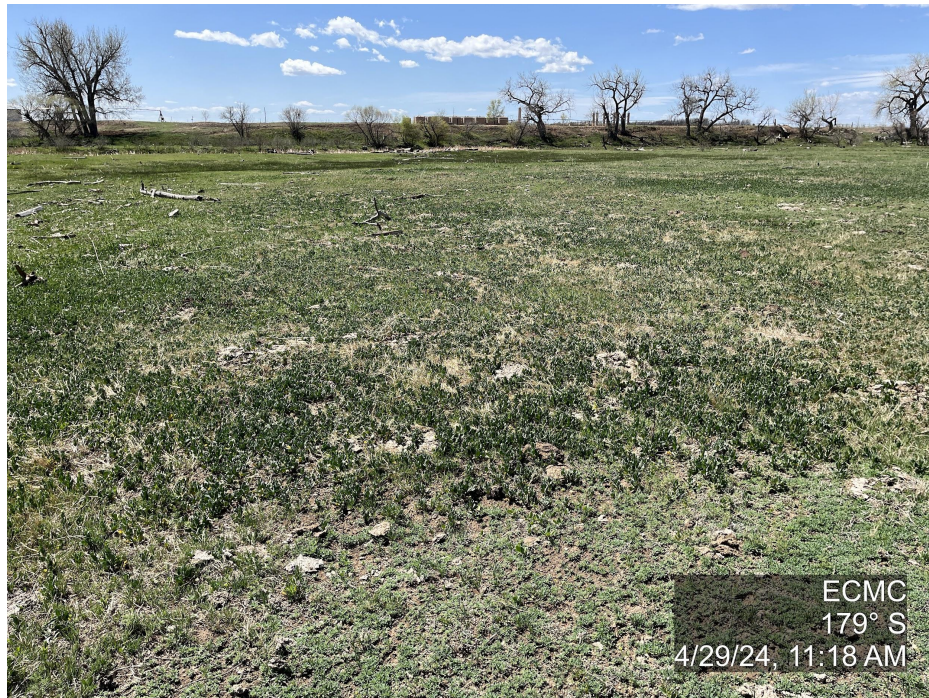
**Photo 5.** The photo was taken at the well location facing South. Refer to the comment for photo 3.

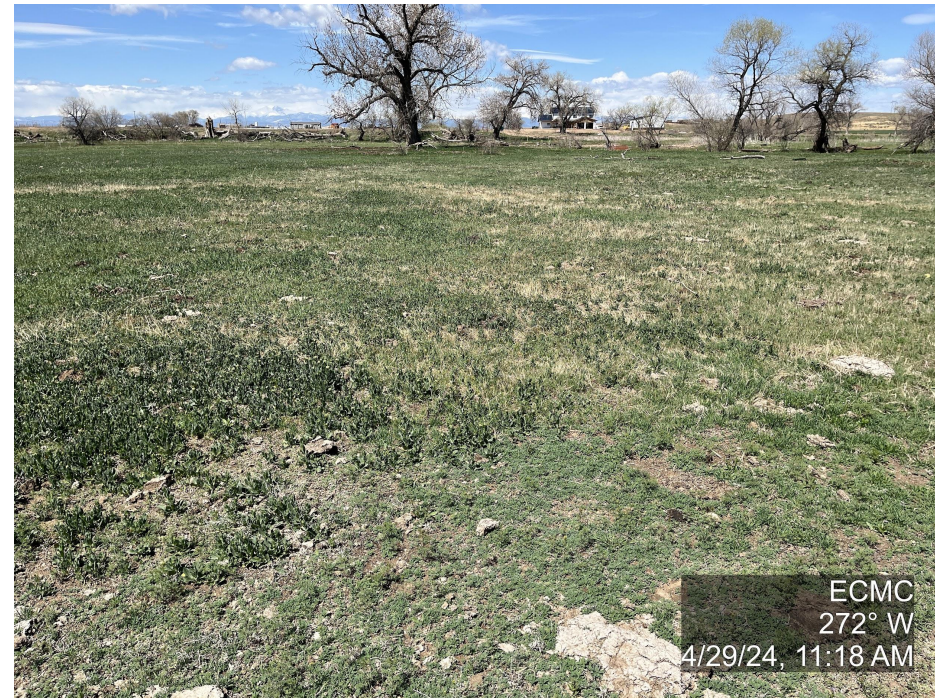
**Photo 6.** The photo was taken at the well location facing West. Refer to the comment for photo 3.

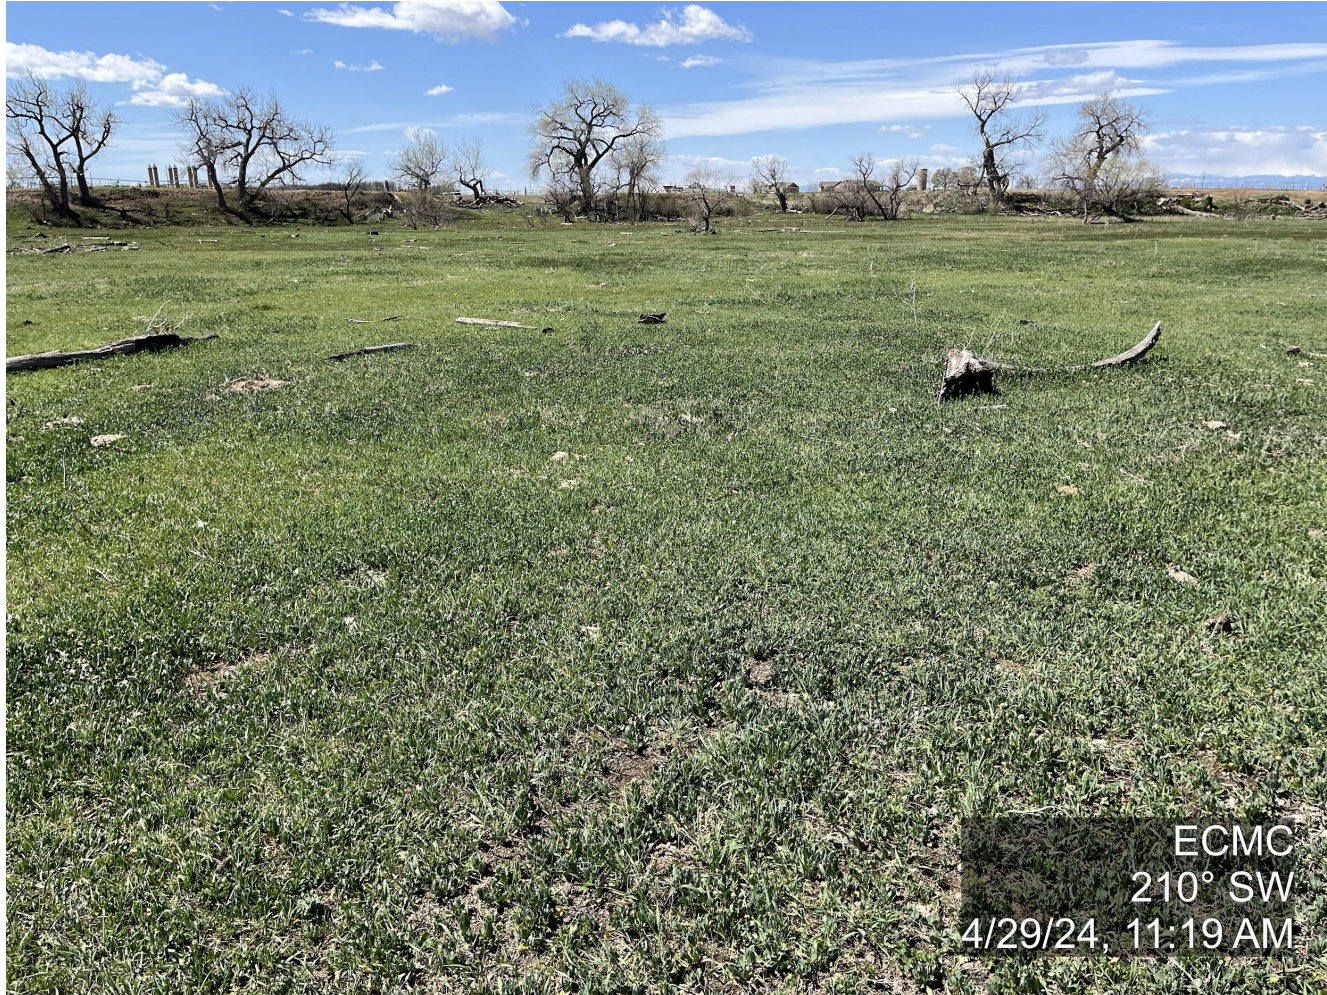
**Photo 7.** The reference photo was taken near the well location facing Southwest. The photo illustrates that reference pasture areas are dominated by perennial grasses.
