Final Reclamation and Stormwater Inspection

Operator: Noble Energy Inc - 100322

Location ID: 447456

Location Name: Daniels PM K 5-13,K 5-25

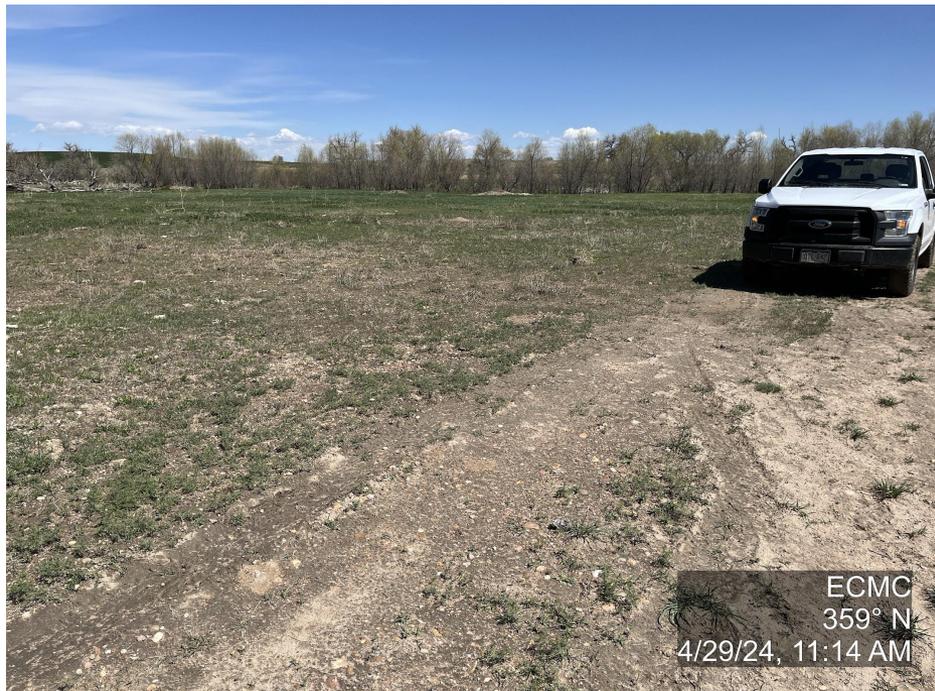
Photo 1. The photo was taken at the tank battery location facing North. The photo illustrates the location is dominated by bare soil, Hoary cress and Kochia.

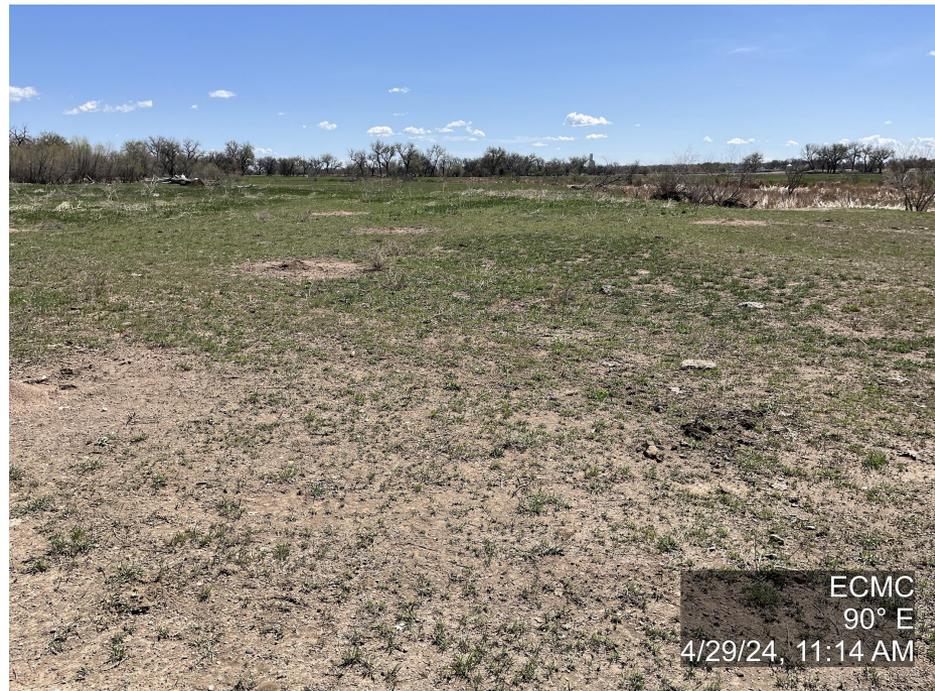
Photo 2. The photo was taken at the tank battery location facing East. Refer to the comment from photo 1.

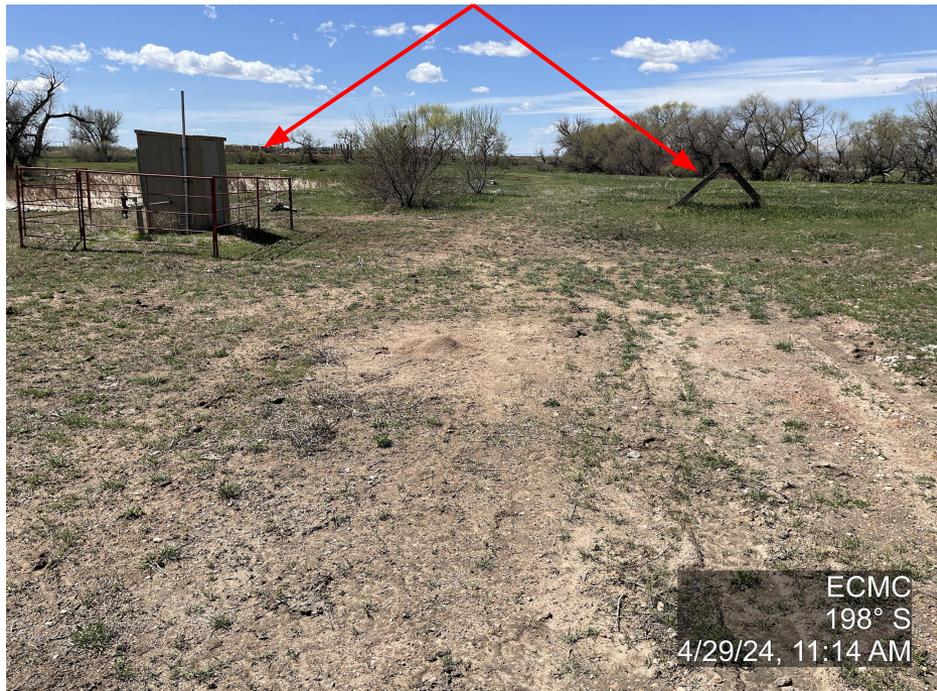
Photo 3. The photo was taken at the tank battery location facing South. Refer to the comment from photo 1.

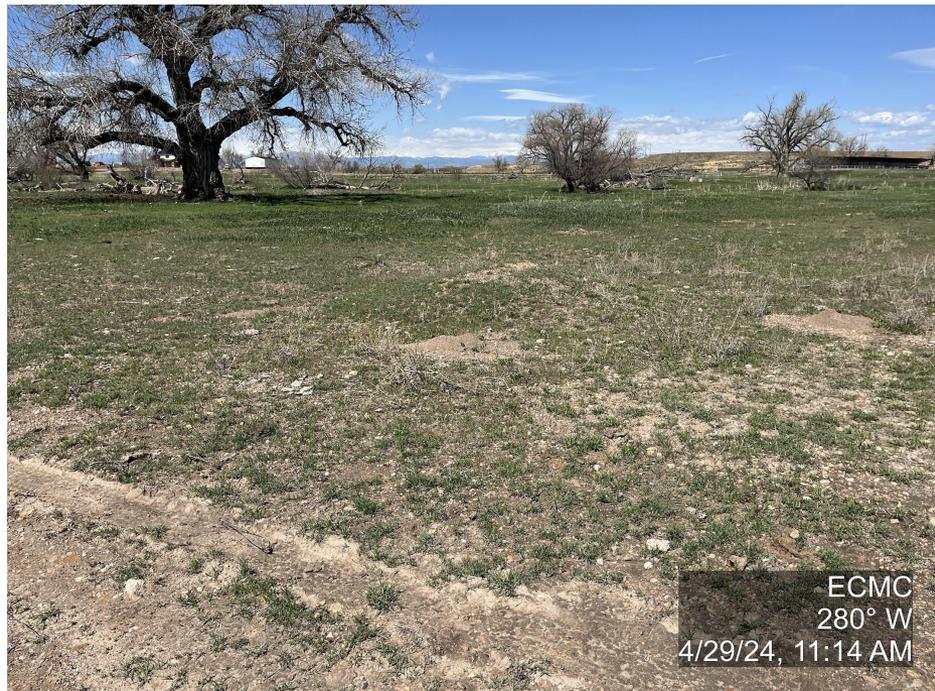
Photo 4. The photo was taken at the tank battery location facing East. Refer to the comment from photo 1.

Note - There is a meter shed and some other piece of equipment still at the location.

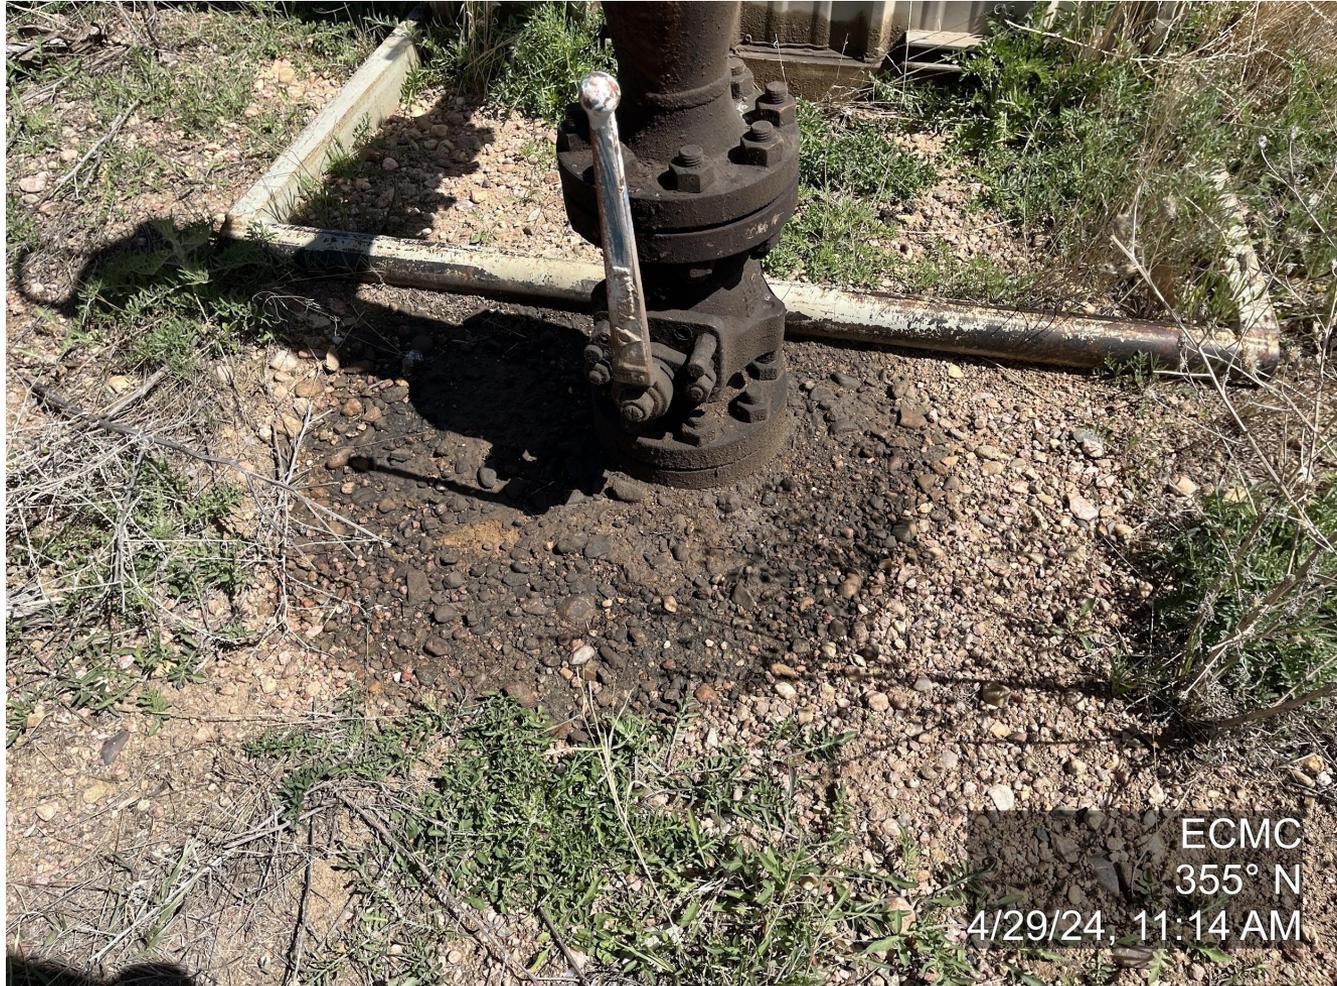
Photo 5. The photo was taken at the tank battery location facing North. The photo illustrates soil staining at the meter shed.
