Operator: HIGHPOINT OPERATING CORPORATION
Location Name: Anschutz Equus Farms 4-62-28 NWNW
Loc ID: 444840
Inspection: 713900527

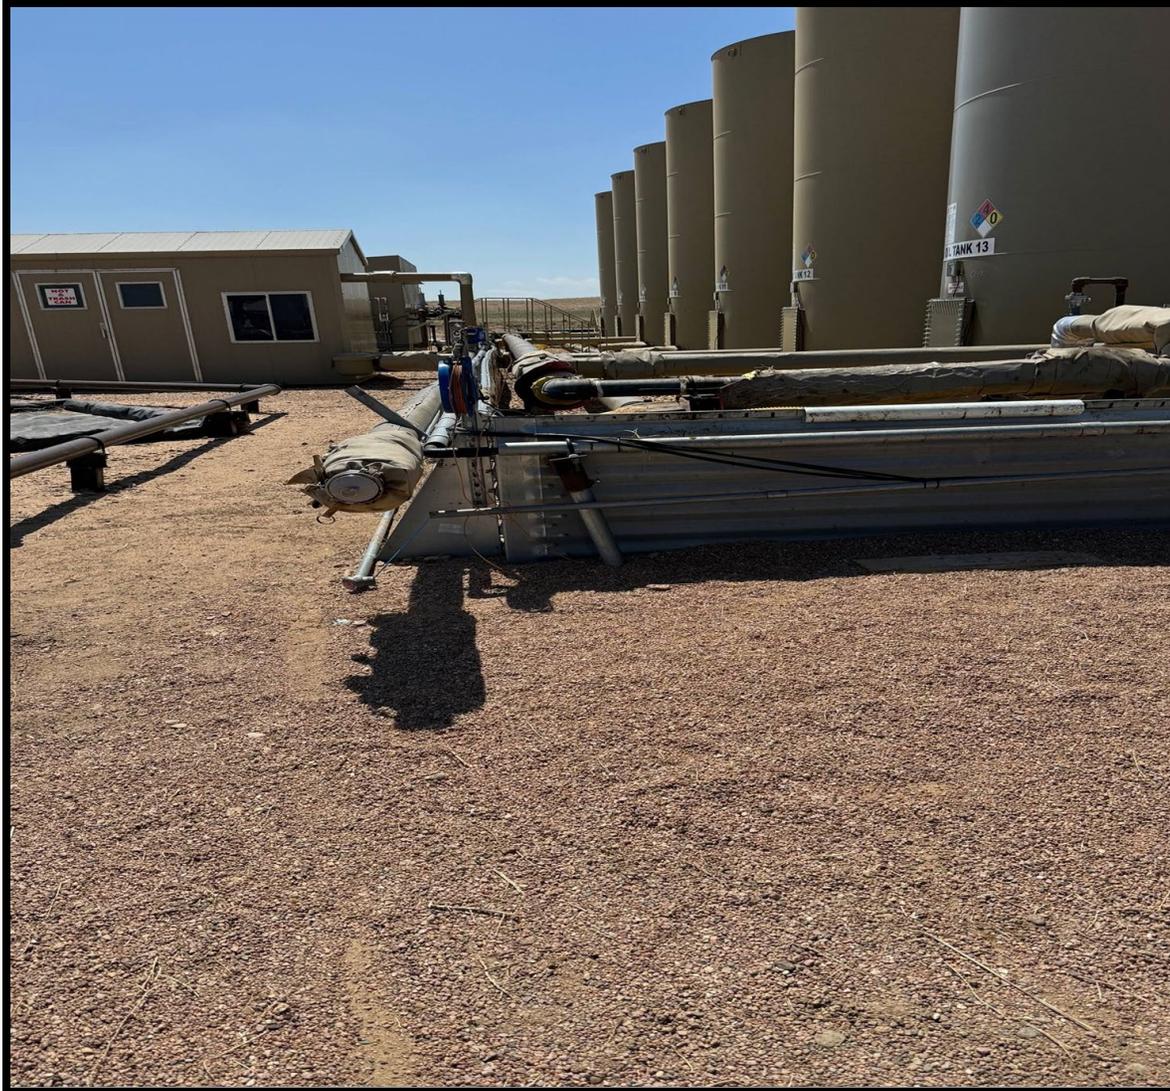
Exhibit A

CA: Stained soil observed on the location and unplugged hoses throughout the production pad. Remove stained soil per Rule 912.a.

CA Resolution: Operator has reported the stained soil has been addressed and disposed of appropriately to comply with Rule 912.a.

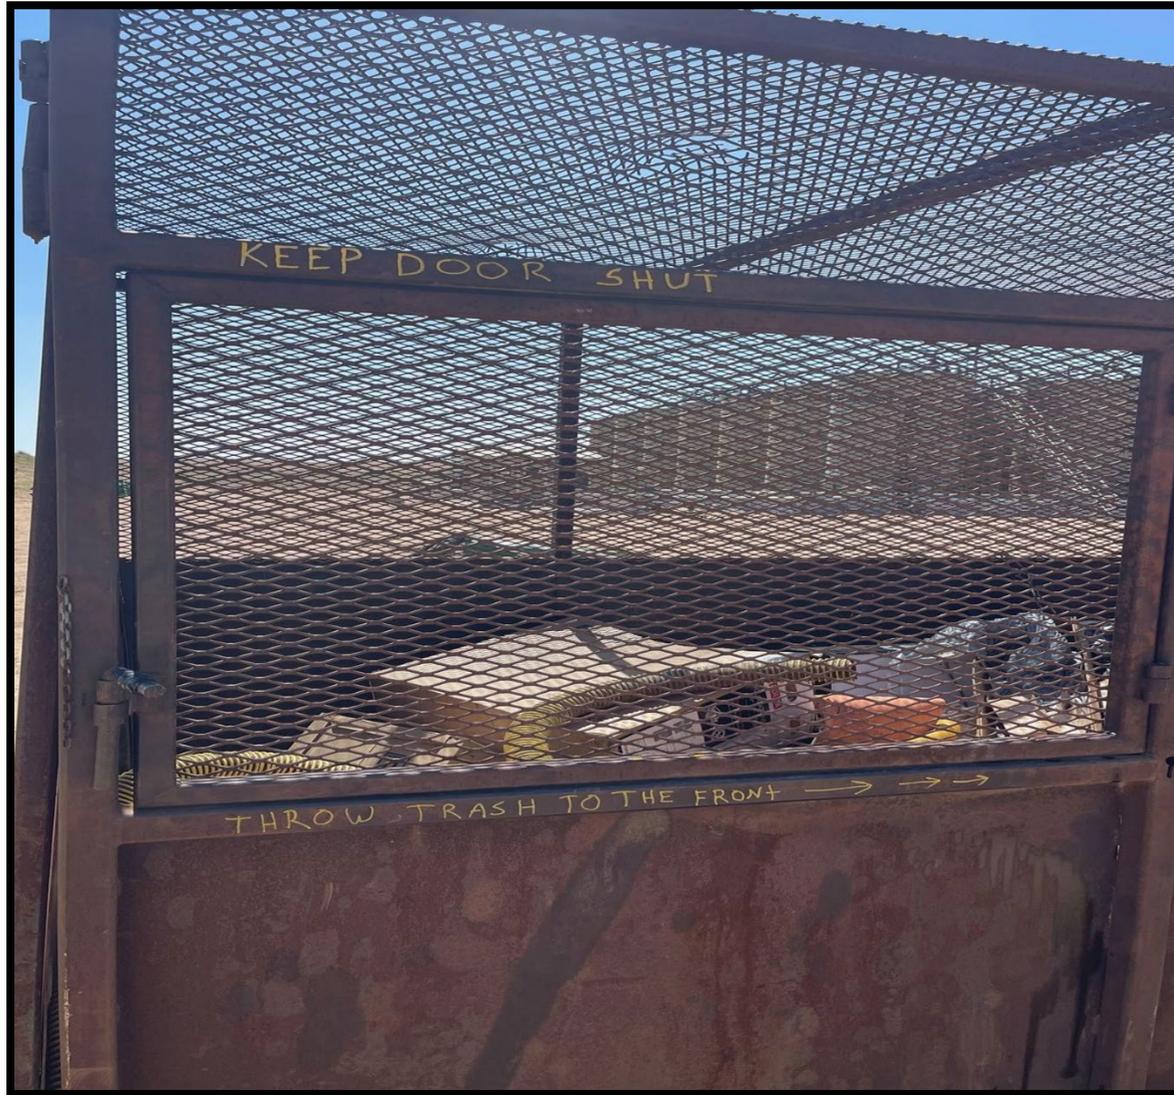
Exhibit A

CA: Trash receptacle is being left open and allowing trash to blow and distribute across the production facility. Comply with Rule 606.

CA Resolution: Operator has reported that identified trash receptacle has been closed and signage added to remind the Field. Debris/trash on location has been cleared to comply with Rule 606.

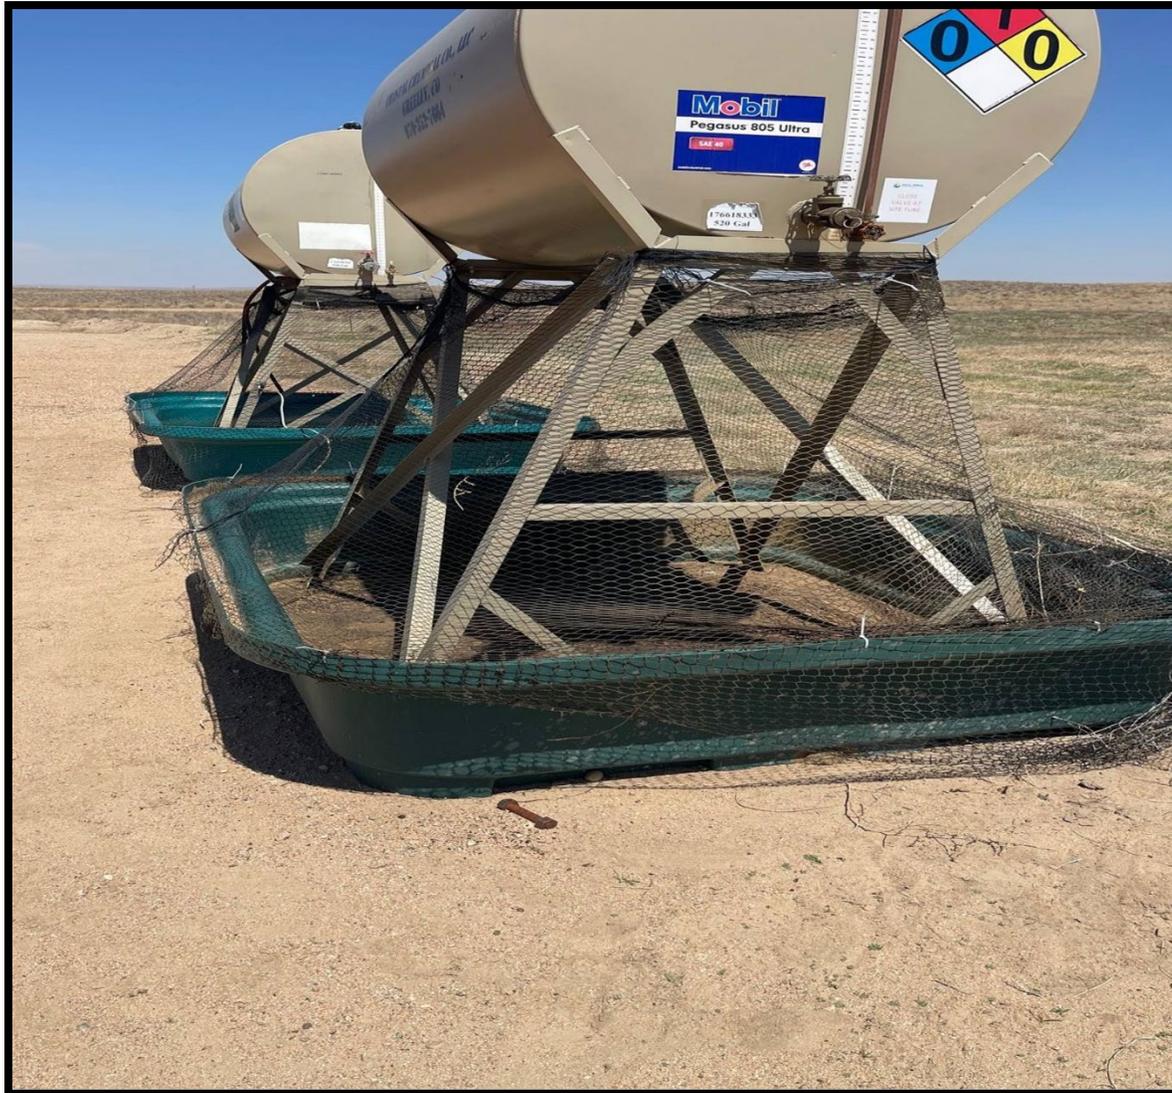
Exhibit A

CA: Wildlife netting was incorrectly installed and should cover the entire secondary containment. Install wildlife protection equipment correctly per Rule 608.

CA Resolution: Operator has appropriately installed wildlife netting to comply with Rule 608.
