Interim Reclamation and Stormwater Inspection

Operator: Crestone Peak Resources Operating LLC -
10633

Location ID: 451622

Location Name: State Challenger 5-65 2-3 3BYH

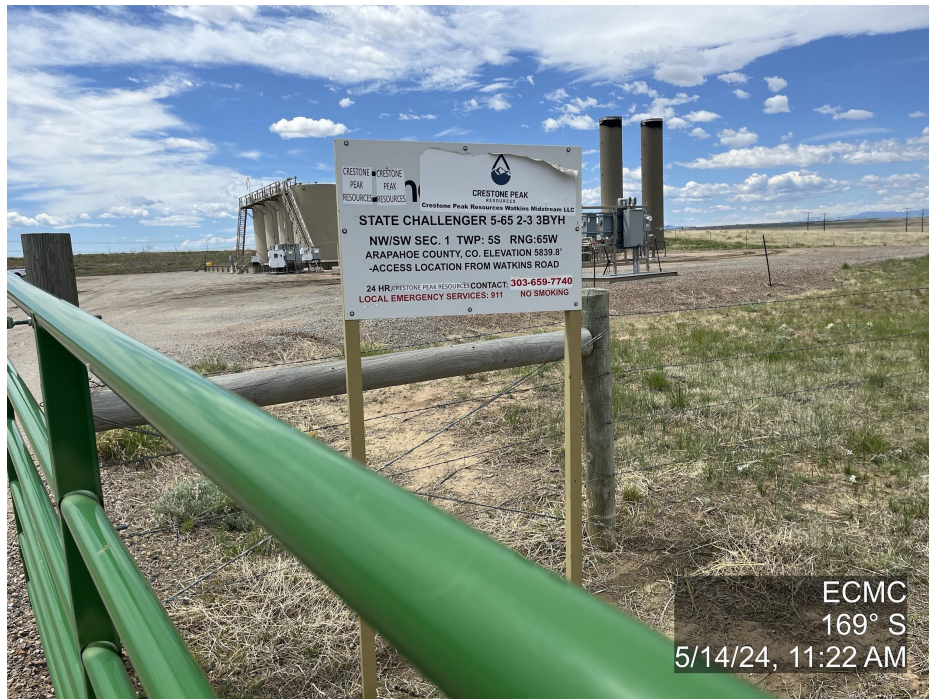
Photo 1. The photo was taken at the well location facing South. The photo illustrates the Operator sign at the entrance.

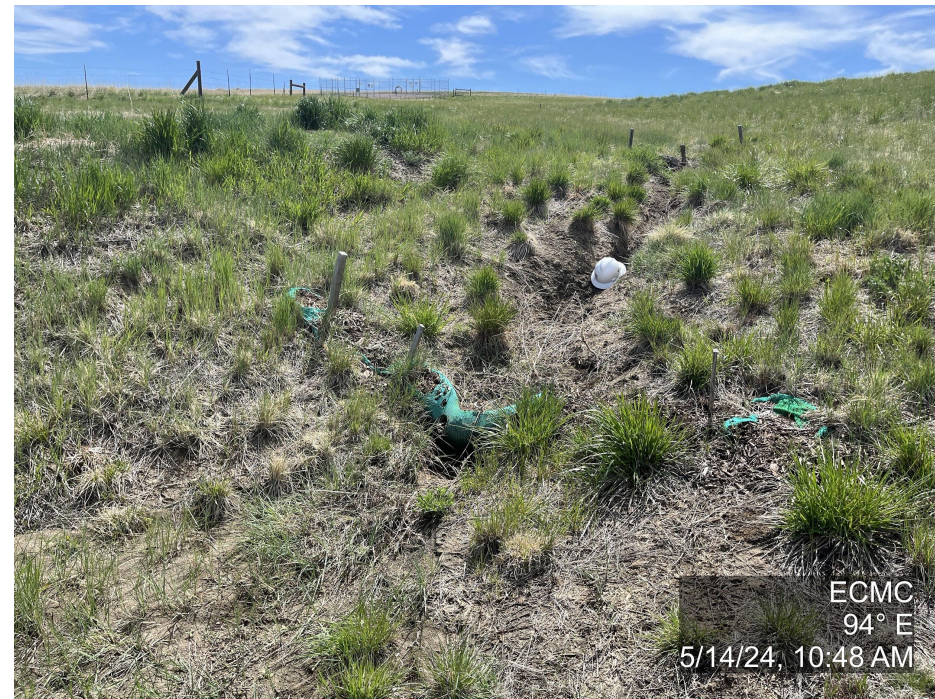
Photo 2. The photo was taken at the well location facing East. The photo illustrates erosion just above the sediment trap that needs repair.

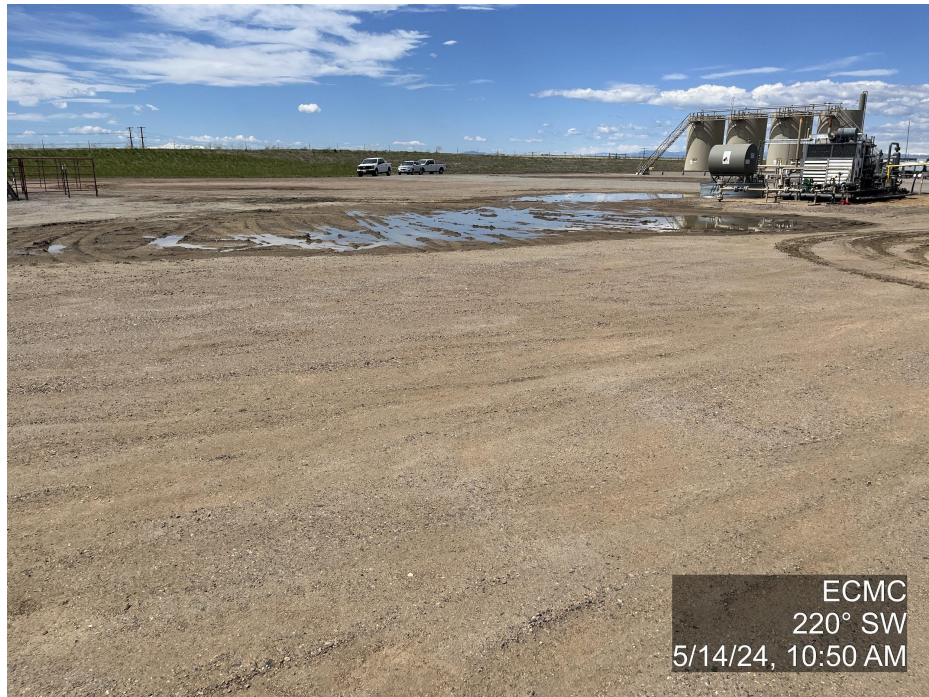
Photo 3. The photo was taken at the well location facing Southwest. The photo illustrates water ponding on the production pad.

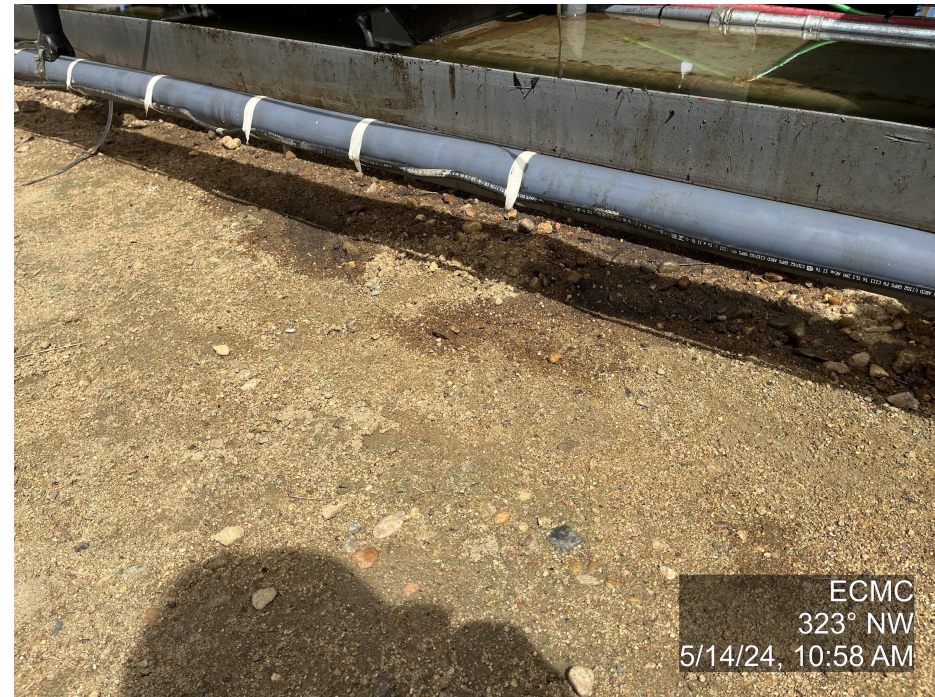
Photo 4. The photo was taken at the well location facing Northwest. The photo illustrates soil staining and stained water on the production sled with no freeboard.

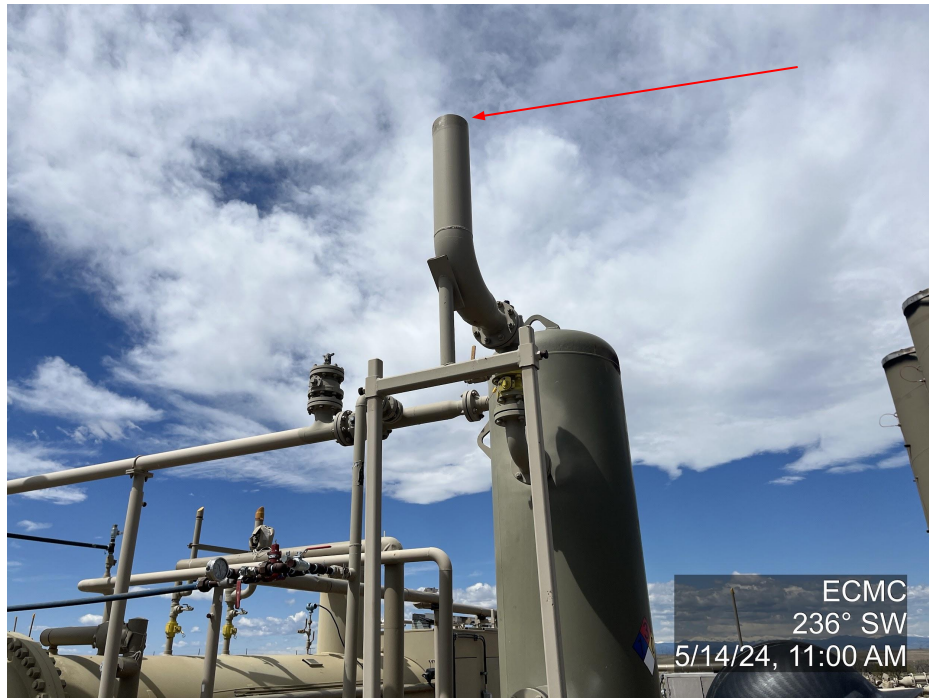
Photo 5. The photo was taken at the well location facing Southwest. The photo illustrates a missing cover on the exhaust of production equipment.

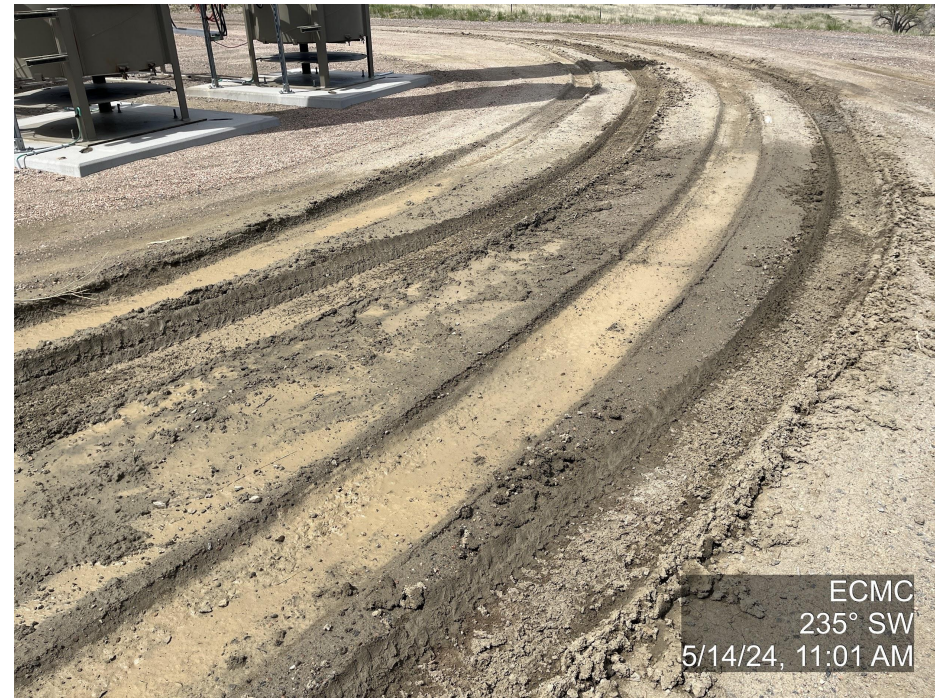
Photo 6. The photo was taken at the well location facing Southwest. The photo illustrates vehicle tracking through water ponding on the production pad.

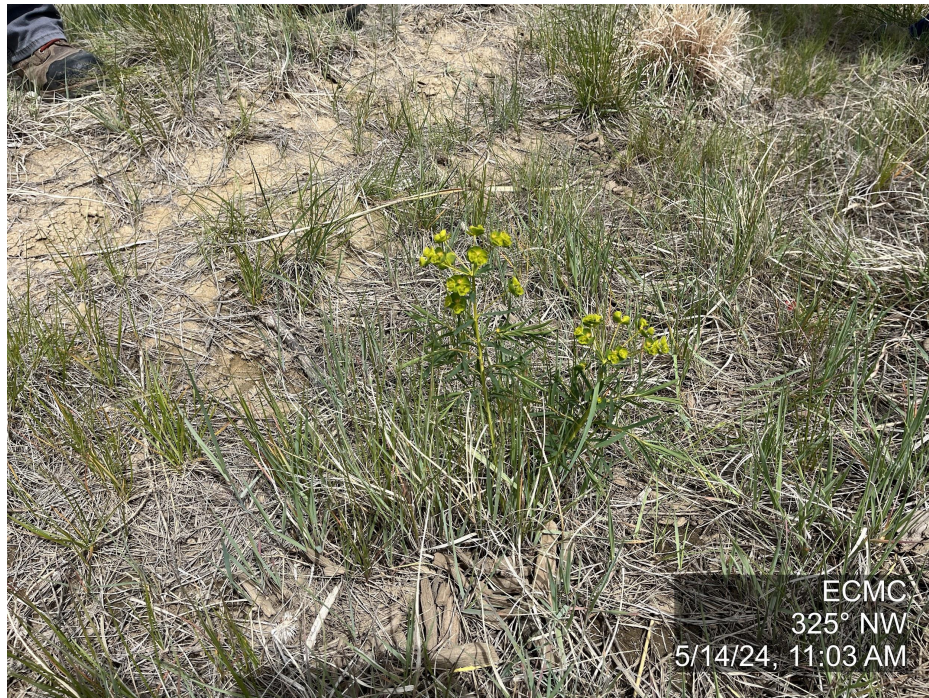
Photo 7. The photo was taken at the well location facing Northwest. The photo illustrates Leafy spurge, CO Noxious Weed List B species, that is growing around the Southwest corner of the interim areas and along the access road.

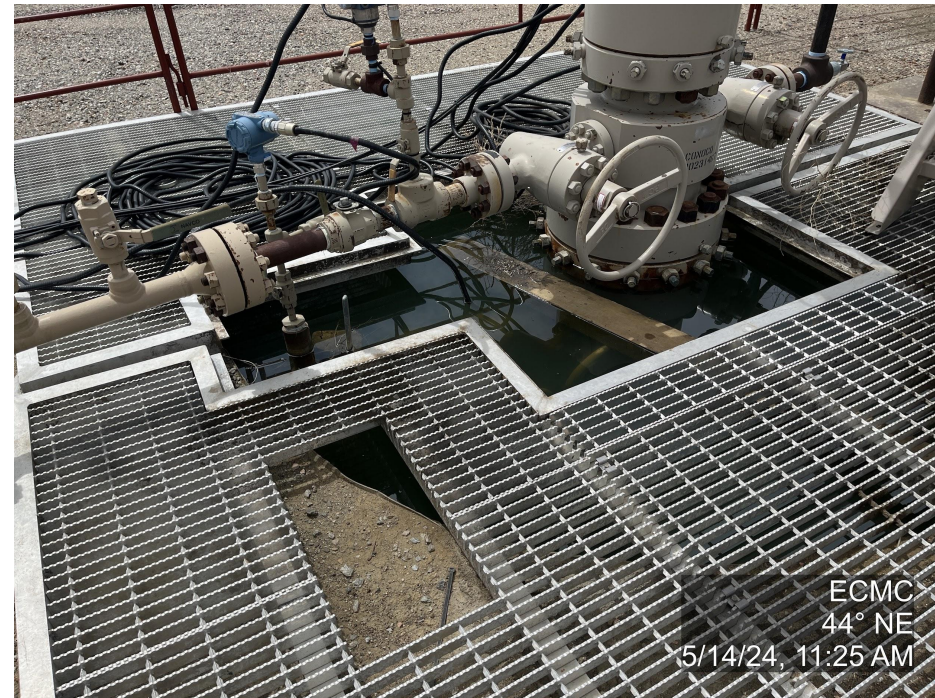
Photo 8. The photo was taken at the well location facing Northeast. The photo illustrates the grate around the wellhead is not sufficient to keep out wildlife and the cellar is full of water which has floated the wooden wildlife ramp that also appears to not be sufficient as a wildlife BMP.
