**Operator: CPR**

**Location Name: Lussing Trust 4-64 19-20 North**

**Inspection: 713900705**

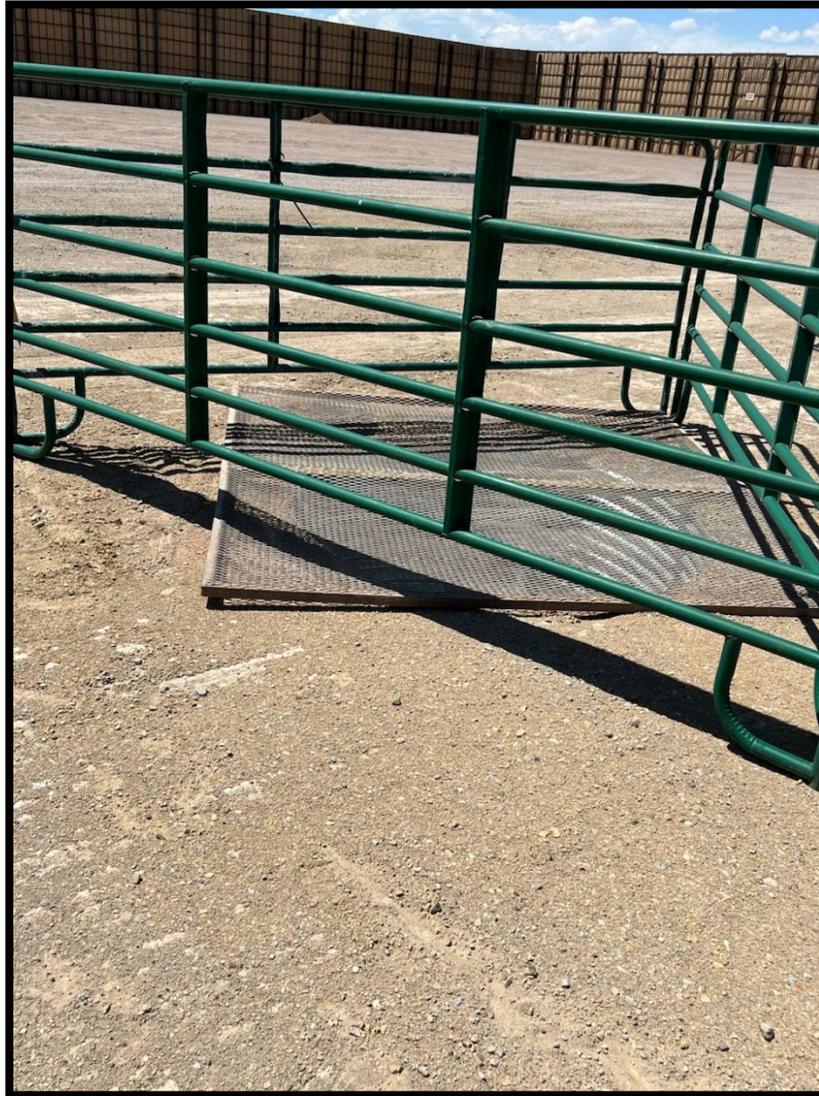
**Exhibit A**

**CA:** At the time of inspection the Operator has failed to install wildlife BMP's on surface casings. Install covers or ramps on surface casings per Rule 406.

**CA Resolution:** Operator has reported as of 6/25, the cellars have been appropriately covered to comply with Rule 406.
