Final Reclamation and Stormwater Inspection

Operator: PDC Energy Inc - 69175

Location ID: 418247

Location Name: Ryland-Marostica Multi-Well

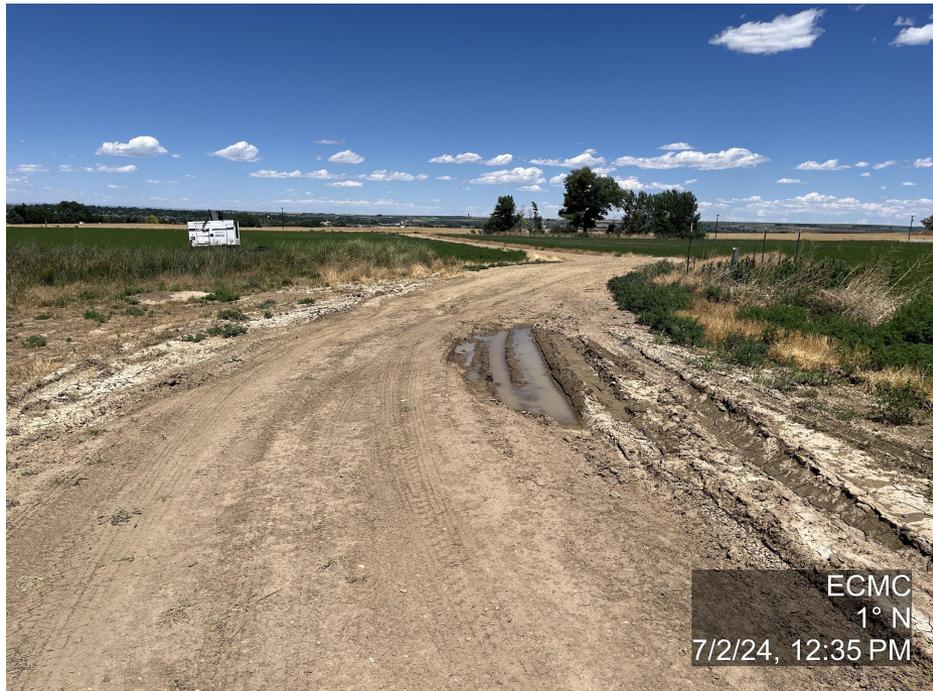
Photo 1. The photo was taken at the well location facing North. The photo illustrates the access road still remains.

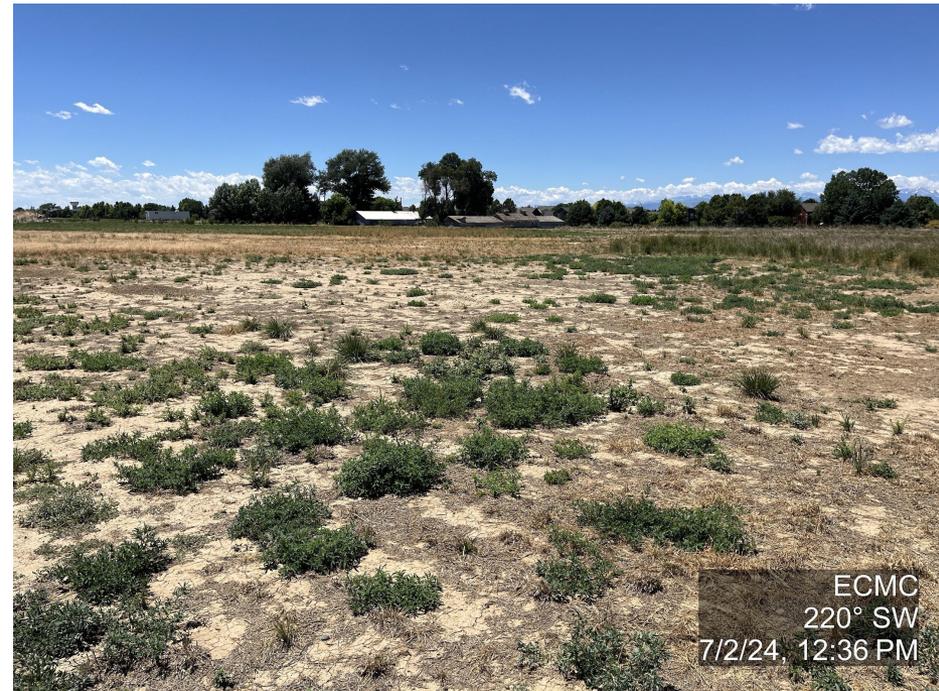
Photo 2. The photo was taken at the well location facing Southwest. The photo illustrates the central and southern area of the well location is dominated by bare soil and Kochia.

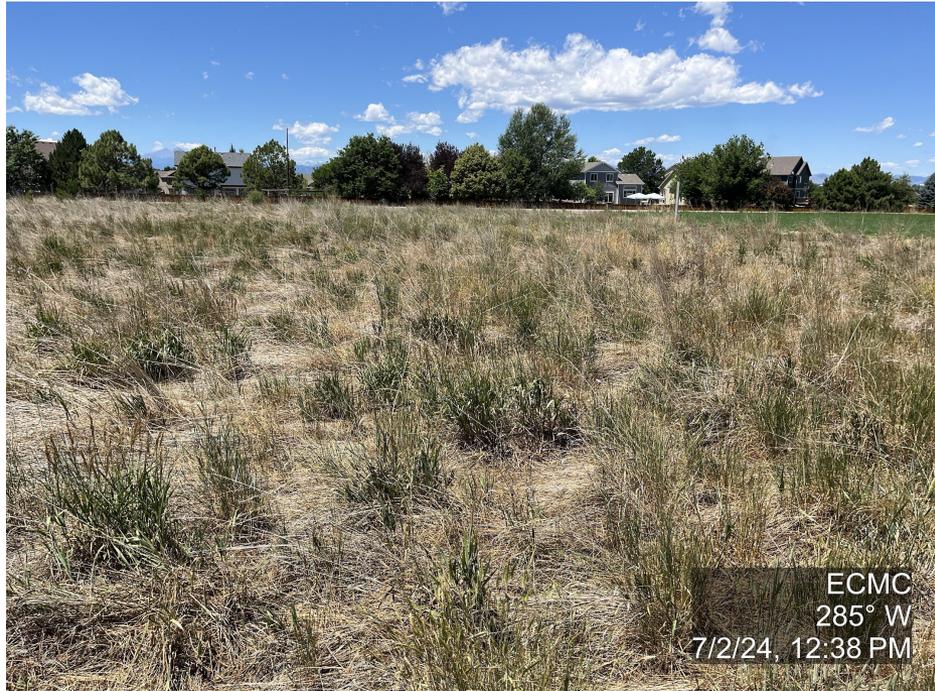
Photo 3. The photo was taken at the well location facing West. The photo illustrates the Northwest corner of the well location is dominated by Smooth brome and Crested wheatgrass.

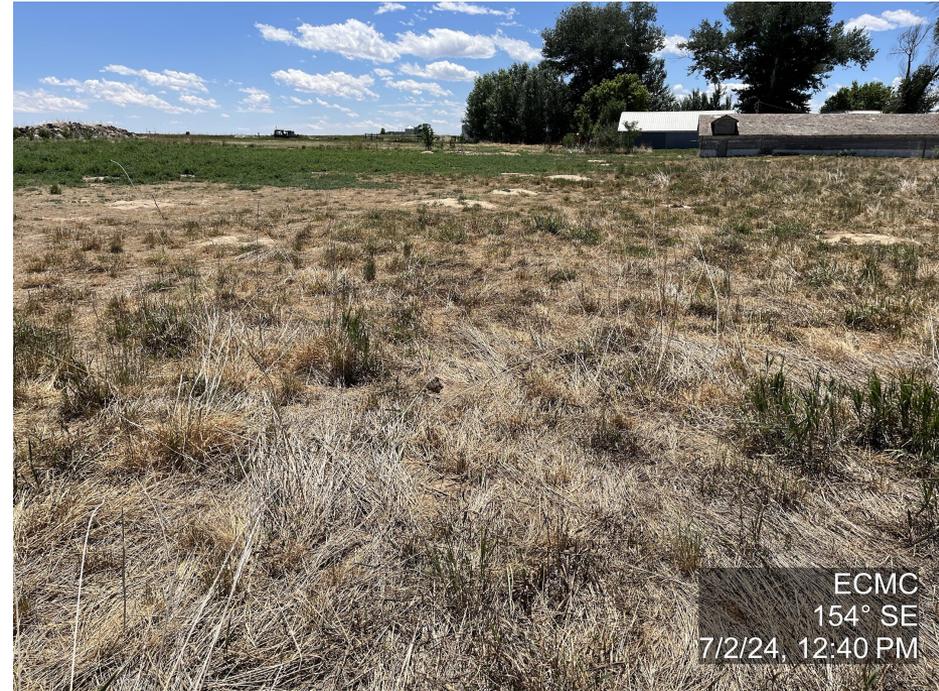
Photo 4. The photo was taken at the well location facing Southeast. The photo illustrates the South side of the well location is dominated by Smooth brome and Crested wheatgrass. Kochia is dominating the Southeast.

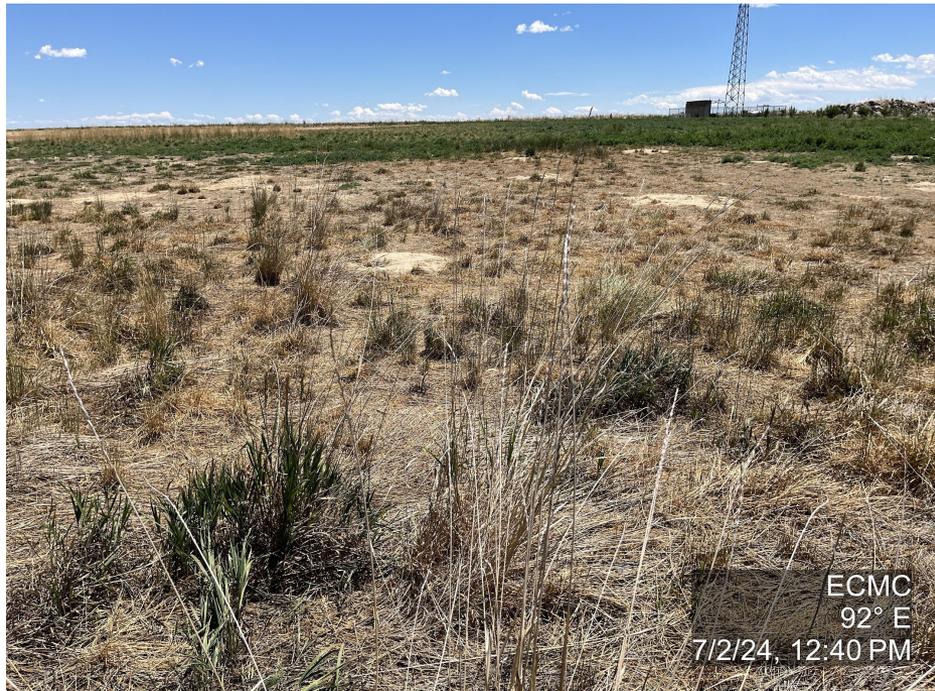
Photo 5. The photo was taken at the well location facing East. The photo illustrates the Southeast corner of the well location is dominated by Kochia and bare soil.

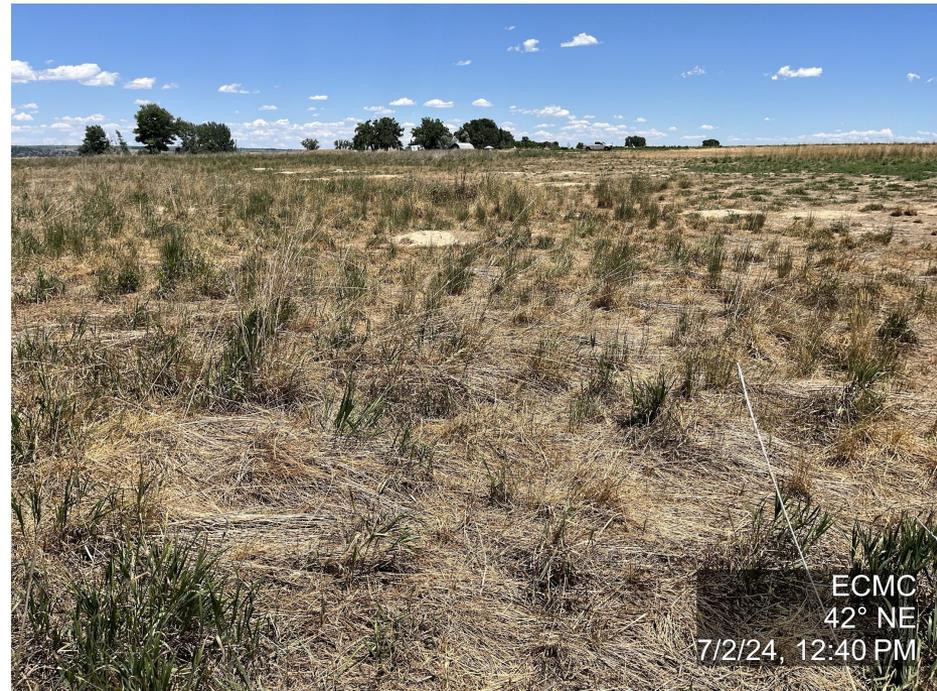
Photo 6. The photo was taken at the well location facing Northeast. The photo illustrates the overview of the well location and demonstrates dominance of bare soil, Smooth Brome and Crested wheatgrass.

Note - An active prairie dog town is throughout the location.

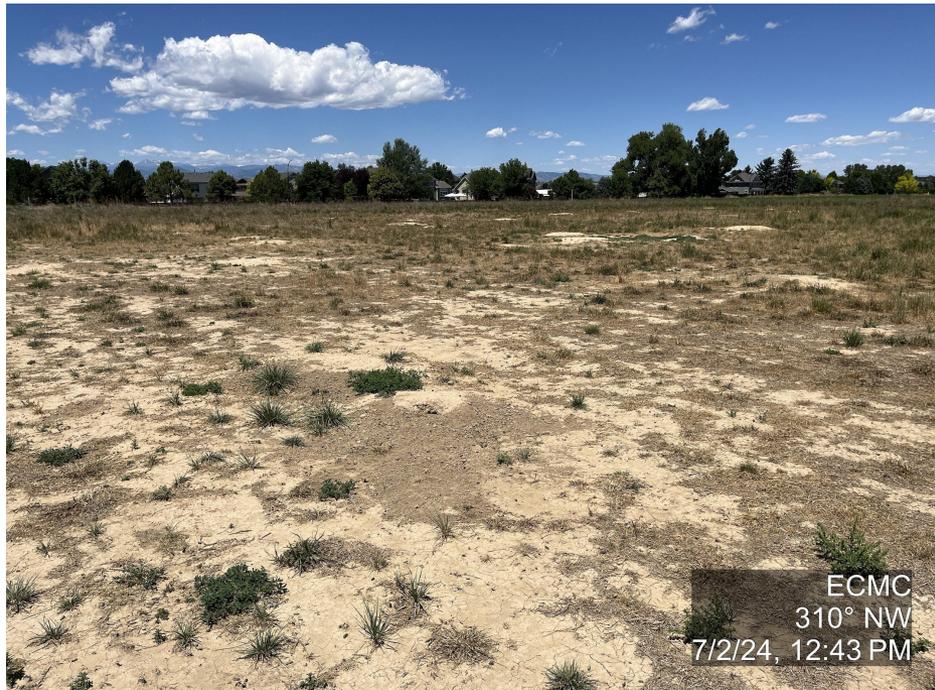
Photo 7. The photo was taken at the well location facing Northwest. The photo illustrates the a large area of bare soil in the center of the well location.

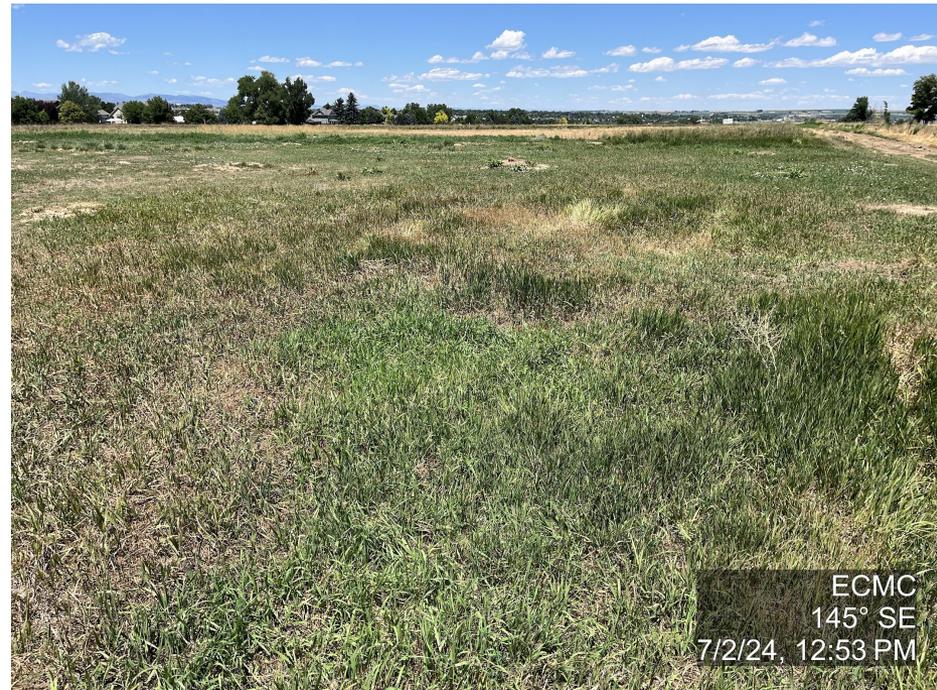
Photo 8. The reference photo was taken near the well location facing Southeast. The photo illustrates reference areas are dominated by Smooth brome.

Note - The rest of the surrounding areas are agricultural fields.
