**Operator: EXTRACTION OIL & GAS INC**

**Location Name: Arellano 10-L Pad**

**Loc ID: 440761**

**Inspection: 708201214**

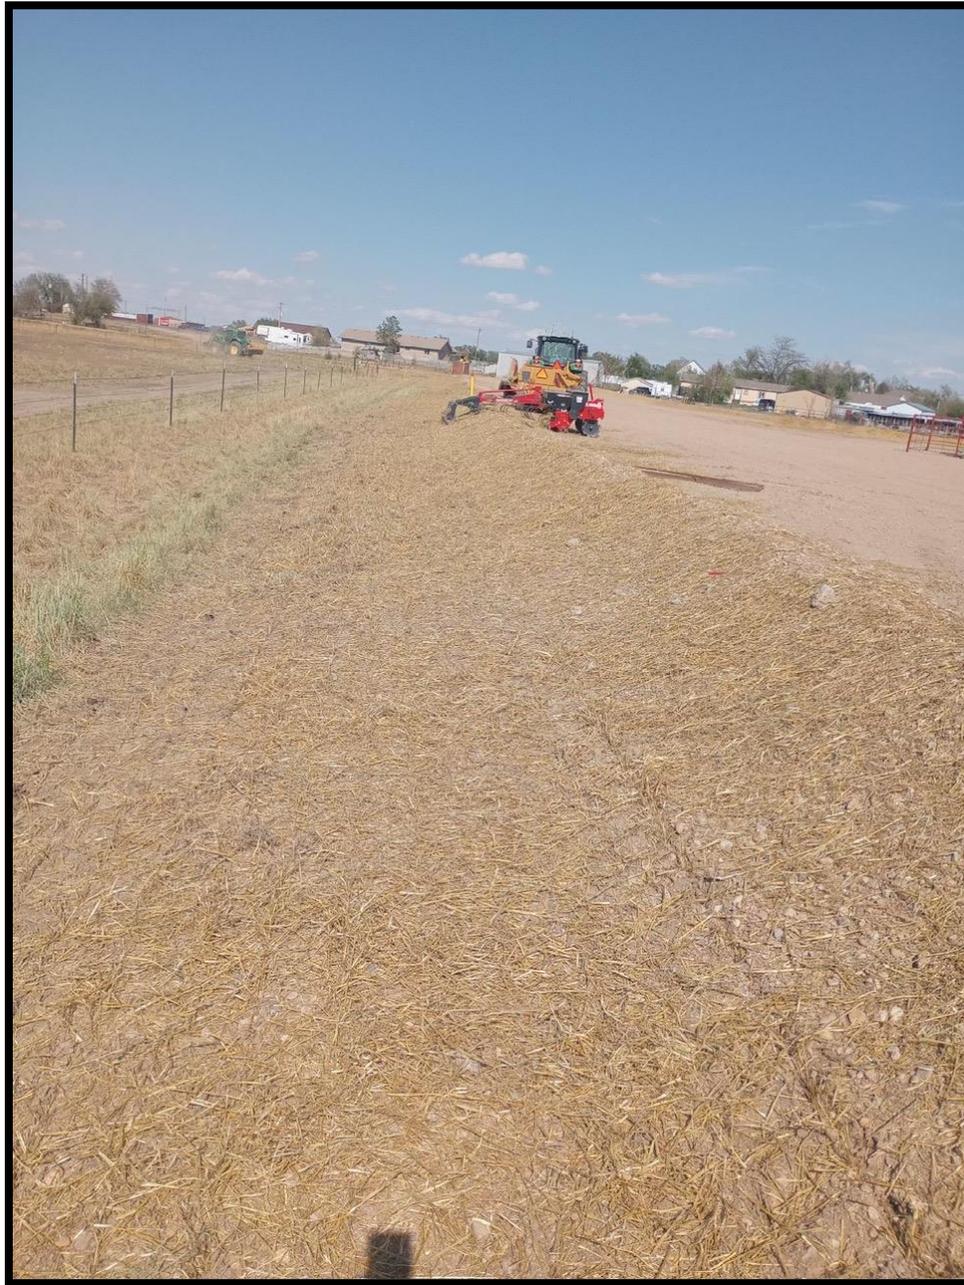
Exhibit A

**CA:** This location does not comply with Rule 1003. During this inspection, it was observed that interim areas do not appear to be progressing towards reclamation/vegetative standards with evidence of undesirable vegetation (e.g. kochia) throughout. Refer to FIR (#708201212) for additional reclamation comments at Location (#440766). Refer to attached inspection photos for additional. Comply with Rule 1003. Perform reclamation in accordance with Rule 1003. Establish vegetation with total perennial, non-invasive uniform plant cover of at least eighty (80) percent of reference area levels. Use a seed mixture requested by the surface owner, or a mixture prescribed by the local county NRCS. Ensure erosion controls are implemented to stabilize the seeded soil and continue to monitor and manage this site until the location meets Rule 1003 standards.

**CA Resolution:** Operator has reported that the location has been seeded, and straw crimped to provide stabilization and promote more uniform future growth. Operator also noted that the location was sprayed prior to interseeding actions to address weeds/additional undesirable vegetation. Location currently complies with Rule 1003.
