**Operator: *CRESTONE PEAK RESOURCES OPERATING LLC***  
**Location Name: LIBERTY 63N68W / 21 NENW 2-21 BATTERY**  
**Loc ID: 424387**  
**Inspection: 694100401**

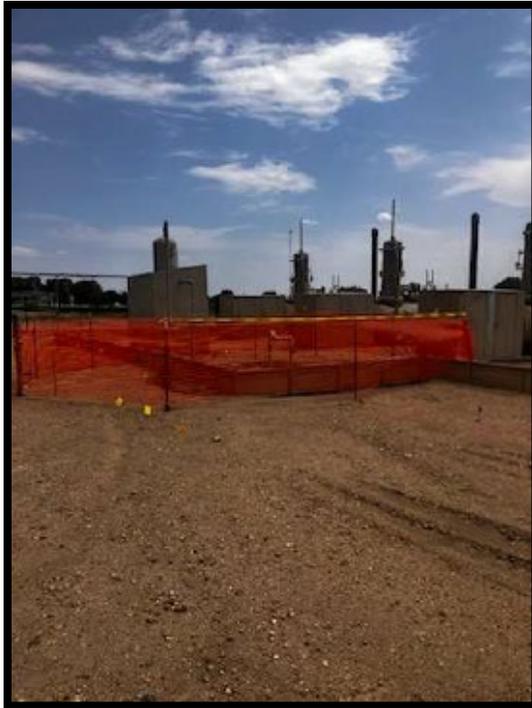
Exhibit A

**CA:** Orange construction fencing around the open excavation is falling down, needs to be resecured. Install or repair required BMP's per Rule 1002.f(2)C
