Operator: Civitas N.

Location Name: HUNGENBERG-611N61W 29SWNW

Loc ID: 410182

Inspection: 691400020

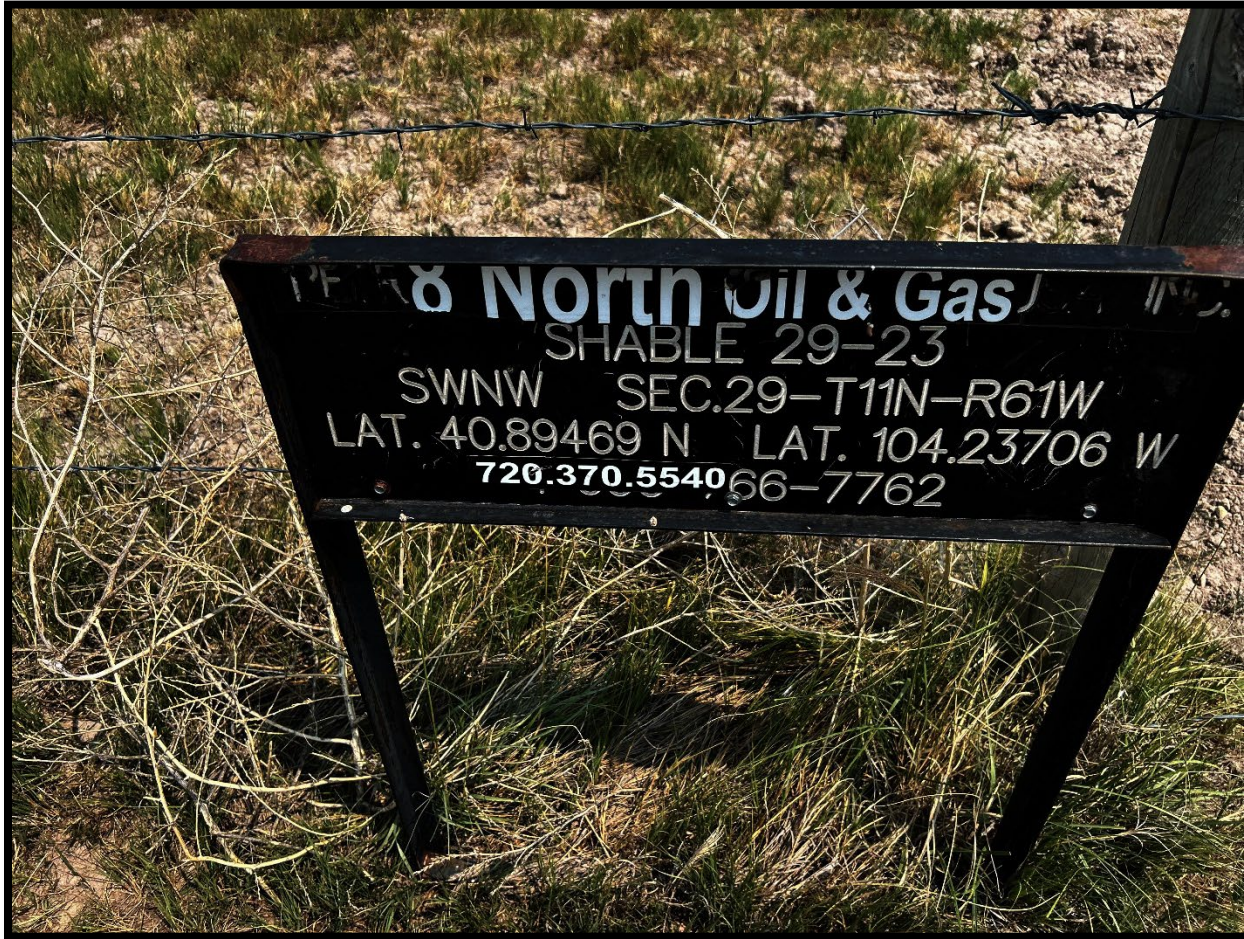
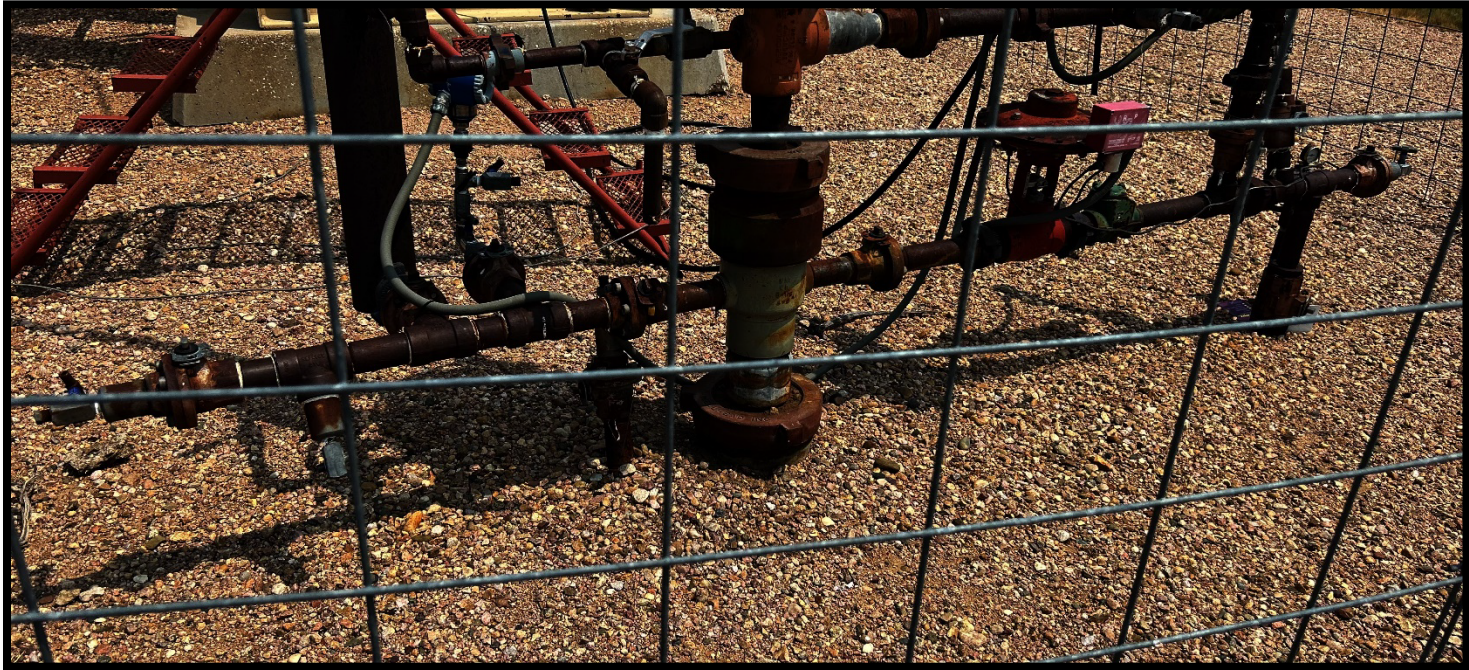
CA: Stained soil around wellhead. Comply with Rule 603.f.

CA Resolution: Operator has provided photo evidence showing that the stained soil at the wellhead has been addressed in compliance with the 600 series.
