Operator: 8 NORTH LLC

Location Name: KAUFMAN PC GL20-68HN

Loc ID: 429749

Inspection: 696301573

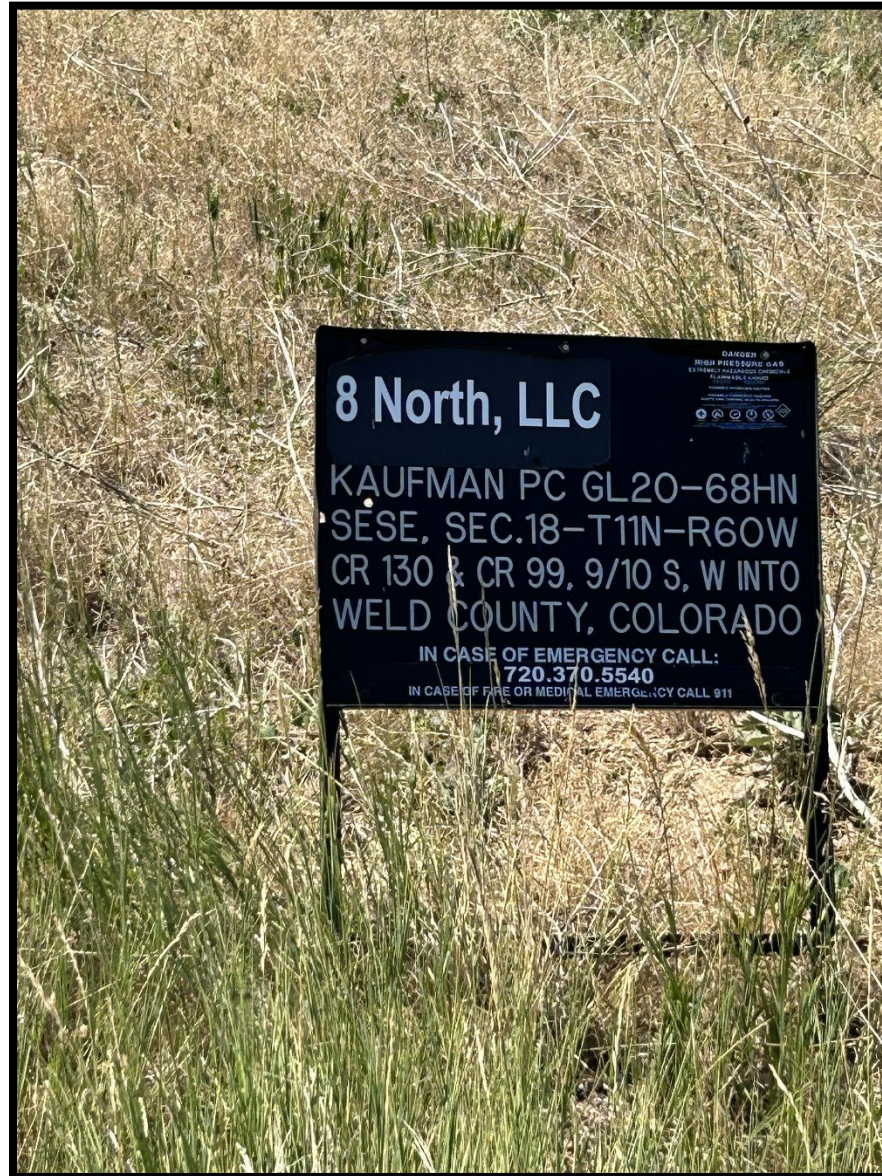
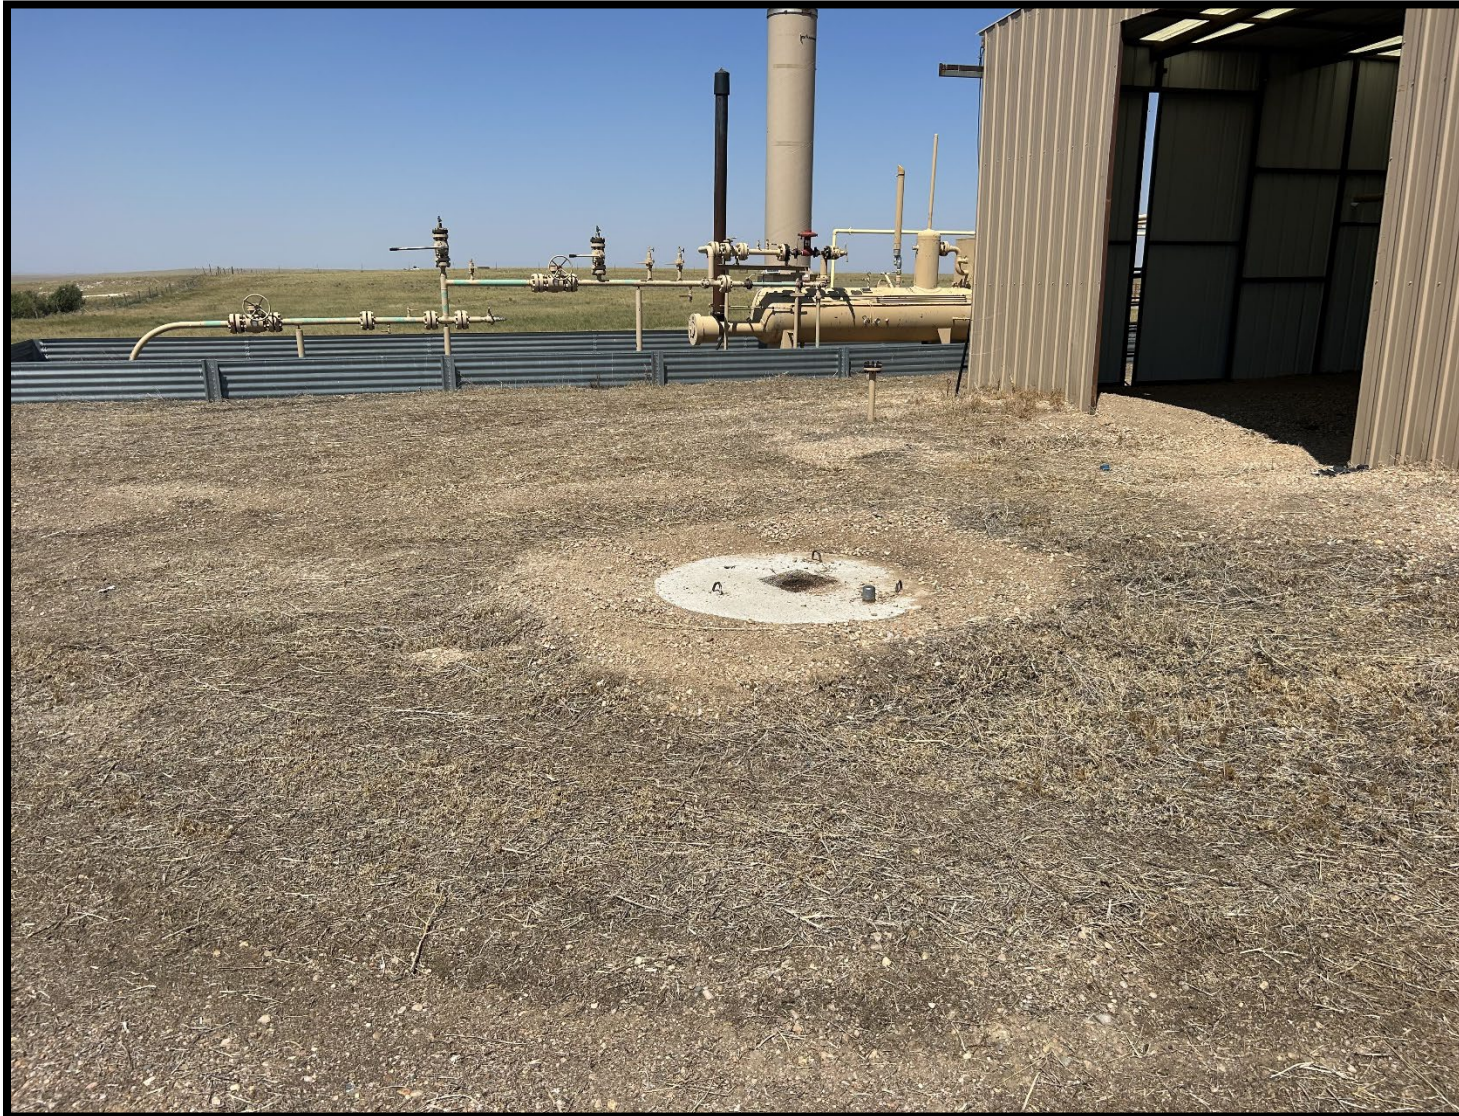
CA: Stained Soil at Compressor drain vault, see photos. For localized stained soils or oily waste - "Properly dispose of oily waste in accordance with 907.e."

CA Resolution: Operator has provided photo evidence showing that the stained soil at the wellhead has been addressed in compliance with the 900 and 600 series.
