Operator: 8 North

Location Name: SHABLE-611N61W 32NENW

Loc ID: 310712

Inspection: 684904657

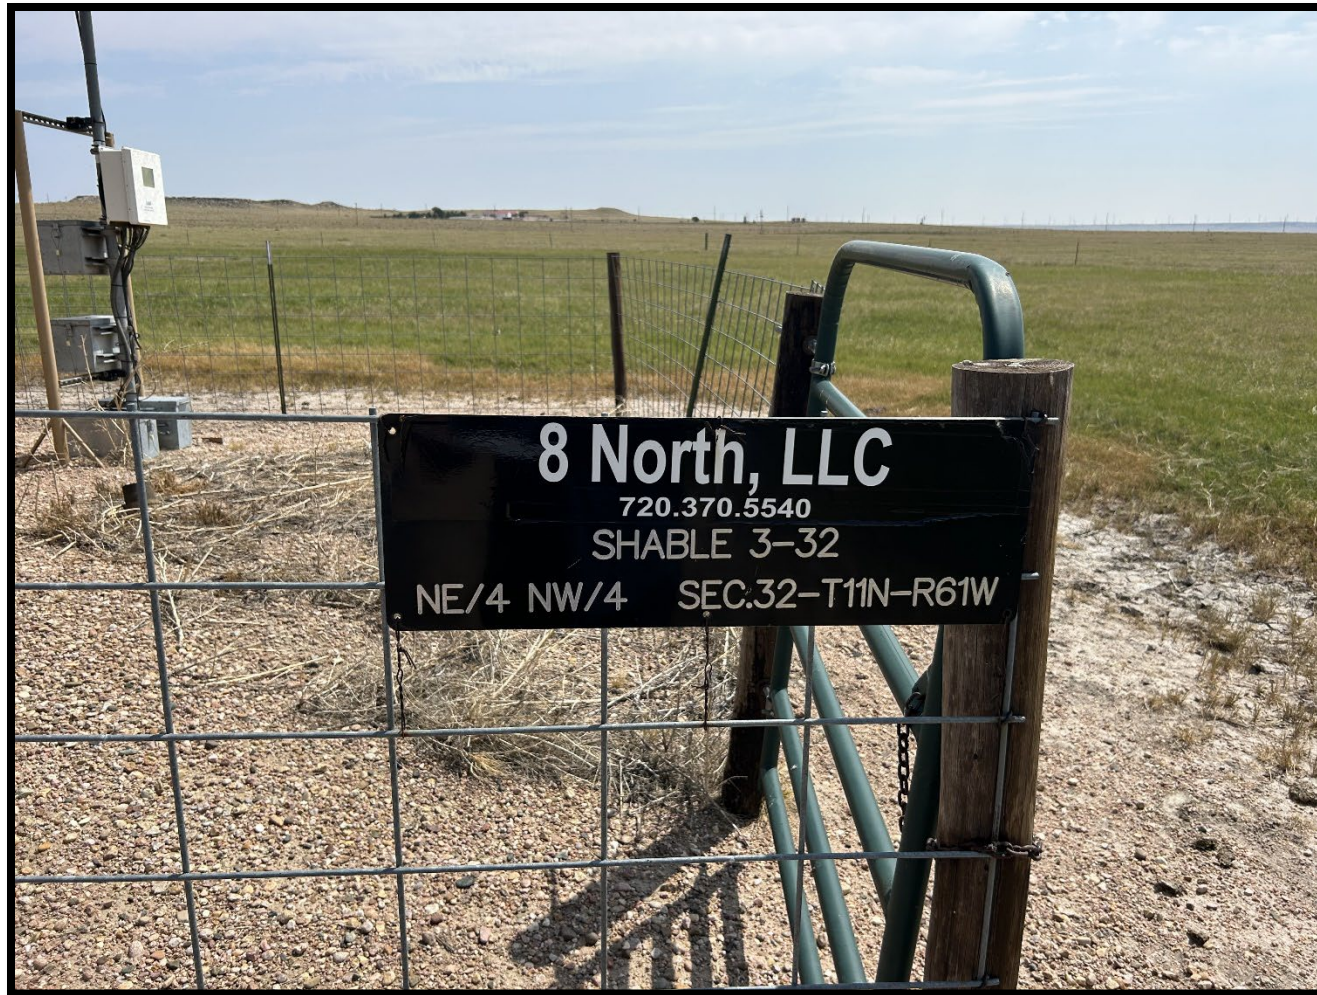
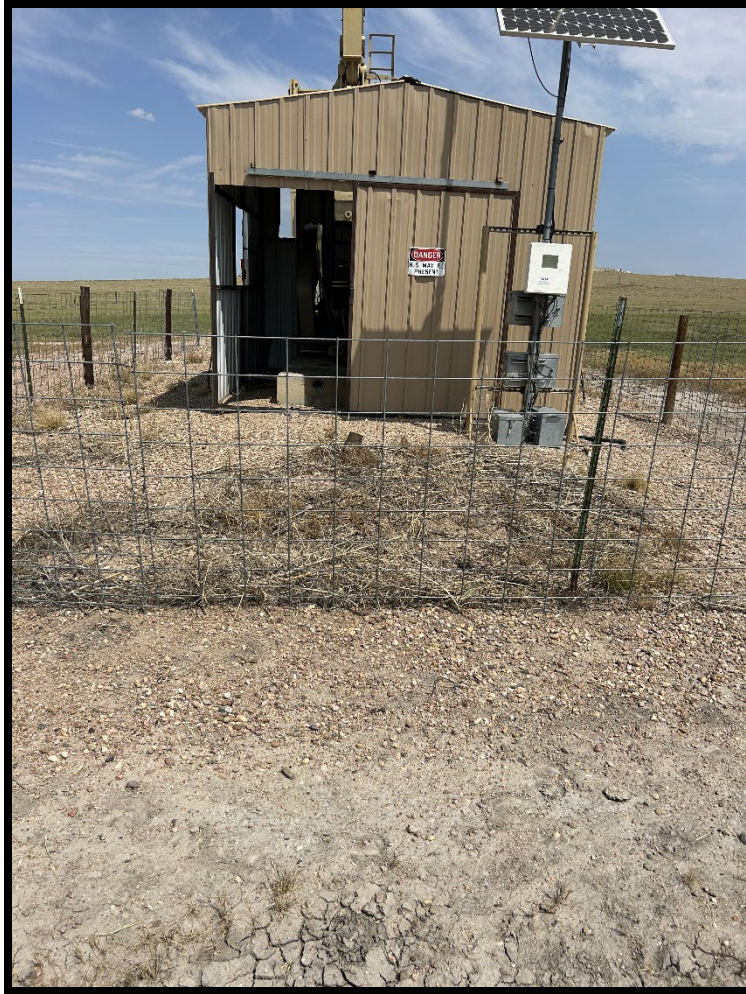
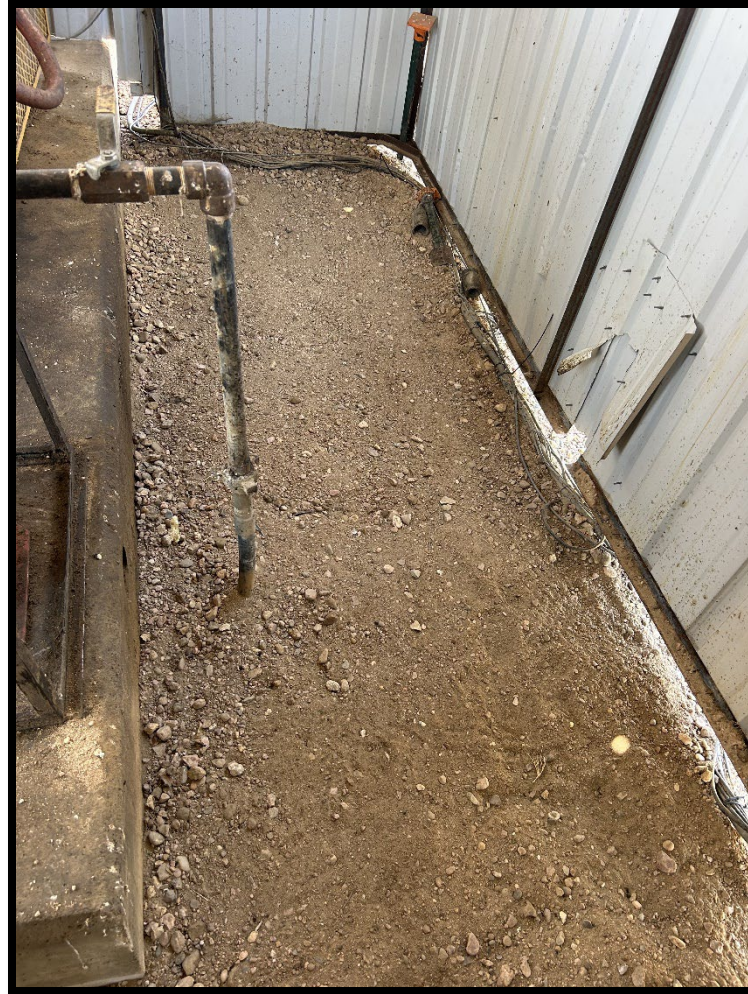
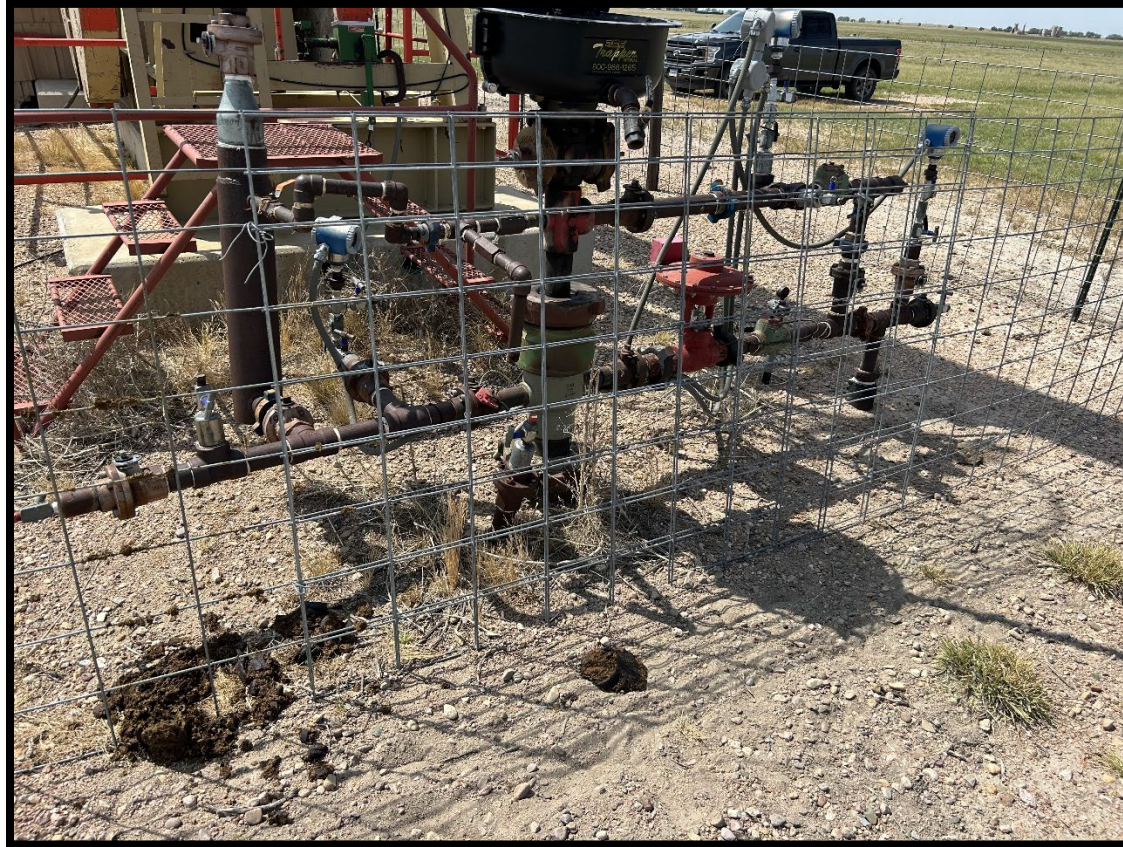
CA: Stained soil at wellhead. Remove or remediate stained soil; Securely fasten all valves, pipes, and fittings to ensure good mechanical condition, inspect at regular intervals and maintain in good mechanical condition per Rule 605.d.

CA: Engine; stained soil in engine house, at exhaust. Remove or remediate stained soil; Securely fasten all valves, pipes, and fittings to ensure good mechanical condition, inspect at regular intervals and maintain in good mechanical condition per Rule 605.d.

CA Resolution: Operator has provided photo evidence showing that the stained soil has been addressed, and the location is currently in compliance with the 900 and 600 series
