**FORM  
INSP**Rev  
X/20**State of Colorado  
Oil and Gas Conservation Commission**1120 Lincoln Street, Suite 801, Denver, Colorado 80203  
Phone: (303) 894-2100 Fax: (303) 894-2109

693807689**FIELD INSPECTION FORM**Loc ID: 316849 Inspector Name: BROWNING, CHUCK On-Site Inspection: ☐ 2A Doc Num: \_\_\_\_\_**Operator Information:**ECMC Operator Number: 10841Name of Operator: AMERICAN HELIUM OPERATING LLCAddress: 600 TRAVIS STREET SUITE 5050City: HOUSTON State: TX Zip: 77002**Status Summary:**

Facility ID	Type	Status	Status Date	Well Class	API Num	Facility Name	Insp Status
273021	WELL	PR	02/01/2021	GW	113-06151	FOSSIL FEDERAL 6-19	PR

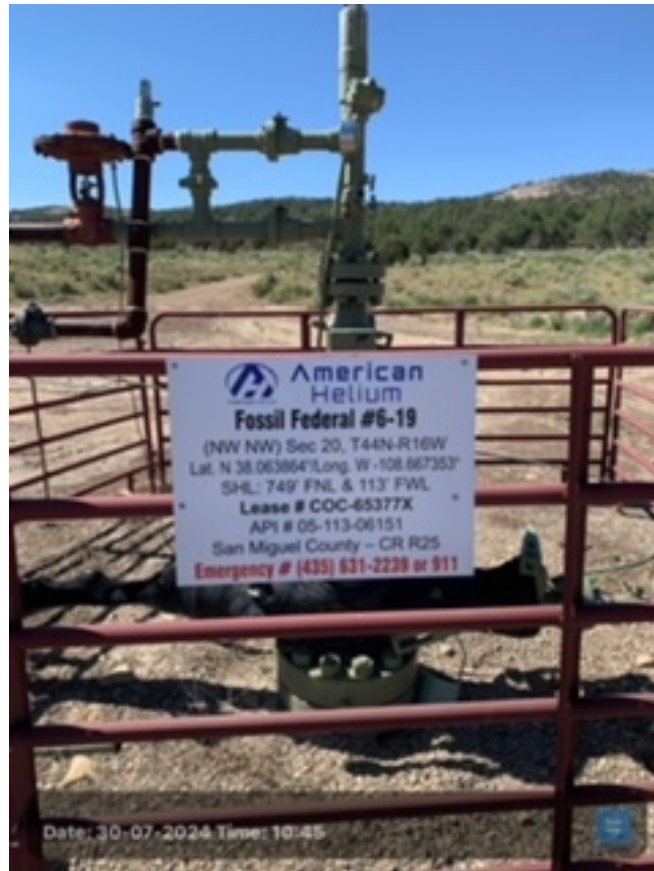
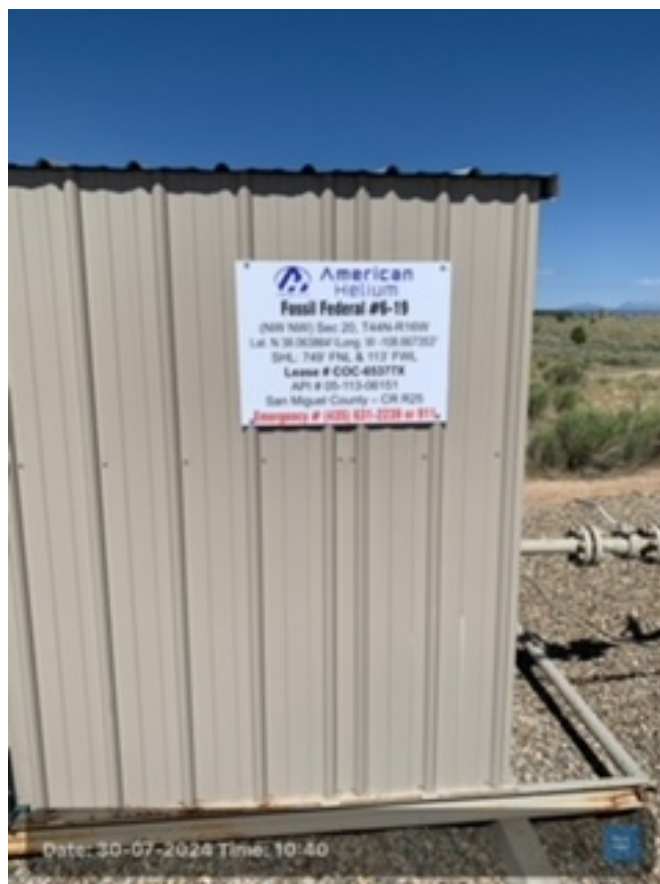
On 7-30-24 signage was corrected on FF 6-19. Please see photo's attached.

Type	WELLHEAD		
Comment:			
Corrective Action:		Date:	
Type	TANK LABELS/PLACARDS		
Comment:	Sign or label not posted or information inaccurate on tanks or containers or sign/label too small to read at distance or installed in place where not visible.		
Corrective Action:	Install sign to comply with Rule 605.h.	Date:	09/30/2024

7-30-24 signage on well and meter house corrected
