# Interim Reclamation and Stormwater Inspection

Operator: FULCRUM ENERGY OPERATING # 10805

Location ID: 324754

Inspection Photos  
Location Name: Spicer Pad  
Location ID: 324754

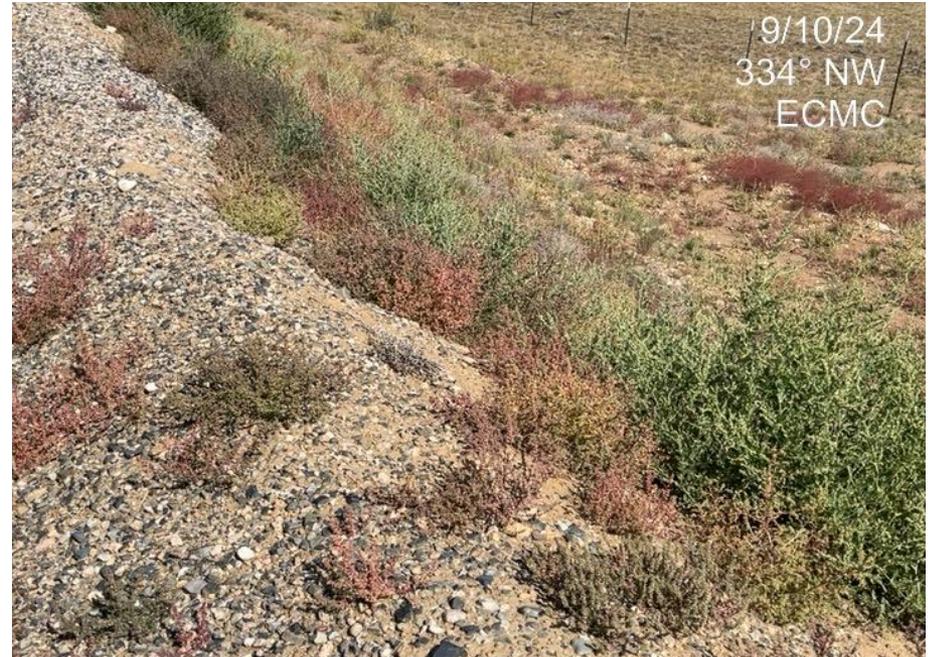
**Photo 2.** Photo taken at the northeast portion of the working pad surface, facing NW. Weeds observed growing on the berms and on other portions of the perimeter.

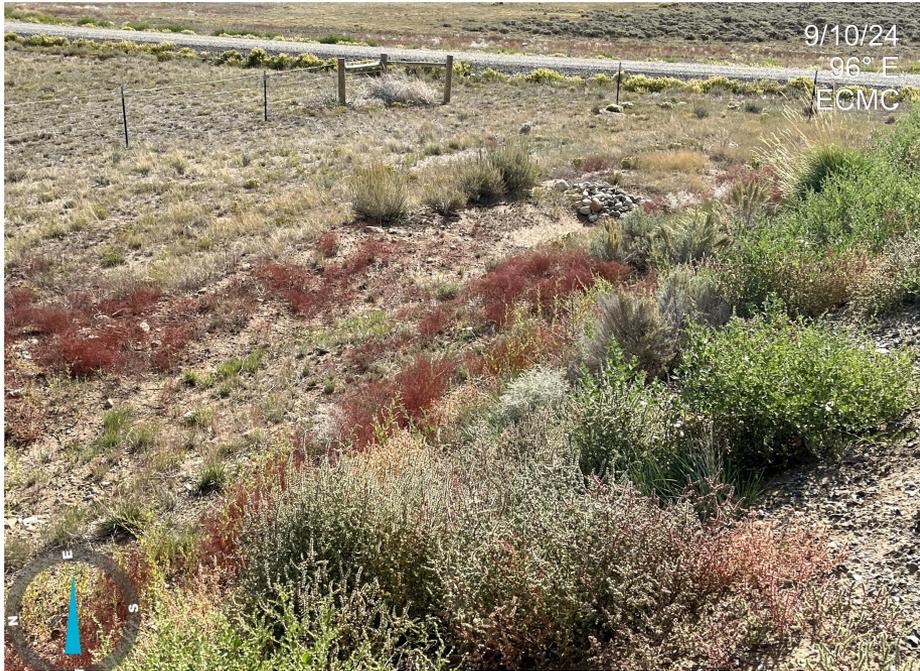
**Photo 3.** Photo taken from northern edge of working pad surface, facing east. Photo illustrates abundant weeds along the perimeter of berm.

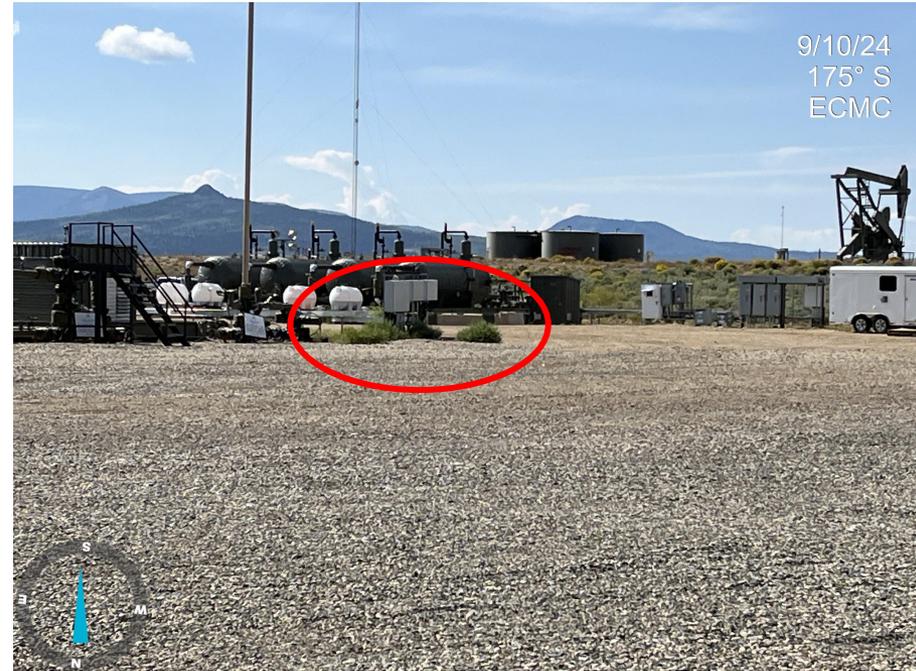
**Photo 4.** Photo taken from the northern working pad, facing south. Photo illustrates weeds at the wellhead.

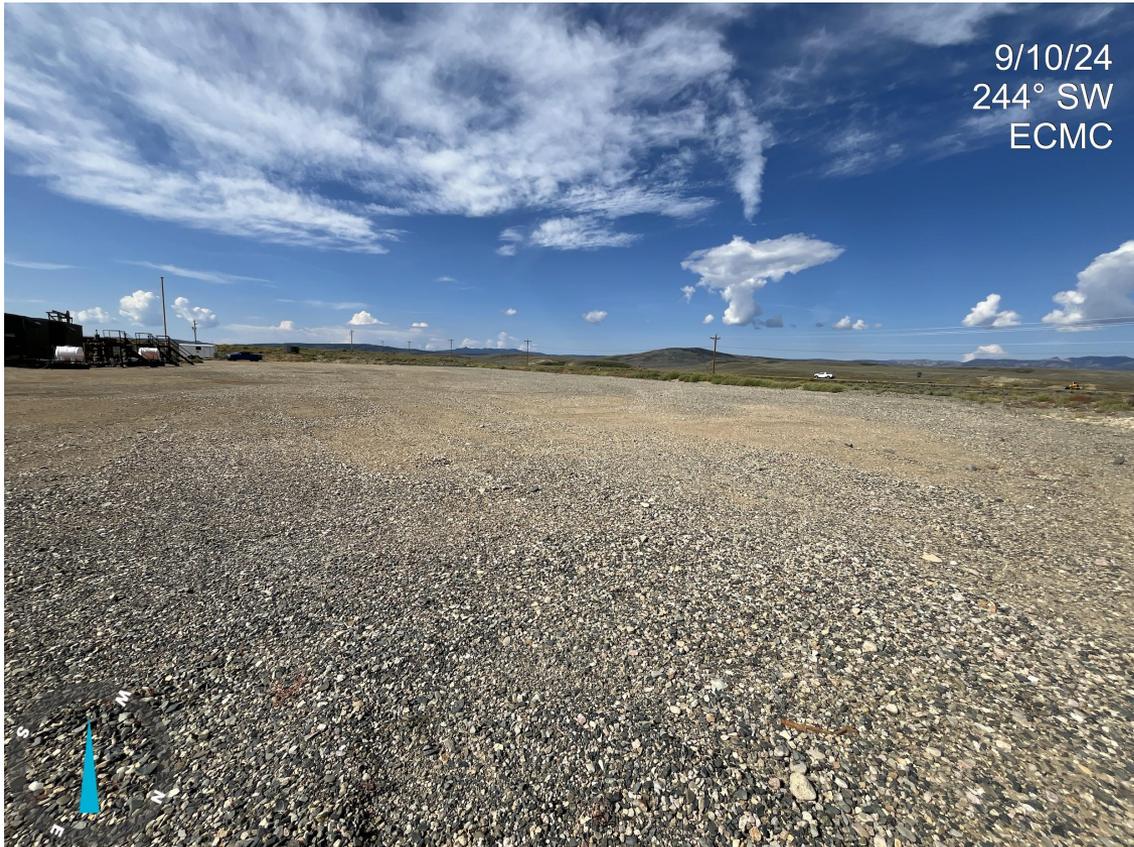
**Photo 5.** Photo taken from the northern working pad surface, facing SW. Photo illustrates areas which appear to be unused for production. Operator shall conduct interim reclamation in areas no longer used per 1003 rules.
