# Interim Reclamation and Stormwater Inspection

September 10, 2024

Operator: FULCRUM ENERGY OPERATING # 10805

Location ID: 463987

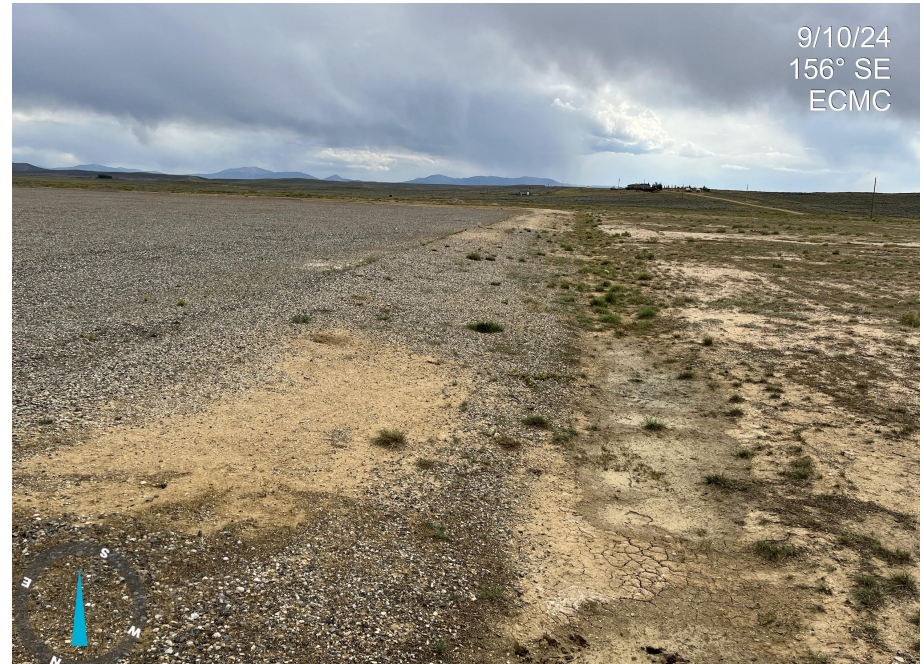
**Photo 2.** Photo taken the entrance of the Location, facing SE. Weeds observed growing along the perimeter. Photo illustrates failure of stormwater BMPs. Evidence of stormwater run-off outside of pad. Operator shall repair stormwater BMPs per Rule 1002.f.

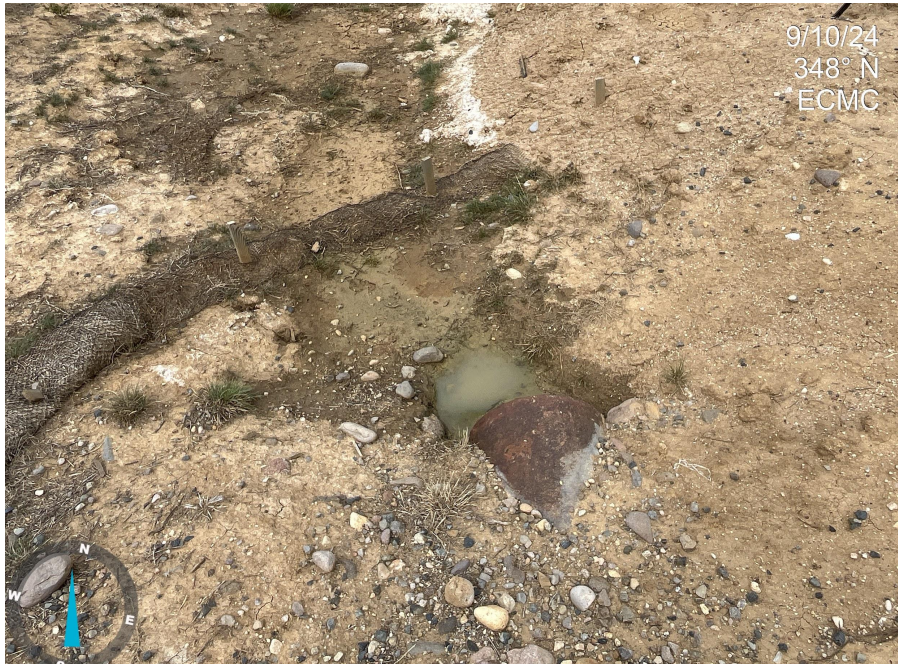
**Photo 3.** Photo taken from the western pad surface, facing north. Photo illustrates erosion. Operator shall install/maintain stormwater BMPs per Rule 1002.f.(2)

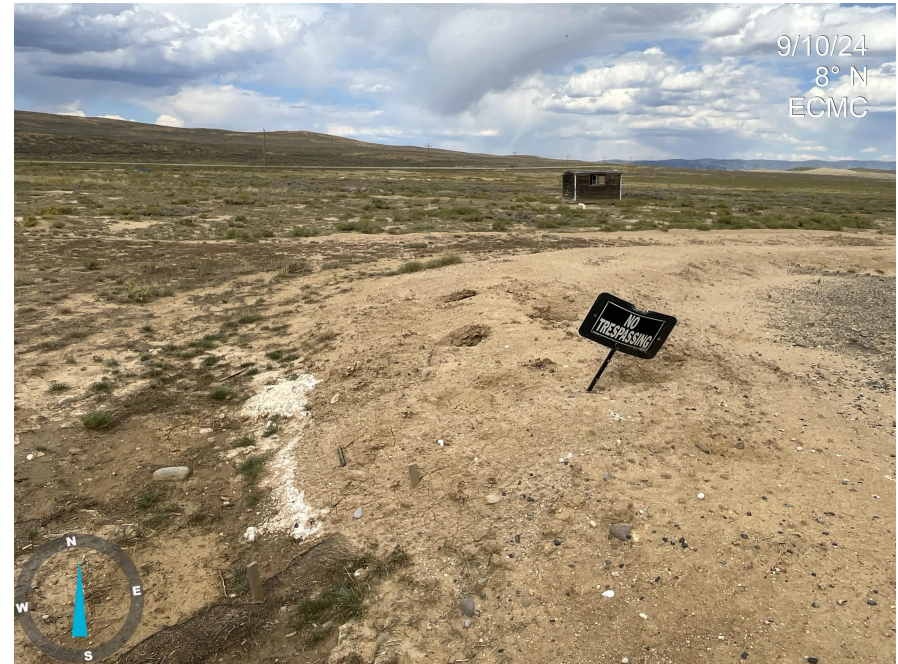
**Photo 4.** Photo taken from the western pad surface, facing north. Photo illustrates failing BMPs. Operator shall install/maintain stormwater BMPs per Rule 1002.f.

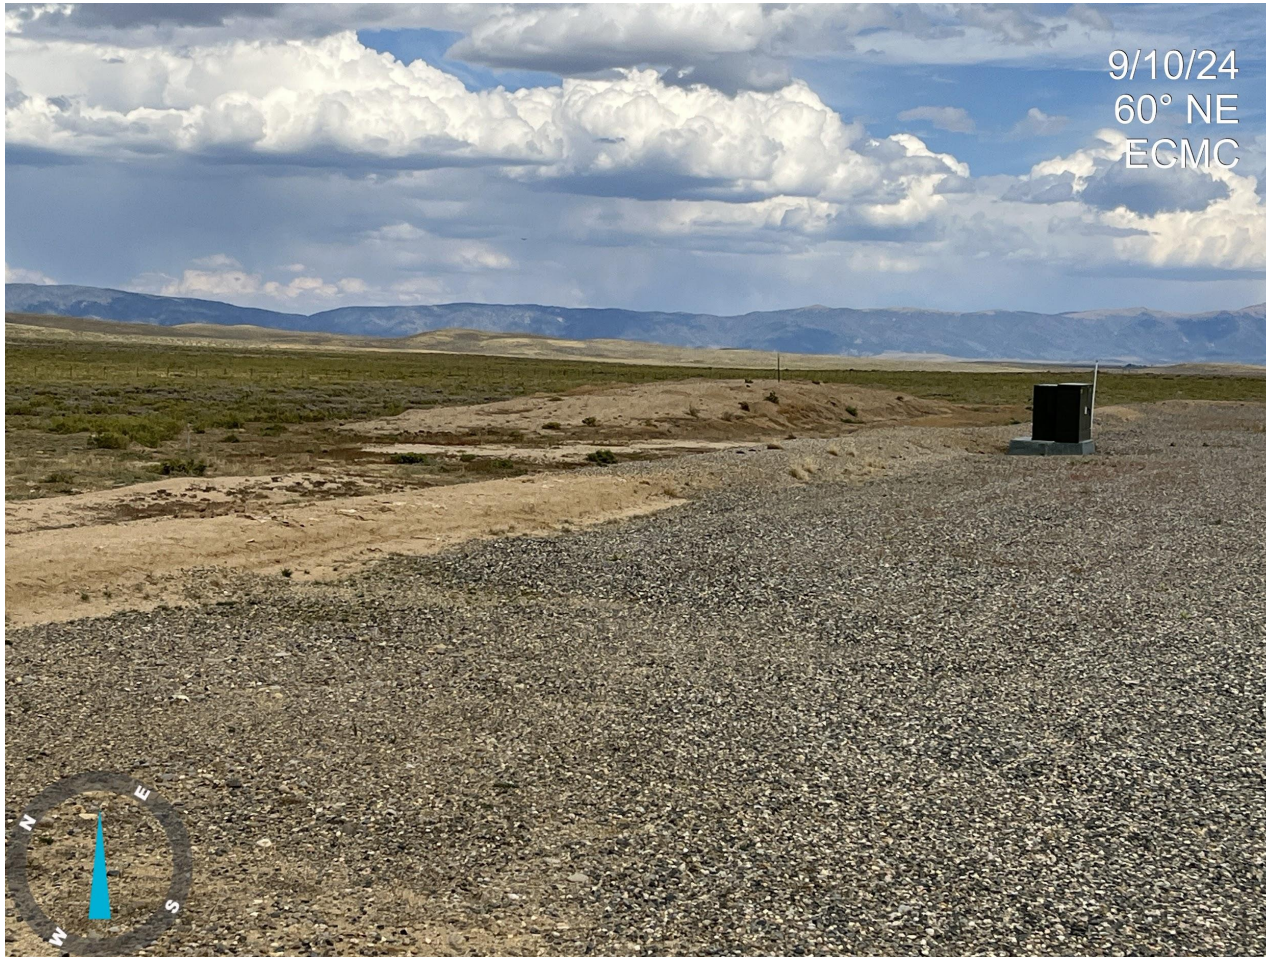
**Photo 5.** Photo taken from the western pad edge, facing NE. Photo illustrates insufficient or missing perimeter BMPs. Operator shall comply with Rules 1002.f.
