WELL NAME: ROBB-HIAWATHA #1, API #: 071-040012, INSP. # 716300175

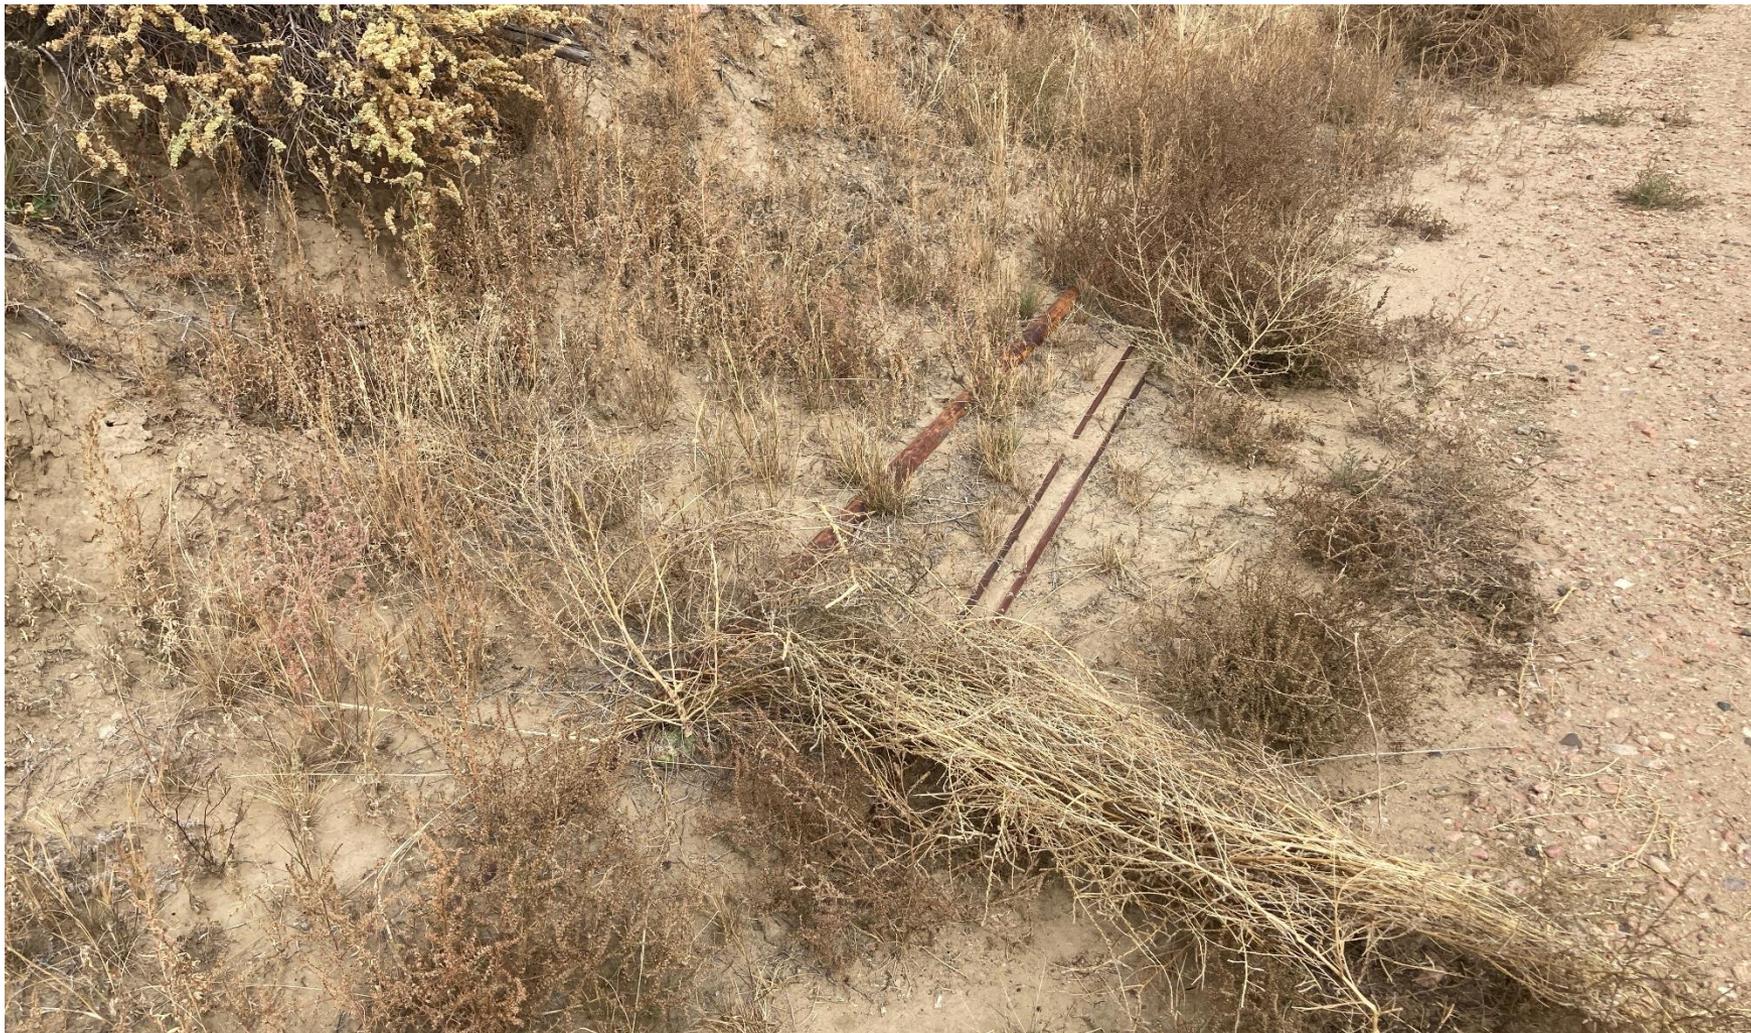
**PHOTO 5: UNUSED EQUIPMENT (TUBING AND RODS ON WEST EDGE OF LOCATION), REMOVE UNUSED EQUIPMENT PER RULE 606. CA DATE 11/17/2024.**

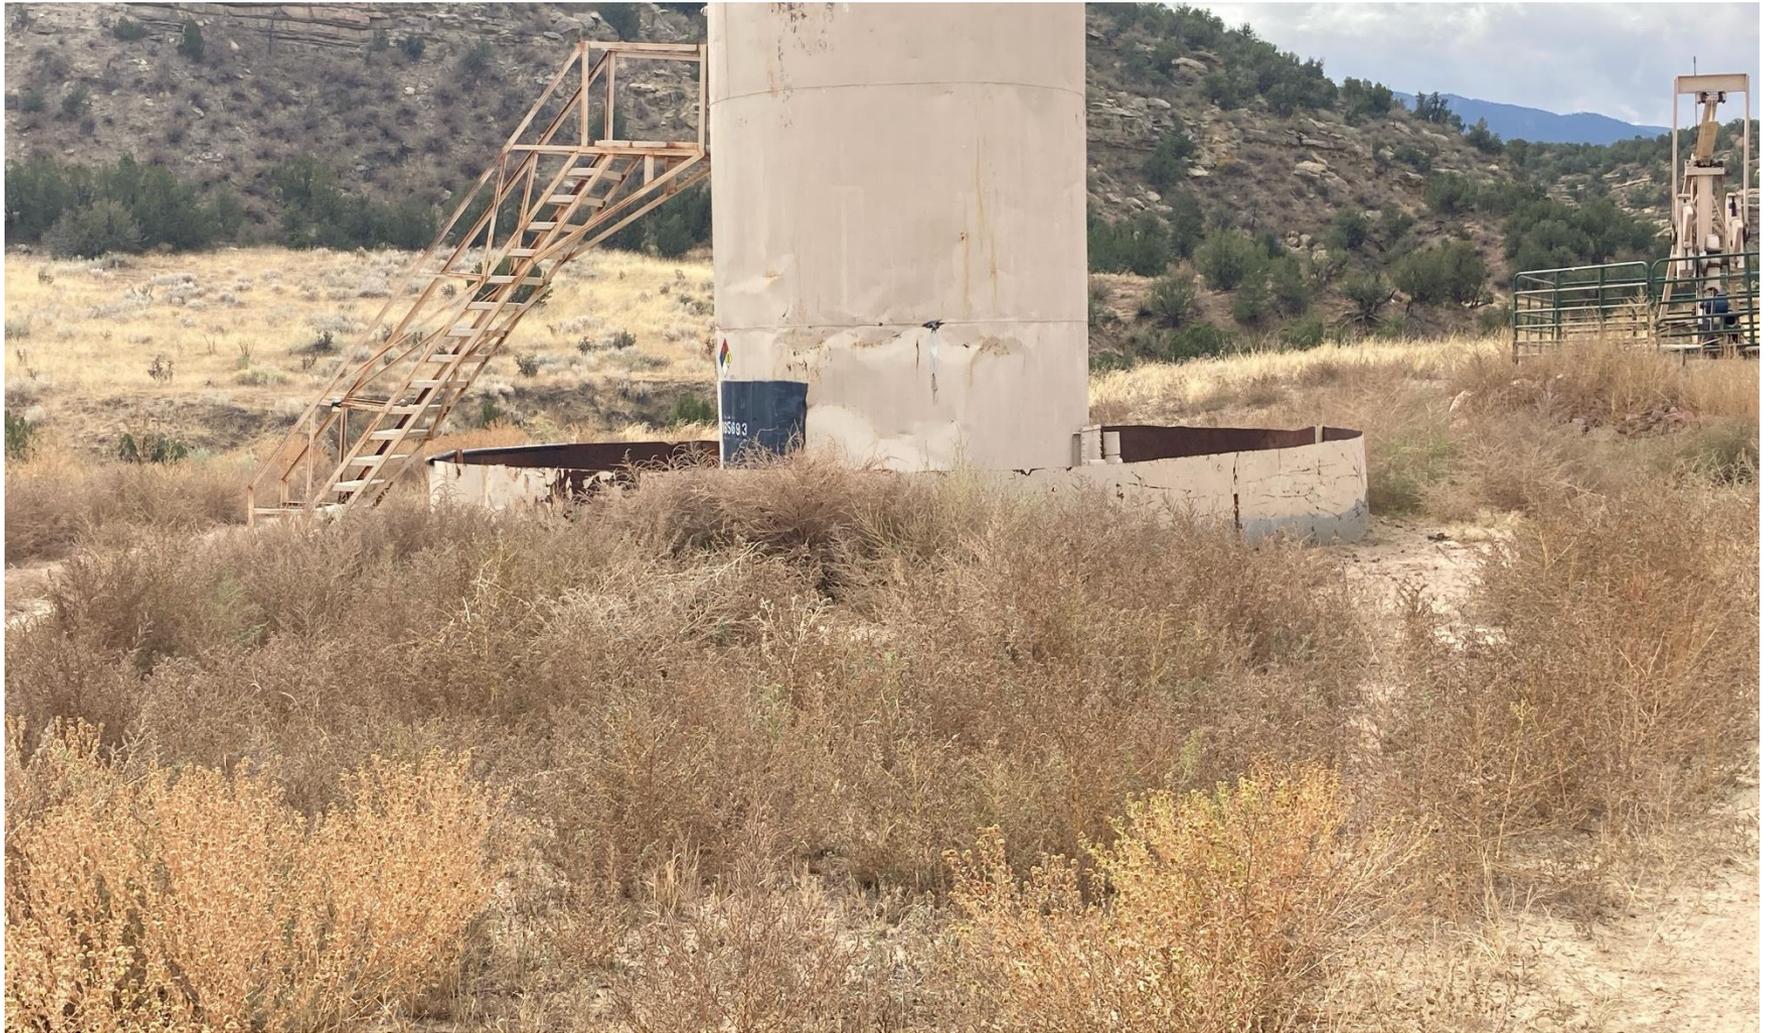
**PHOTO 6: WEEDS NOT MAINTAINED THROUGHOUT LOCATION, MAINTAIN WEEDS PER RULE 606. CA DATE 11/17/2024.**

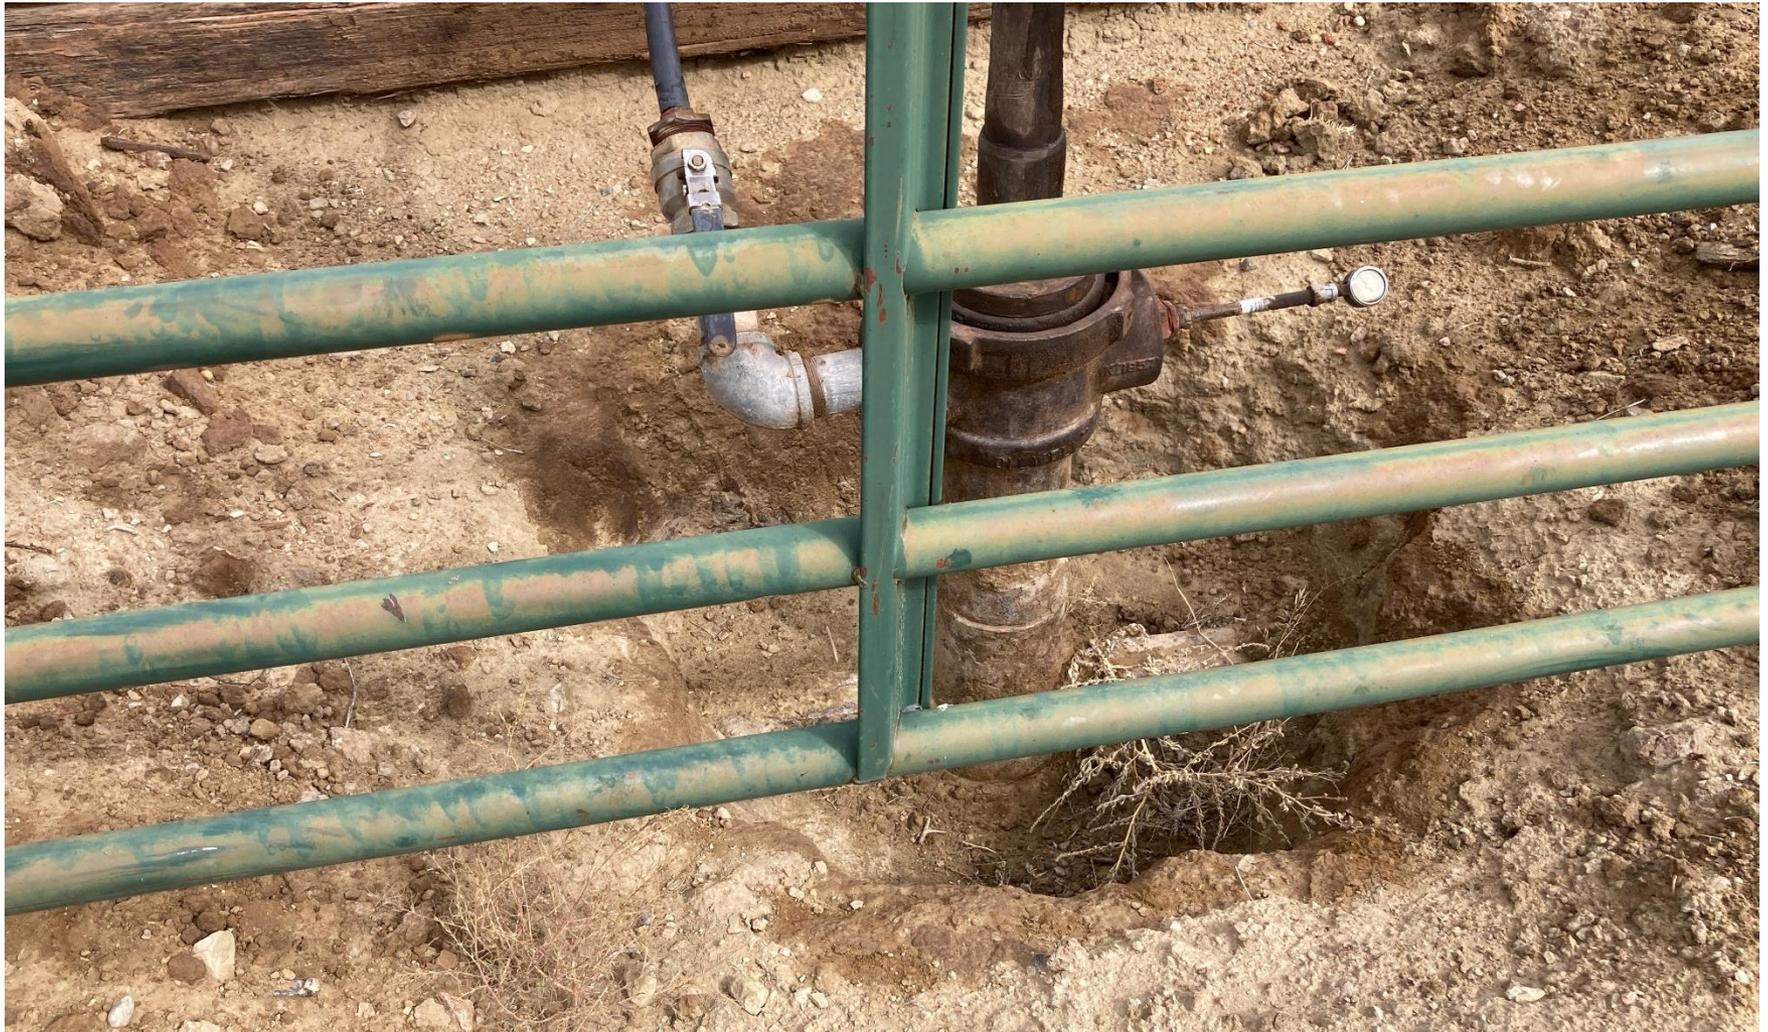
**PHOTO 7: Bradenhead inaccessible or not visible( wellhead tree does not appear to include a Bradenhead in it original install). Install appropriate fittings to allow bradenhead visual inspection as per Rule 419.a.(1), (2). THIS IS THE SECOND NOTICE IMMEDIATE ACTION IS REQUIRED.**
