**Operator: *Crestone Peak Resources Operating LLC***

**Location Name: ANNIS-62N65W 24NWSE**

**Loc ID: 323195**

**Inspection: 714201777**

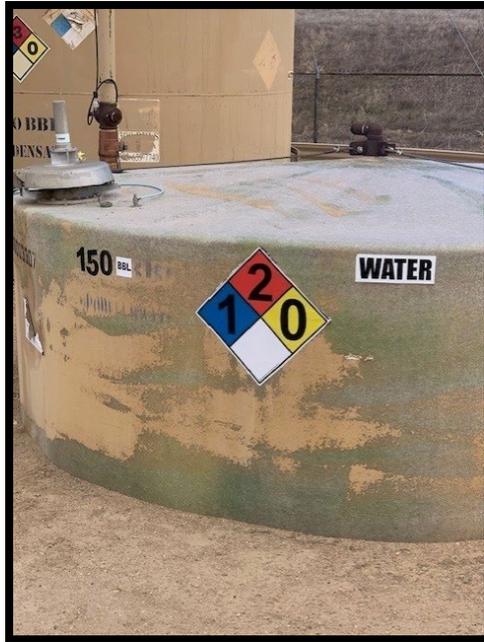
Exhibit A

**CA:** H2O BBLs are not legible. See attached photo. Install sign to comply with Rule 605.h

**CA Resolution:** Operator has added tank volume to the fiberglass water tank in order to comply with Rule 606.
