# Inspection Photos

**Operator:** GUNNISON ENERGY LLC #10515

**Location ID:** 324485

**Inspection Doc:** 696206402

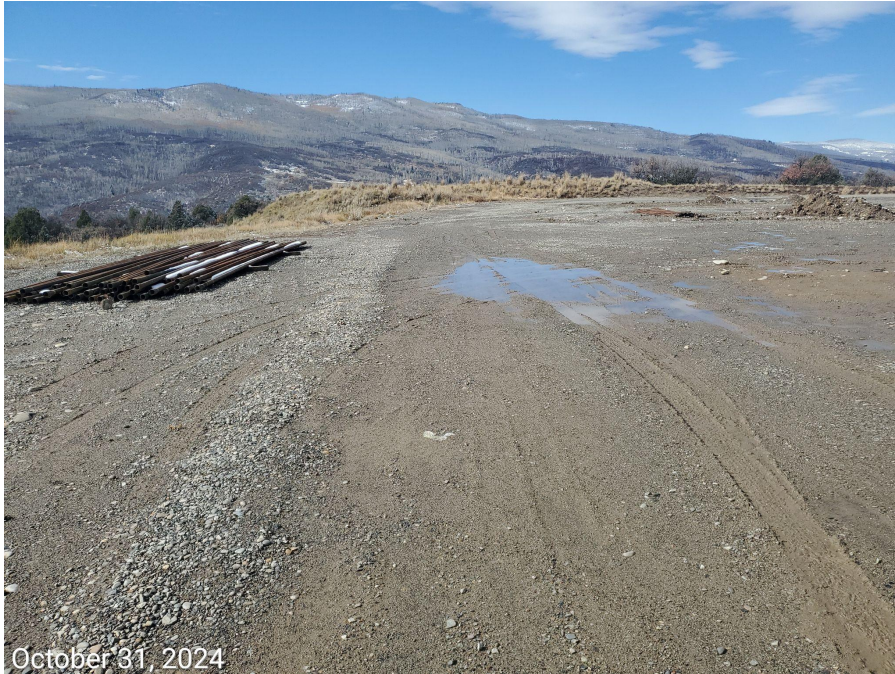
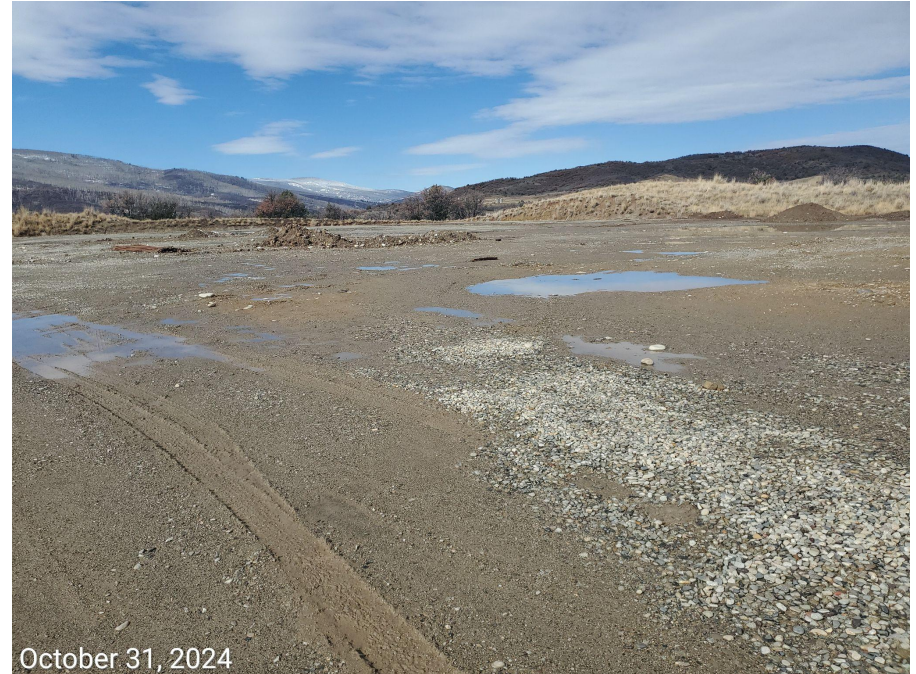
**Photo 1:** Photos taken from the south end of the Location. Photos provide an overview of the Location west to northwest. All wells on the Location have been plugged. Location is now subject to 1004 Requirements.

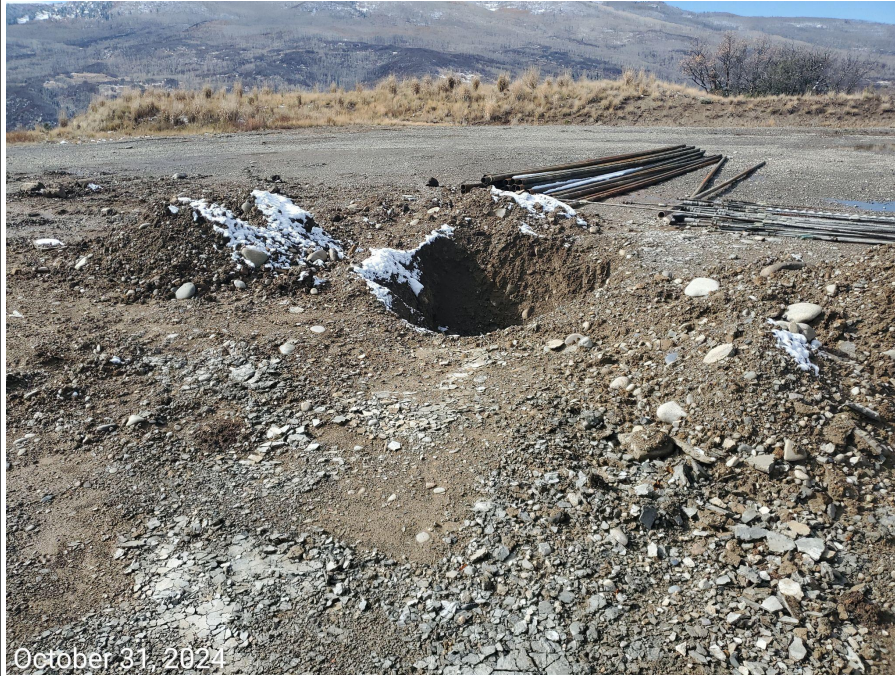
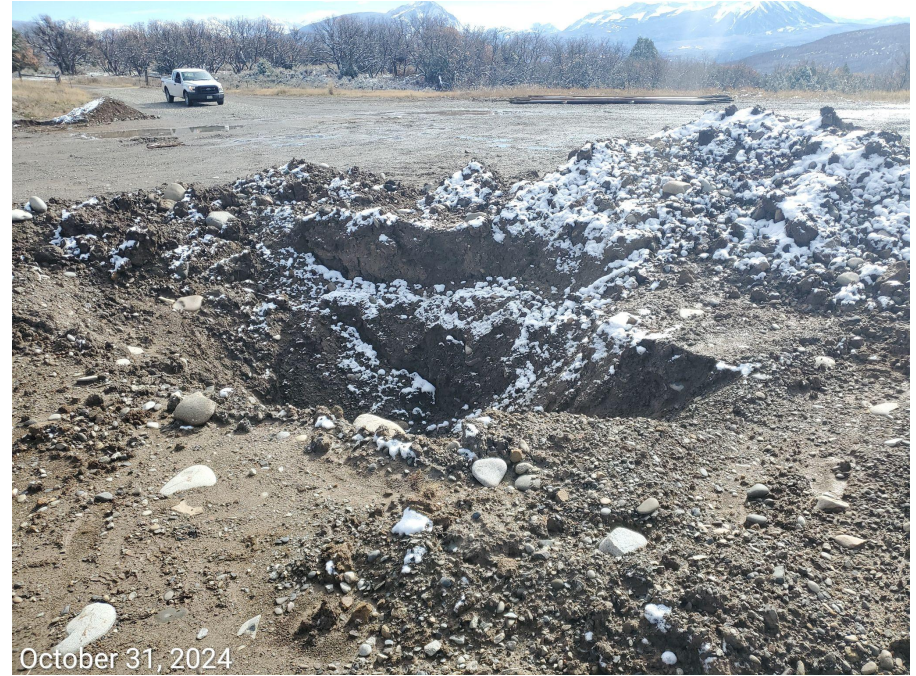
**Photo 2:** Photos examples showing excavations missing required fencing, and stockpiled soils missing BMPs pursuant to Rules 1002.c and 1002.f. Photo also shows various pipe remaining on Location.

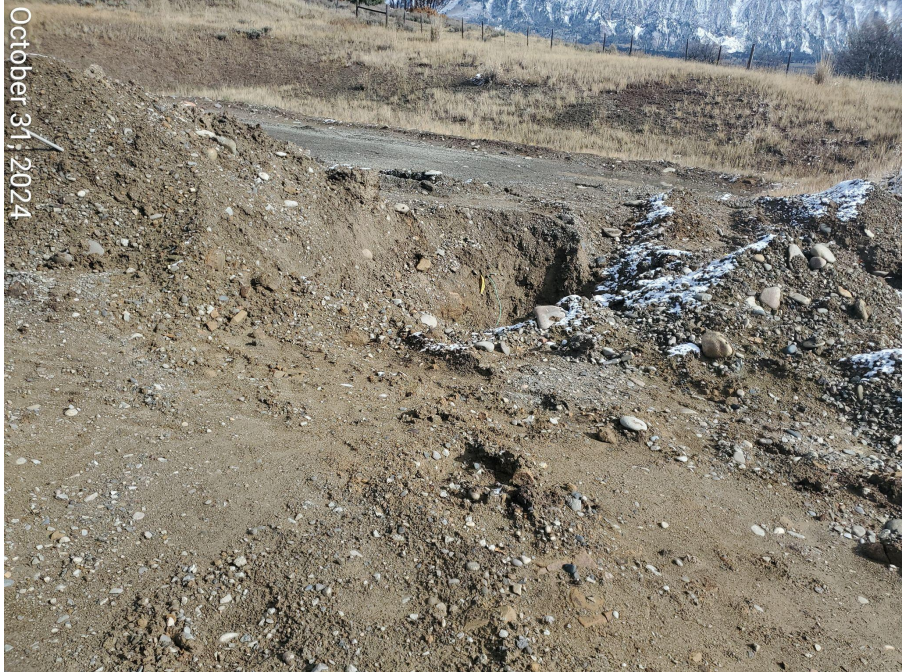
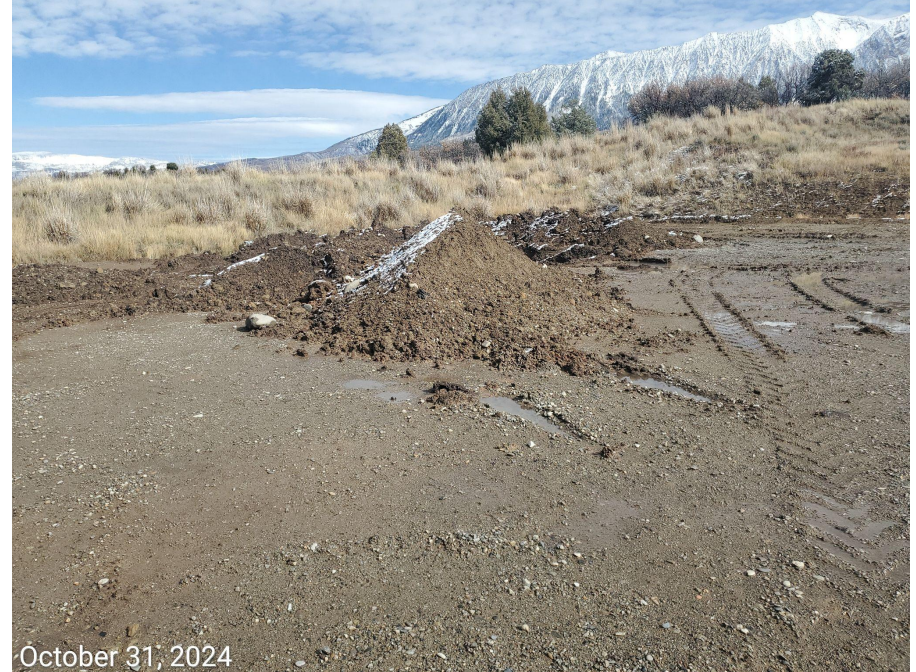
**Photo 3:** See comments under photo 2.

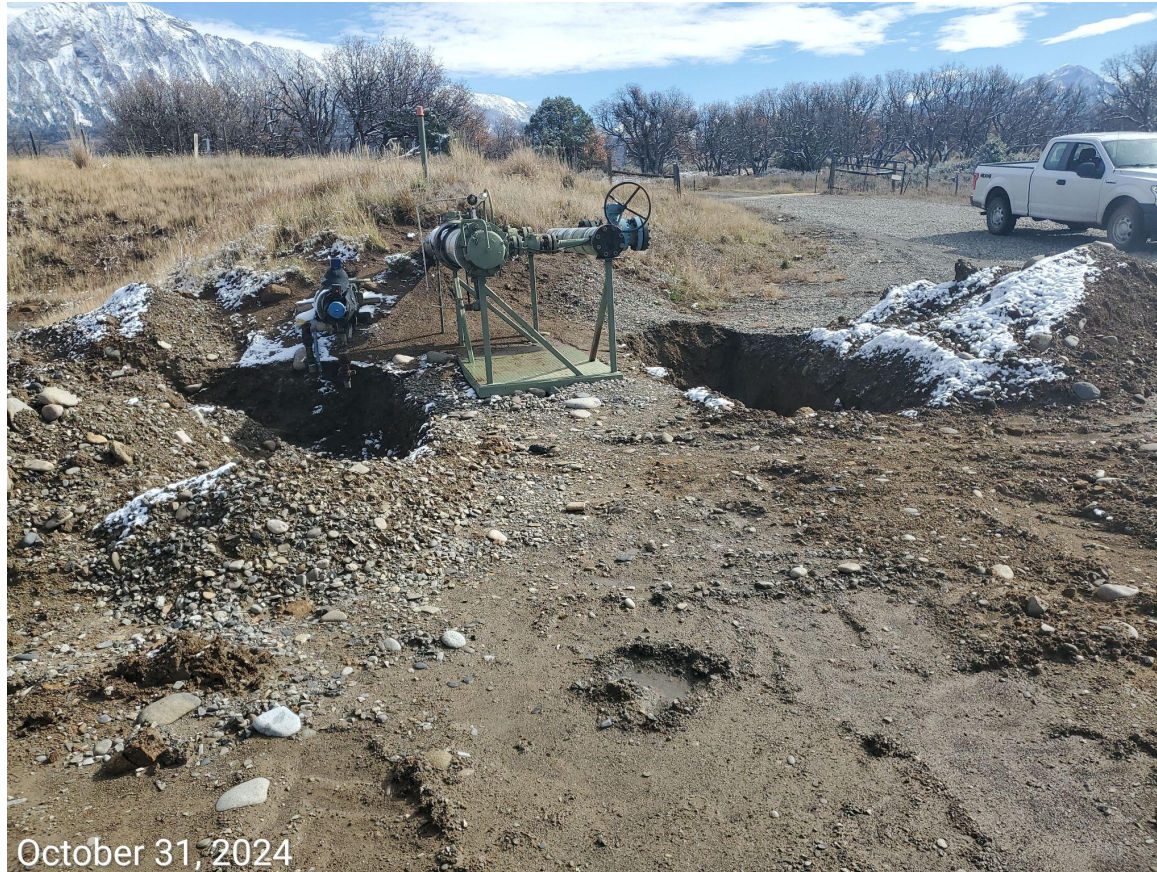
**Photo 4:** See comments under photo 2. Pipe/Equipment requires removal pursuant to 1004 requirements.
