**Operator: *CRESTONE PEAK RESOURCES OPERATING LLC***

**Location Name: Ruhl 32H-B264 East**

**Loc ID: 439042**

**Inspection: 713901136**

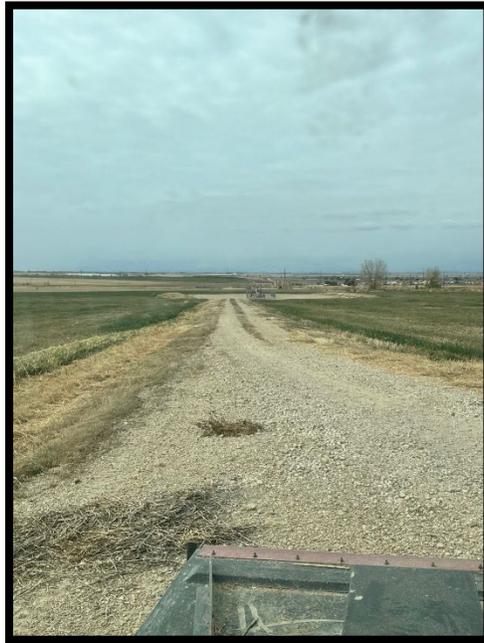
**Exhibit A**

**CA:** Weed debris in the form of tumbleweeds were observed along the boundary of the well location and on the irrigation berms of the well location. Tumbleweeds are a troublesome annual non-native weed that easily breaks off at the stem. Operator failed to control and manage weeds to prevent weed waste and prevent the spread of seeds onto adjacent lands. Comply with Rule 606 to remove weed debris.

**CA Resolution:** Operator has addressed the weed debris issue, property has been mowed as well in order to comply with Rule 606.
