Inspection Photos

Operator: PUBLIC SERVICE COMPANY OF
COLORADO - 72400

Location ID: 312451

Inspection Doc: 718100171

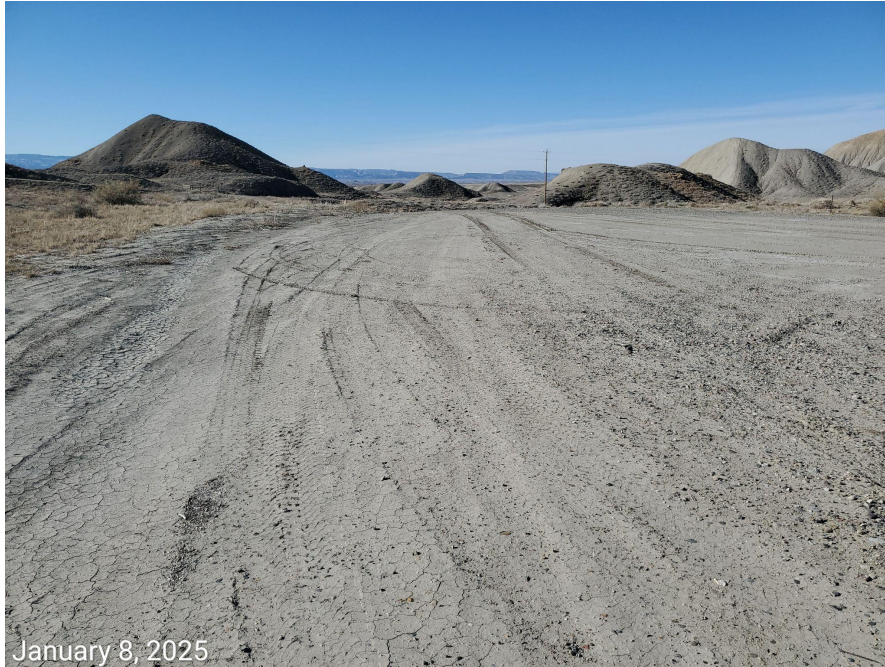
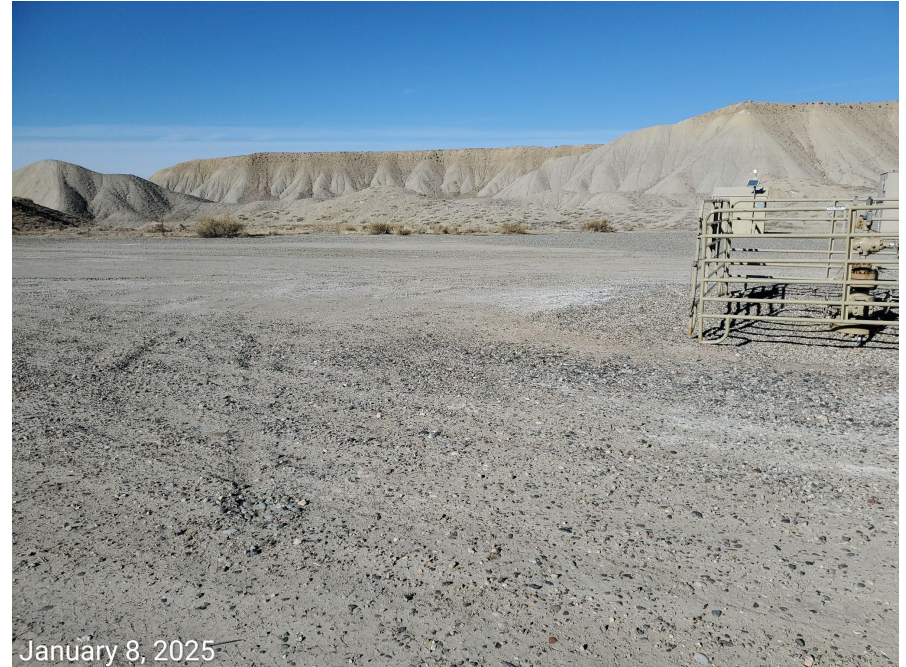
Photo 1: Photos 1-2 taken from the south end of the Location. Photos provide an overview of the Location southwest, west, north to northeast.

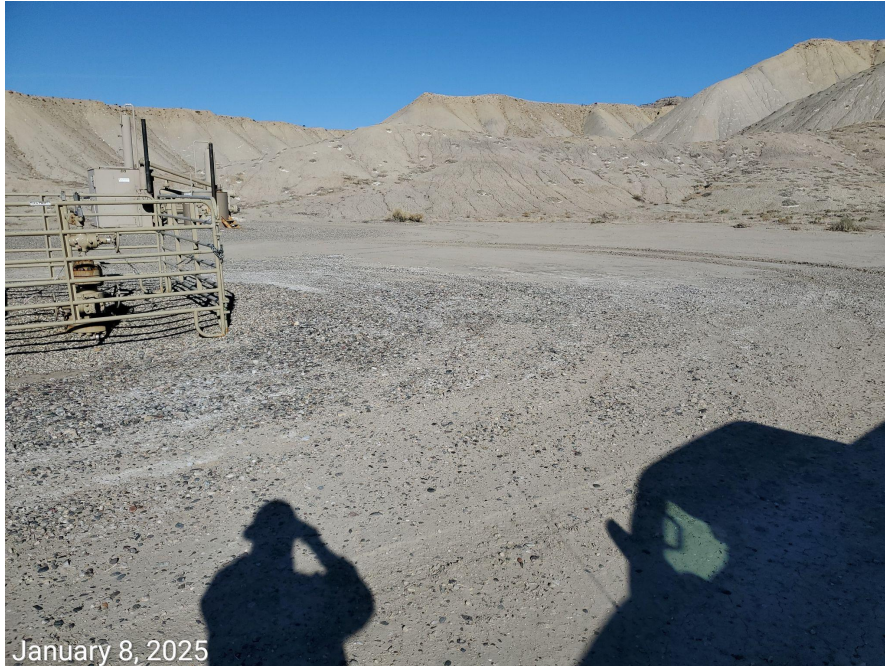
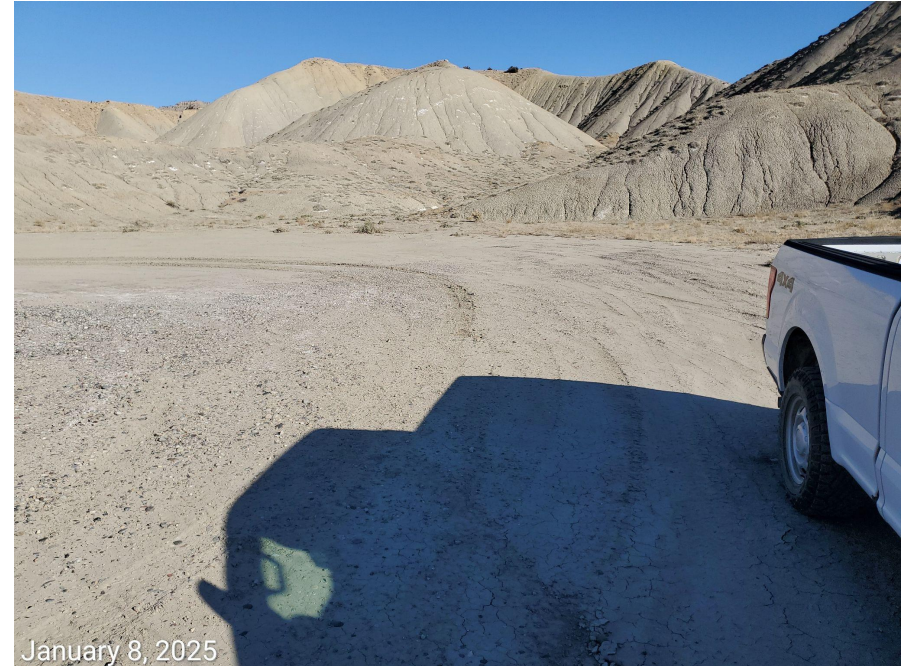
Photo 2: See comments under photo 1.

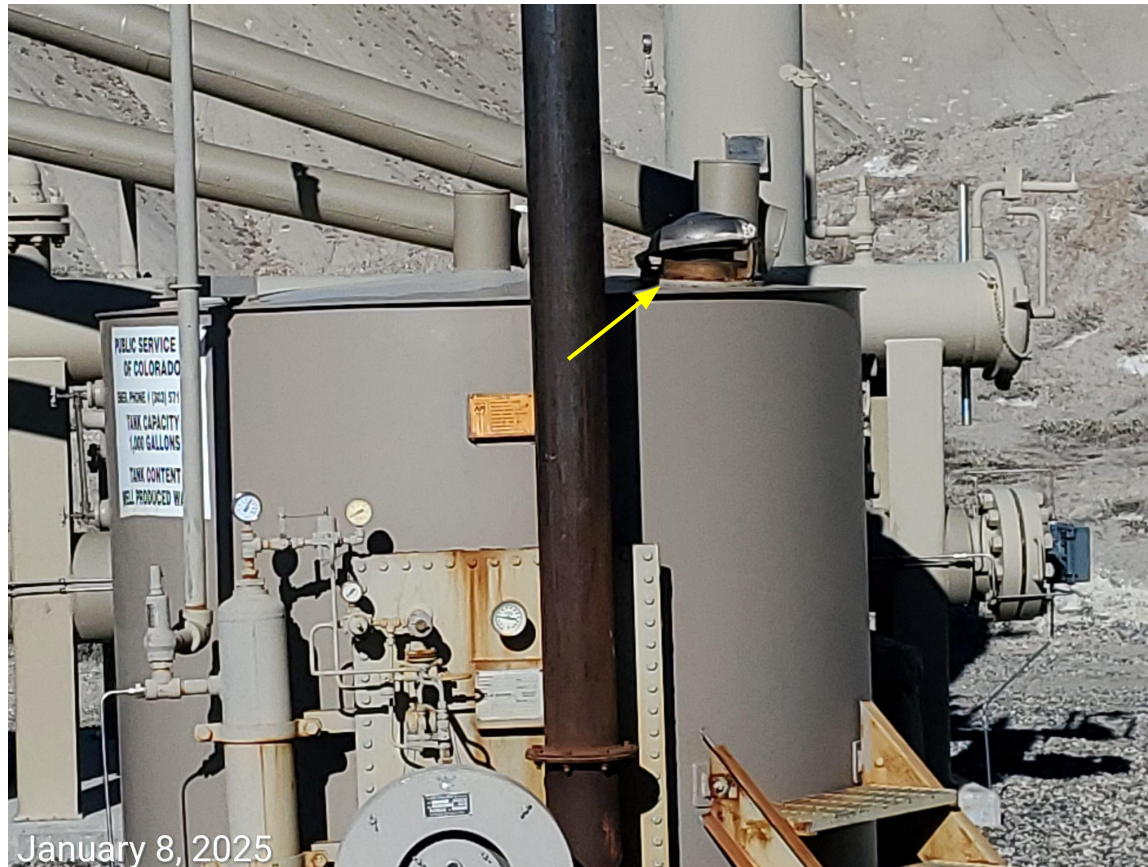
Photo 3: Photo shows hatch (arrow) at the produced water tank is open and currently venting to atmosphere.

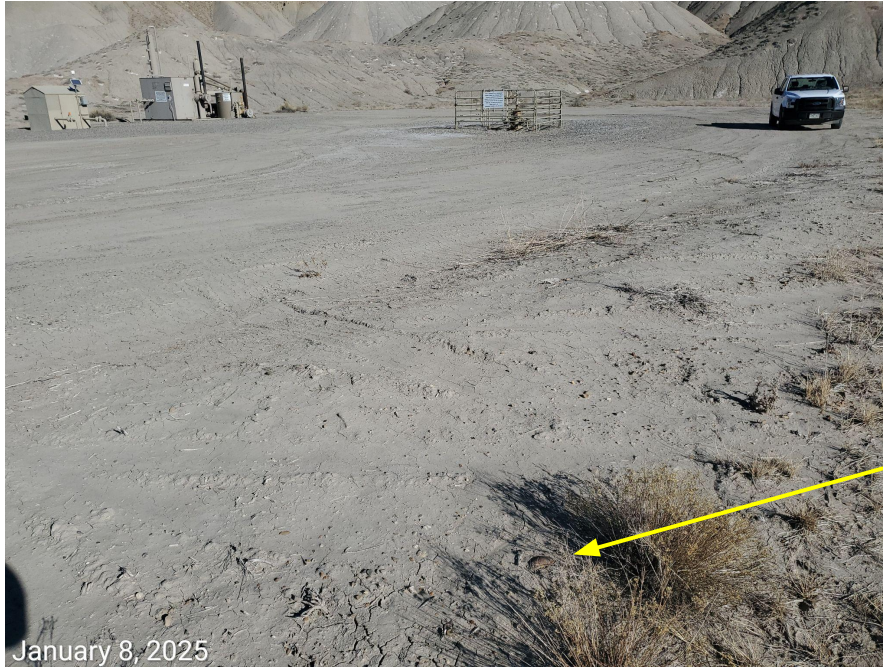
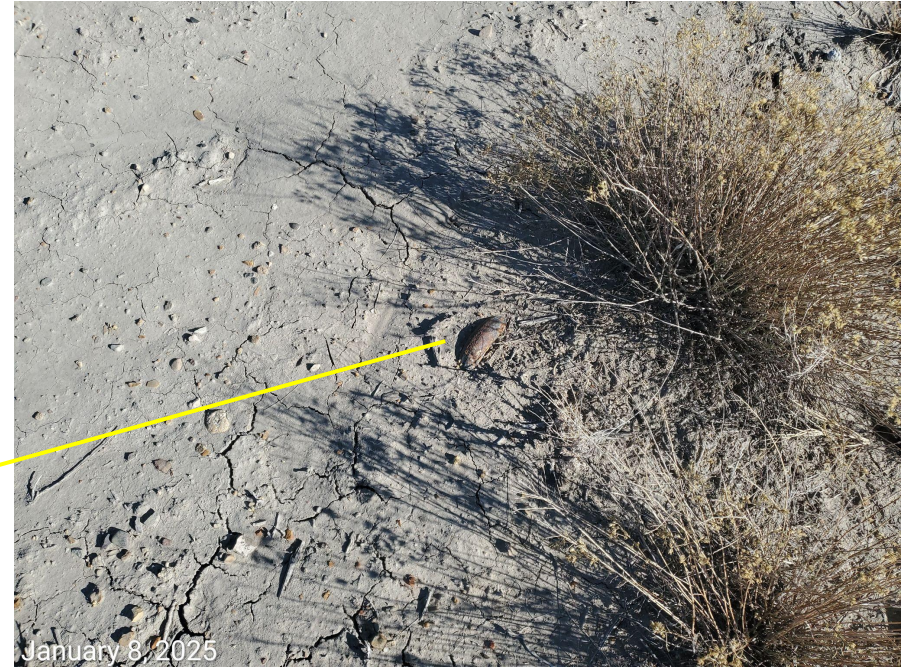
Photo 4: Photos examples showing anchors on the Location have not been marked in accordance with 603.j/1003.a requirements.

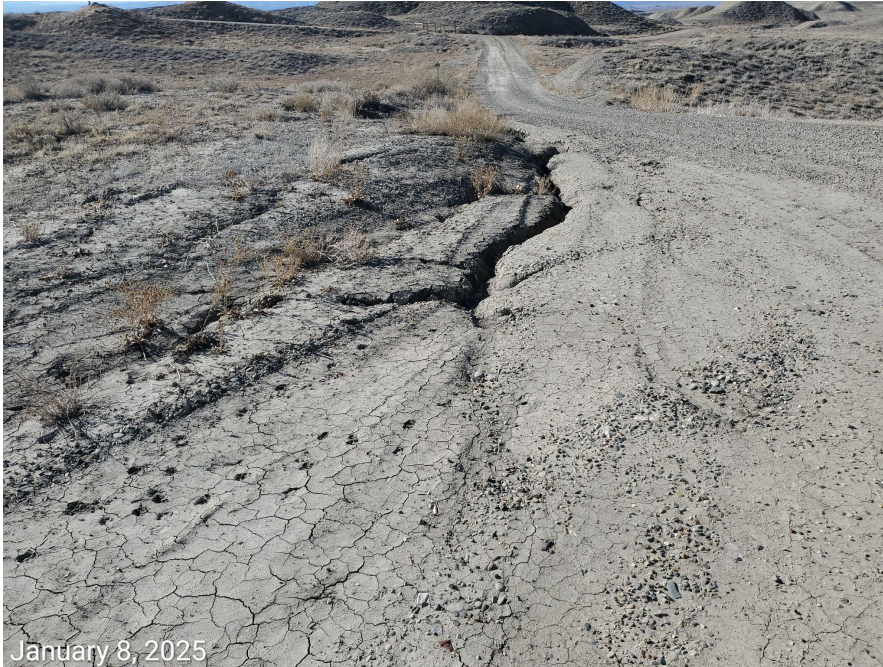
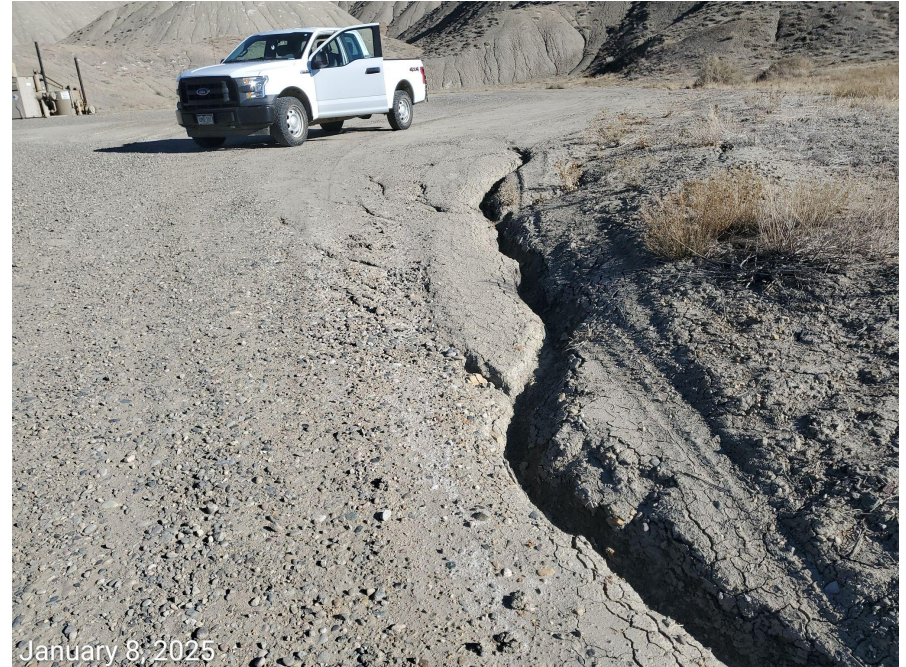
Photo 5: Photos taken from the Location entrance. Photos show showing erosion degradation due to runoff from the Location; stormwater and erosion control measures to manage runoff in a manner that minimizes erosion, degradation and sediment transport are missing or insufficient.

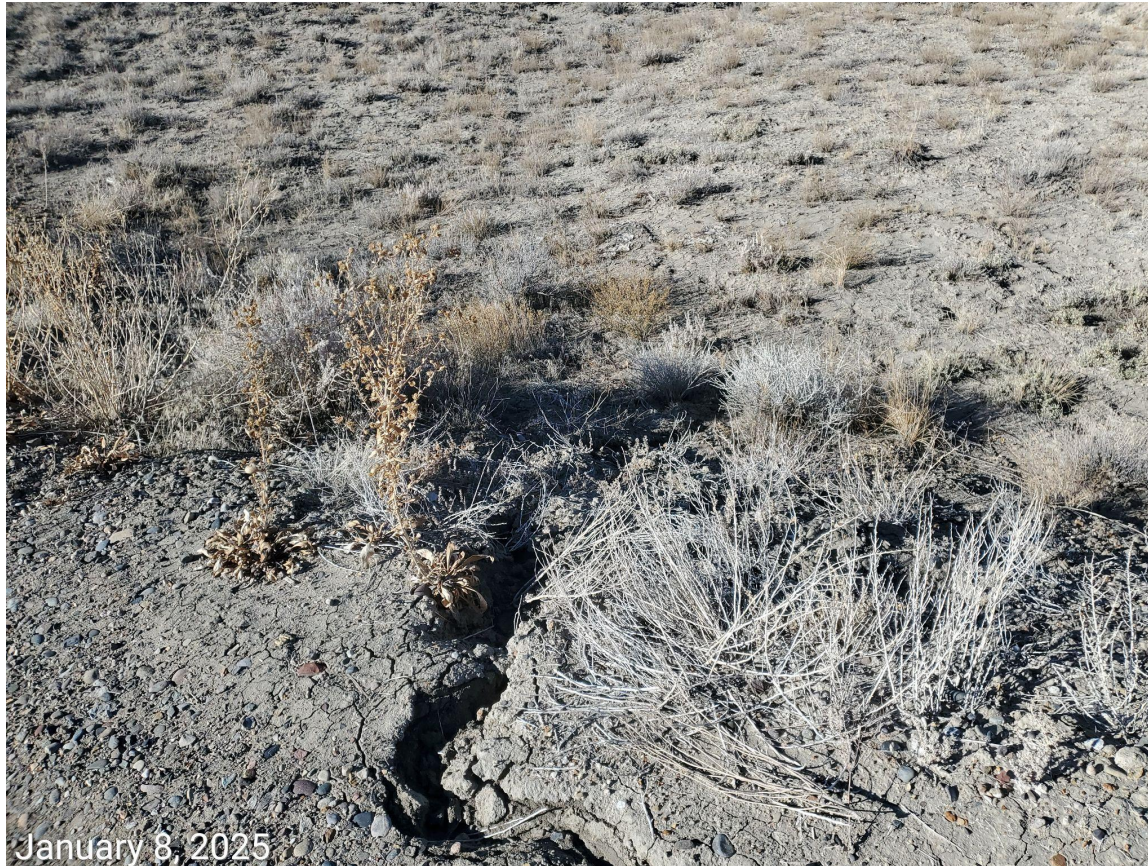
Photo 6: See comments under photo 5.
