Operator: HIGHPOINT OPERATING CORPORATION

Location Name: RSU Anschutz Fed 4-62-2_1 SE 3

Inspection: 717700914

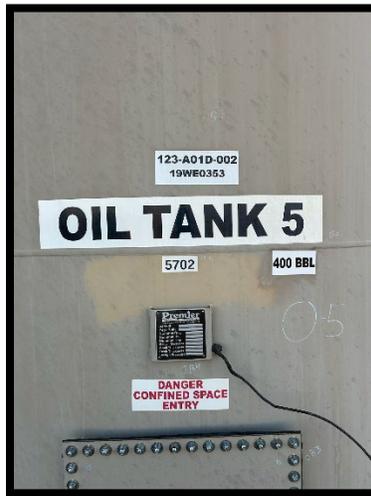
Exhibit A

CA: Missing Capacity Labels on the production tanks need to be installed. See attached photos. Install sign to comply with Rule 605.h.

CA Resolution: Operator updated signs and labels in order to comply with Rule 605.h.
