WELL NAME: ANDREW 23-15, API #: 071-08460, INSP. # 716300582

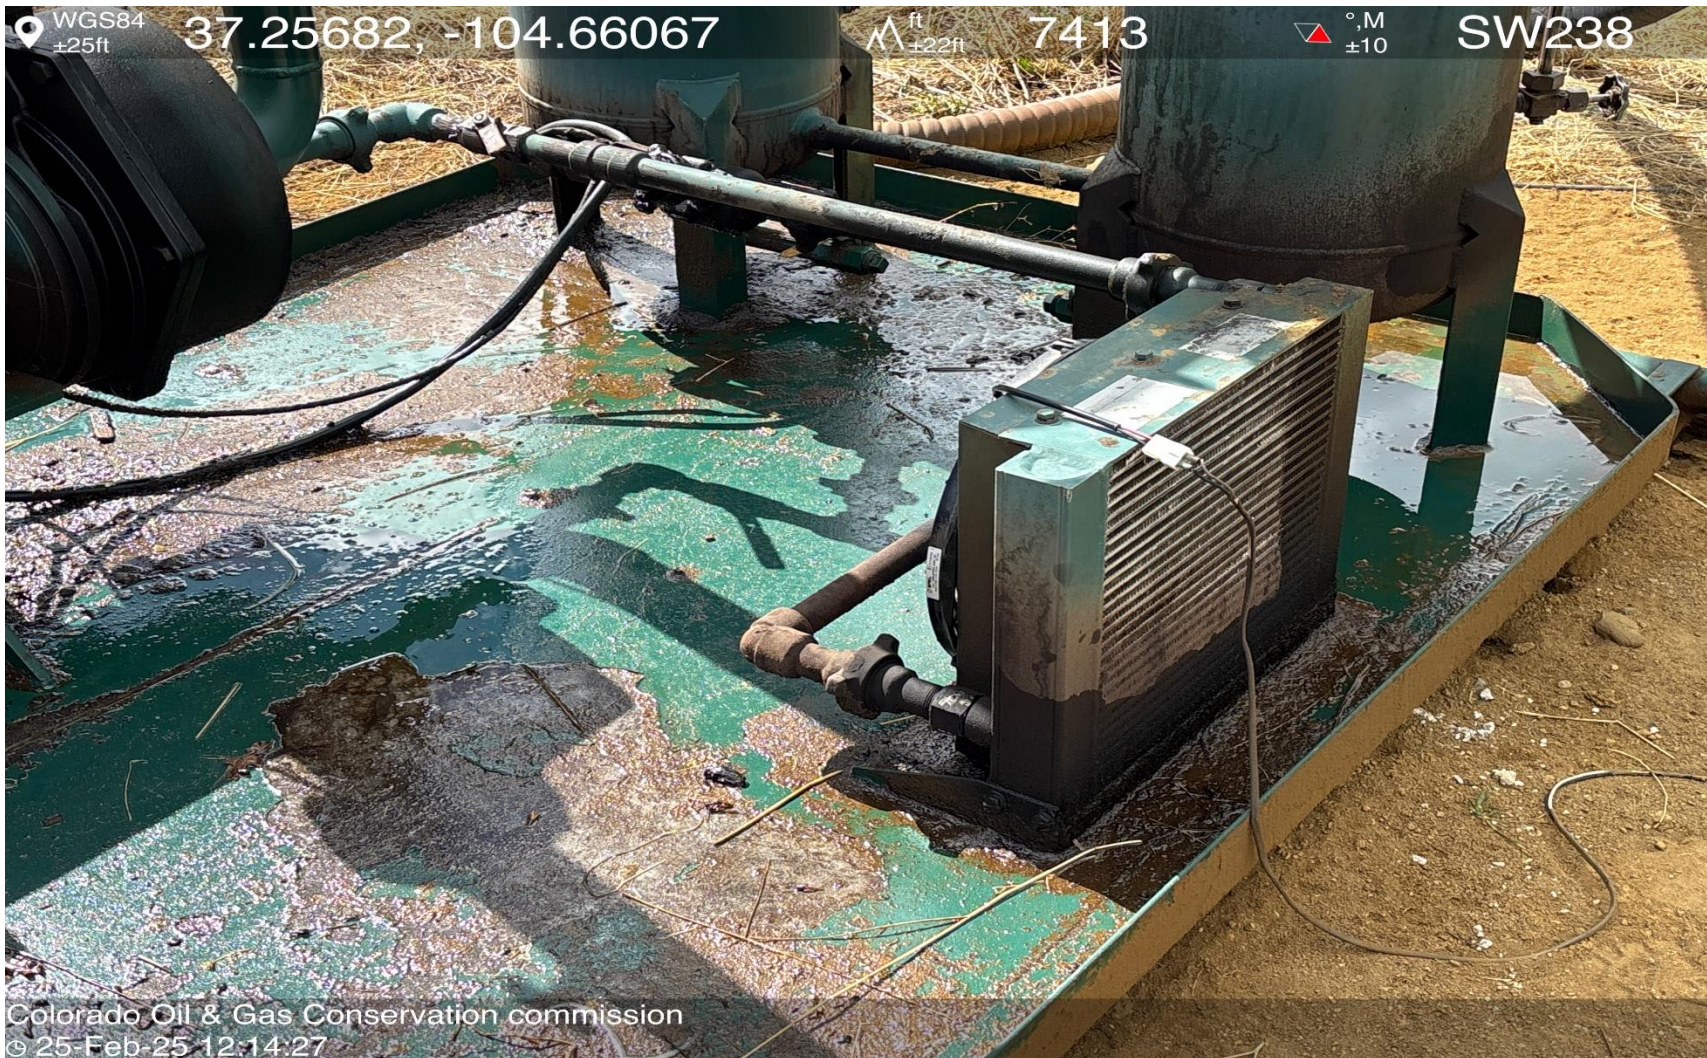
**PHOTO 4: OILY WASTE IN PRIME MOVER ENGINE SKID. DRAIN OILY WASTE REPAIR ALL LEAKS AND REMOVE OR TREAT IMPACTED SOIL PER RULE 1002..(2).D & 1002.f.(2)B, Comply with general provisions of the oil and gas act for wildlife protection AND SB-181. CA DATE 2-26-2025**

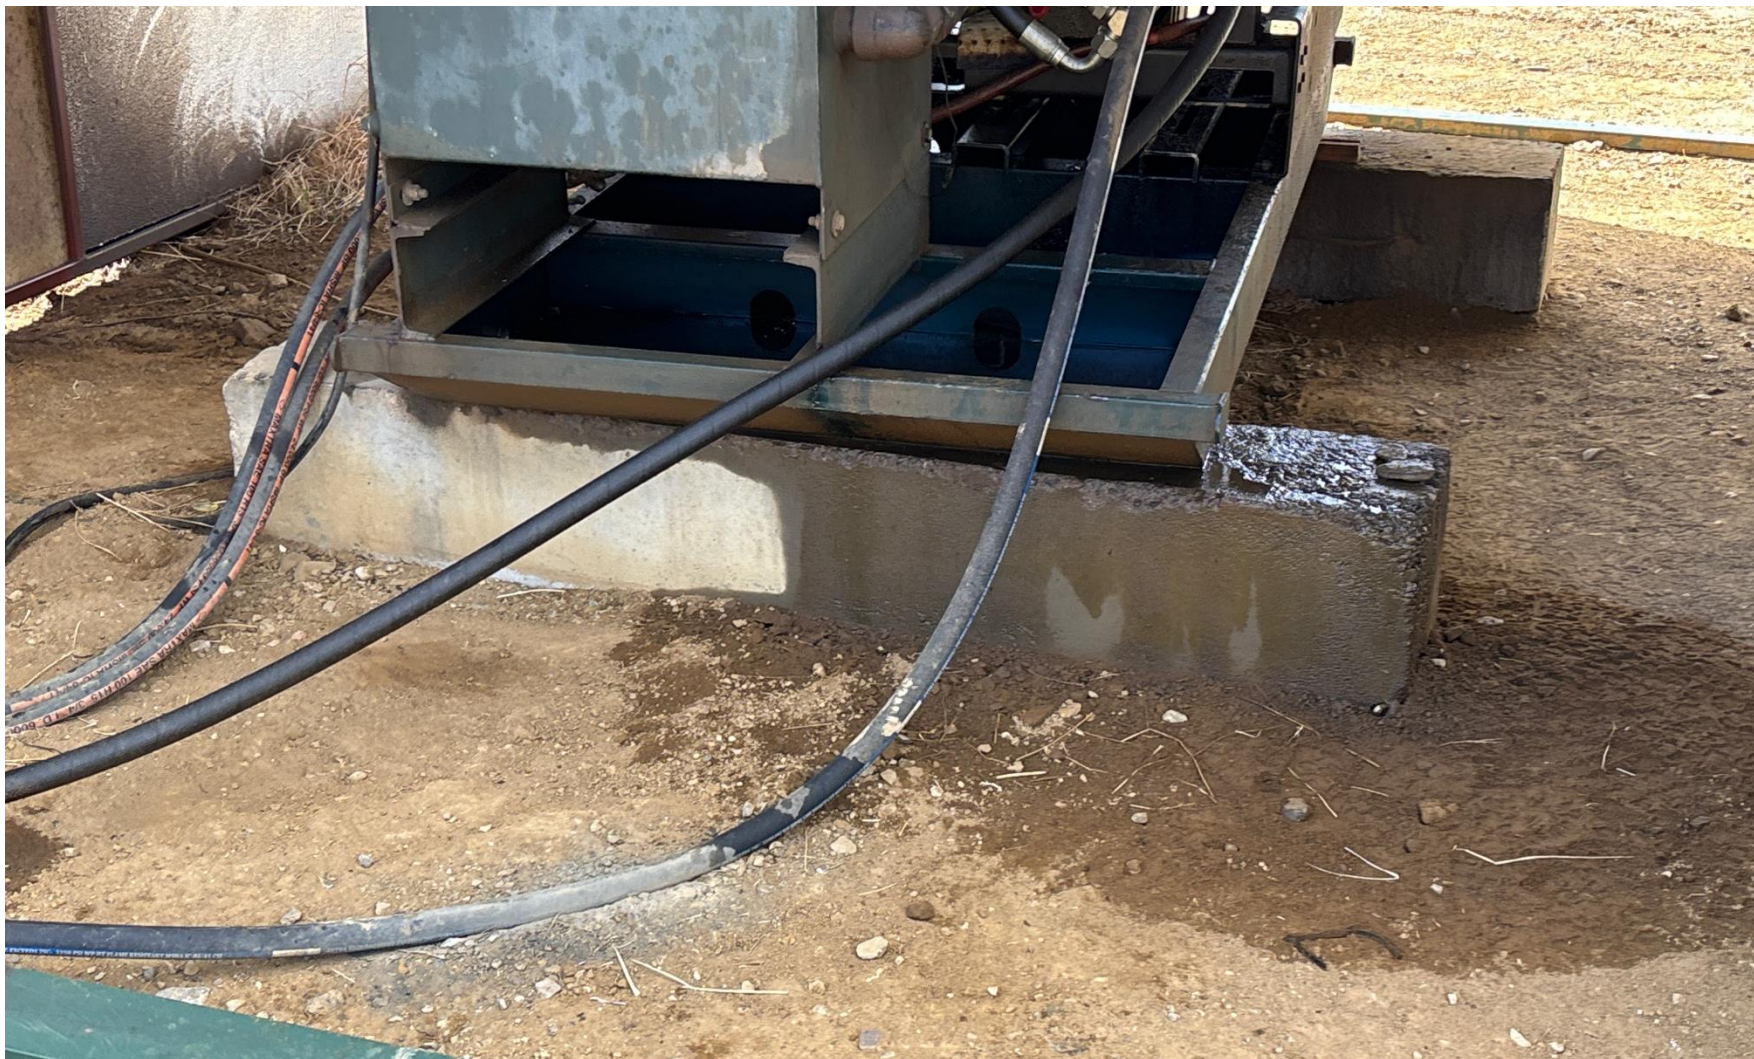
**PHOTO 5: OILY WASTE IN COMPRESSOR SKID. DRAIN OILY WASTE REPAIR ALL LEAKS AND REMOVE OR TREAT IMPACTED SOIL PER RULE 1002..(2).D & 1002.f.(2)B, Comply with general provisions of the oil and gas act for wildlife protection AND SB-181. CA DATE 2-26-2025**

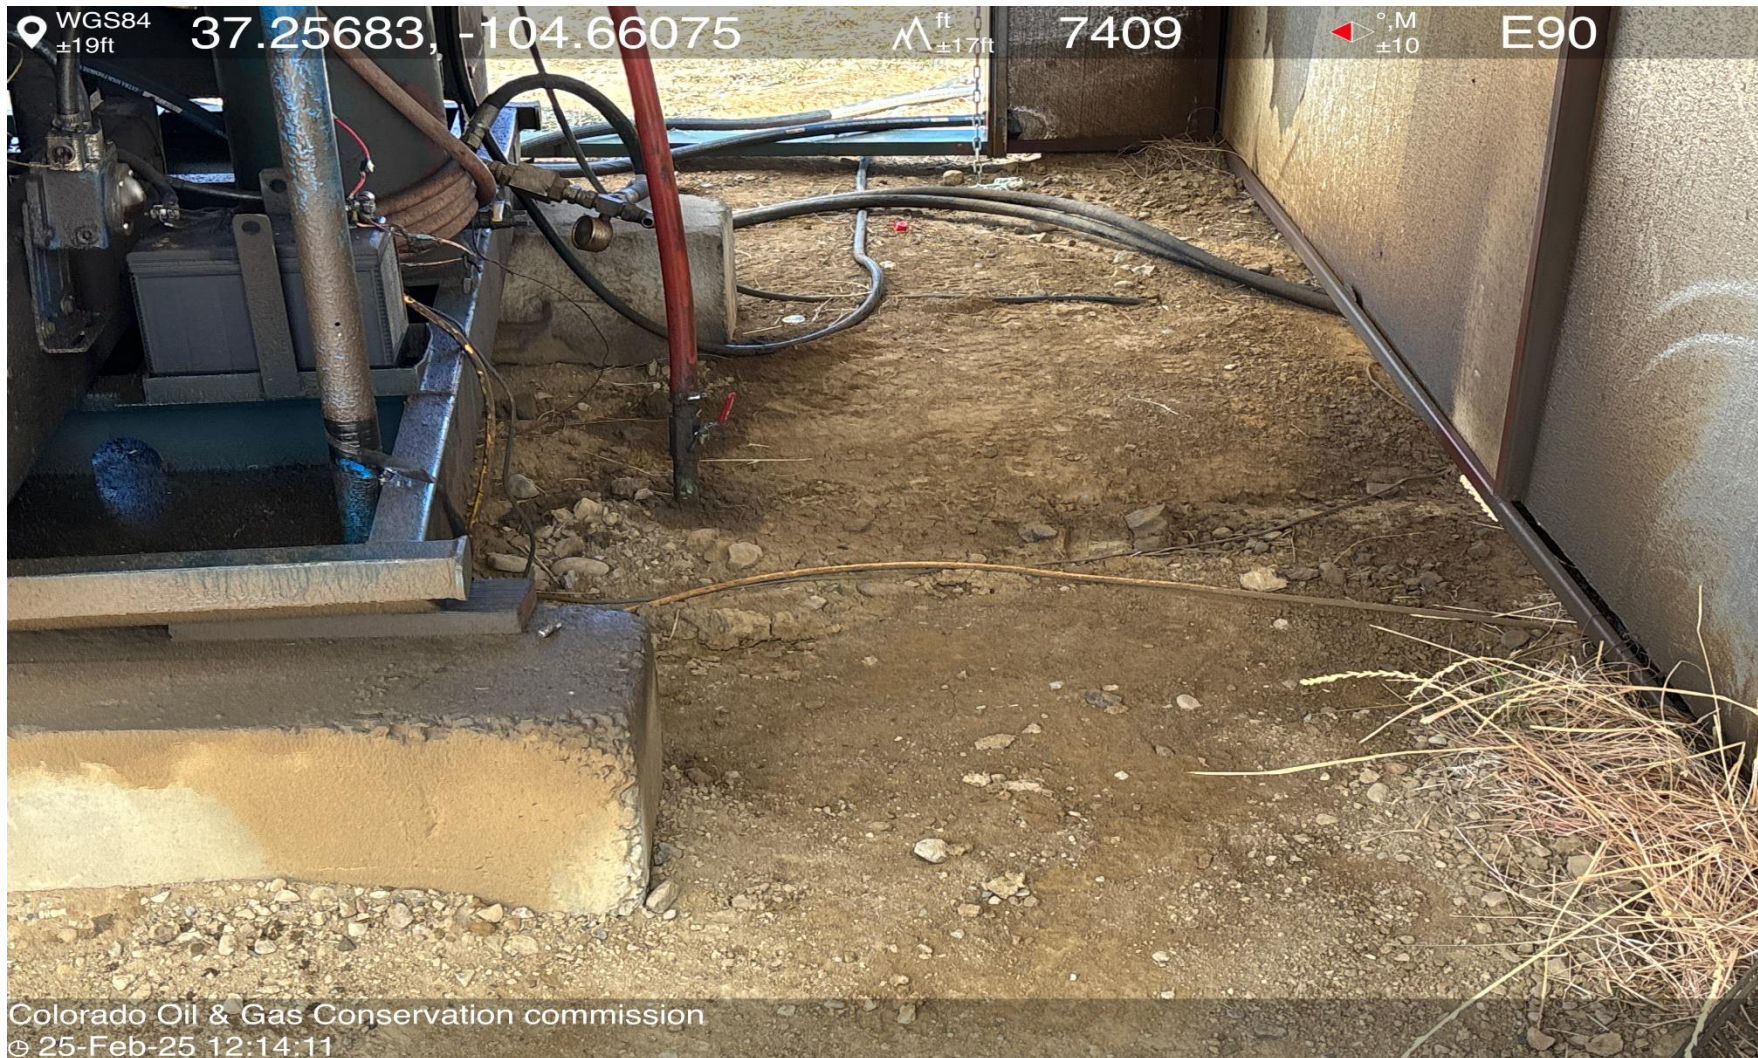
**PHOTO 6: AREA OF IMPACTED SOIL AROUND PRIME MOVER ENGINE SKID. Conduct maintenance on equipment, cleanup stained material and review self inspection processes. COMPLY WITH RULE 1002,.(2).D. CA DATE 3-2-2025.**
