# Final Reclamation and Stormwater Inspection

Location ID: 312265

Inspection Document #: 718700330

Inspection Photos  
Location Name: Emerald 7-34  
Location ID: 312265

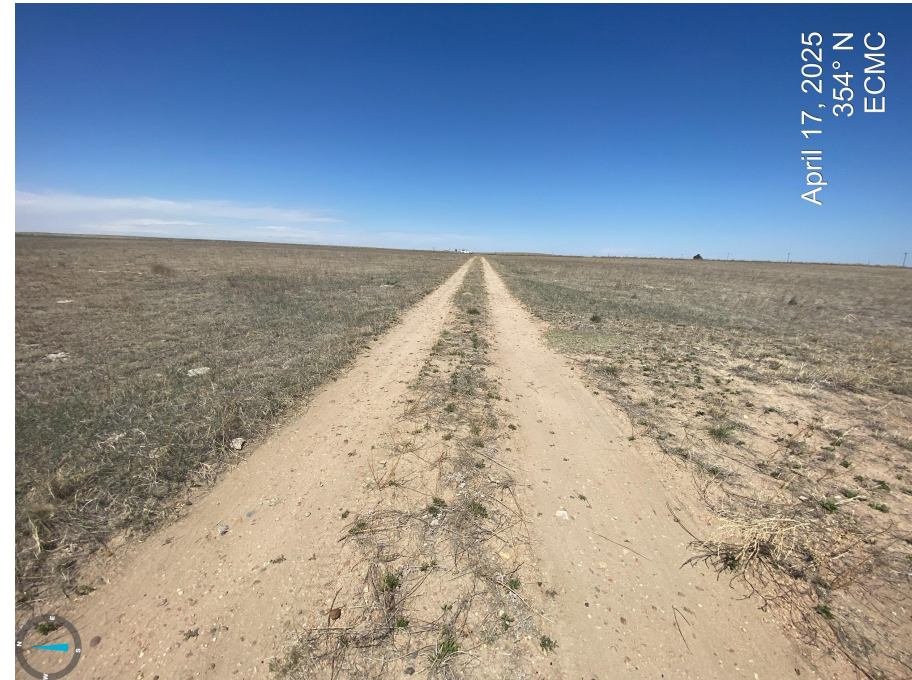
April 17, 2025  
354° N  
ECMC

**Photos 1 & 2.** It does not appear that the access road has been reclaimed with evidence of contouring/grading issues and road base material present.

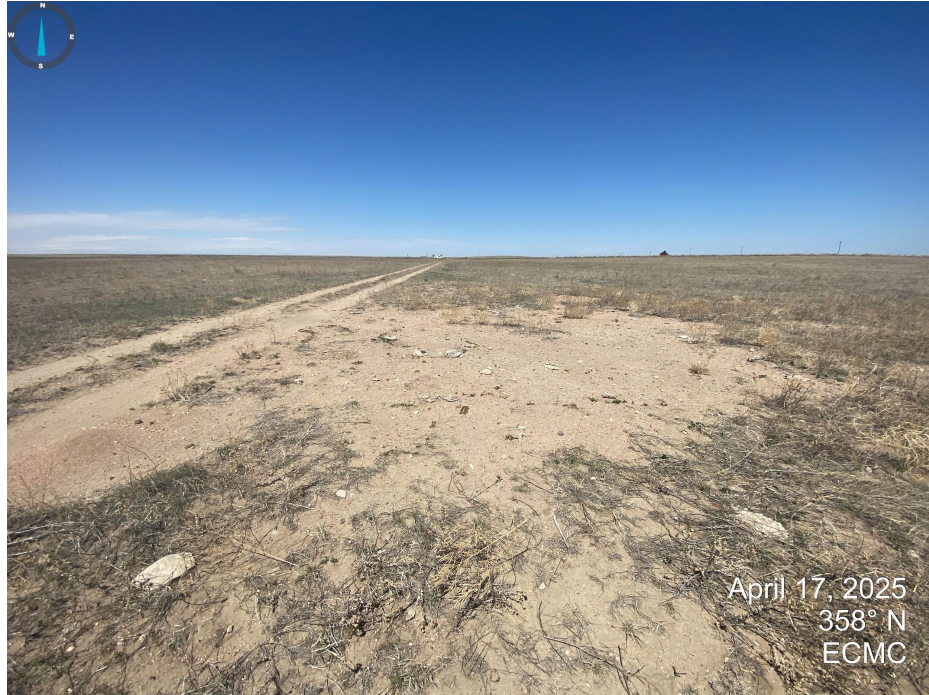
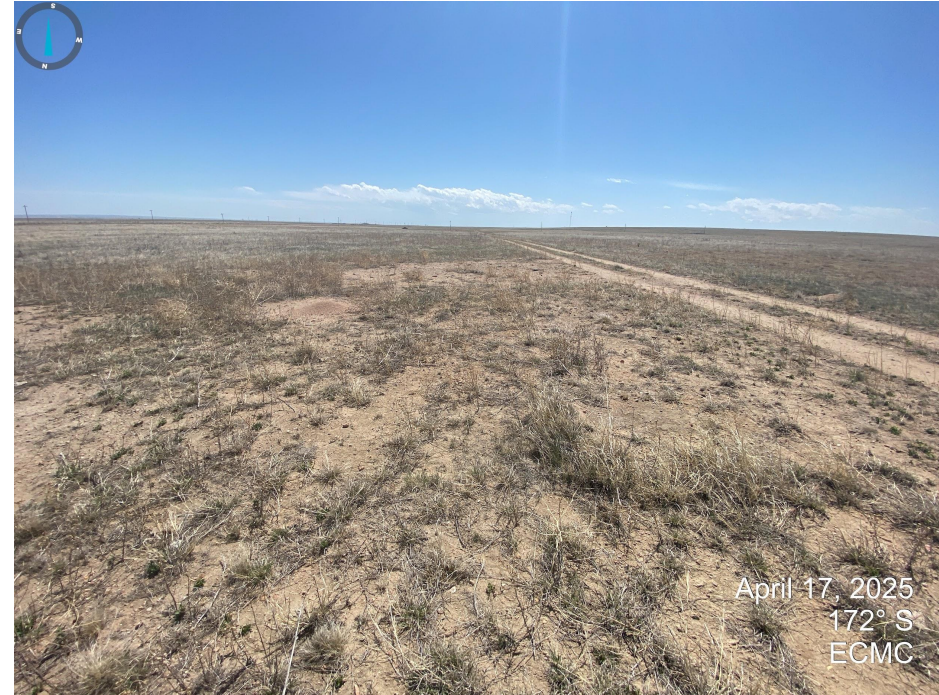
**Photos 3 & 4.** It does not appear that any reclamation activities have been performed at the former well location with evidence of road base material observed and non-uniform vegetation cover.

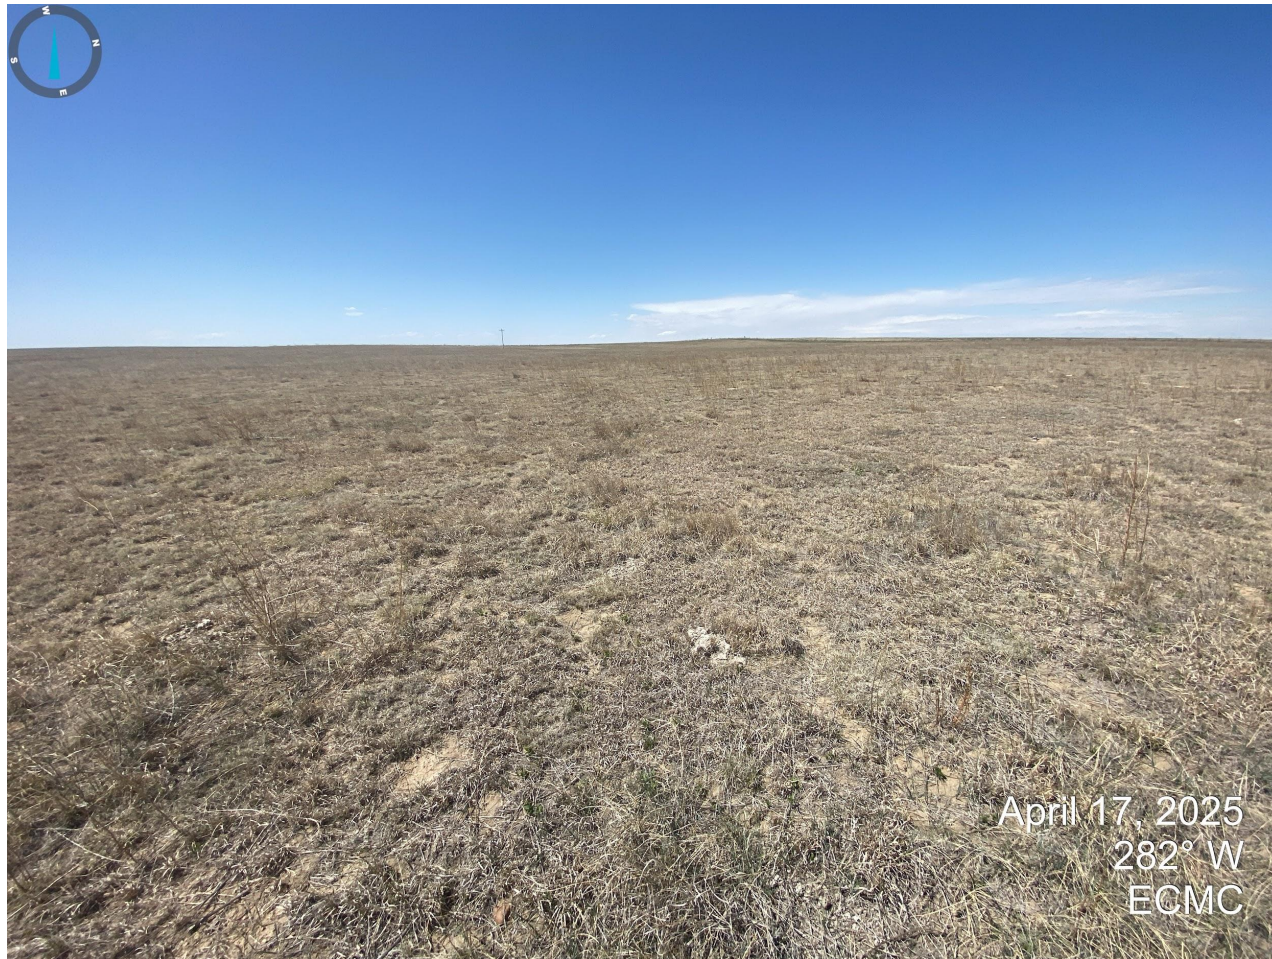
**Photo 5.** Adjacent reference area taken west of the former location.
