Interim Reclamation and Stormwater Inspection

Location ID: 464916

Location Name: Dottie Doris/11,12-34

Inspection Document #: 718600514

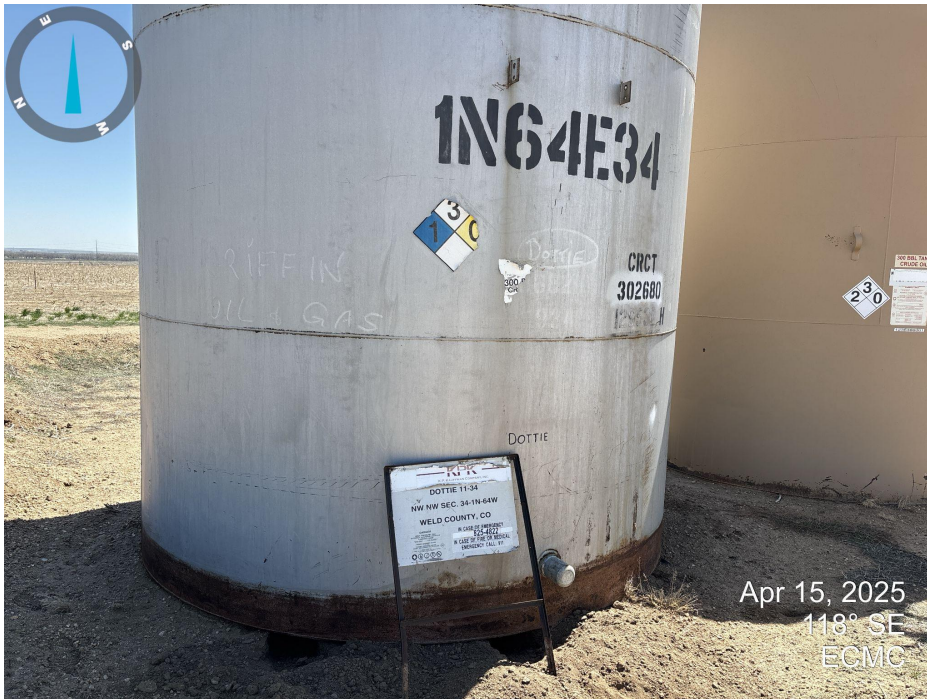
Photo 1. North side of the tank battery. Sign reads DOTTIE 11-33.

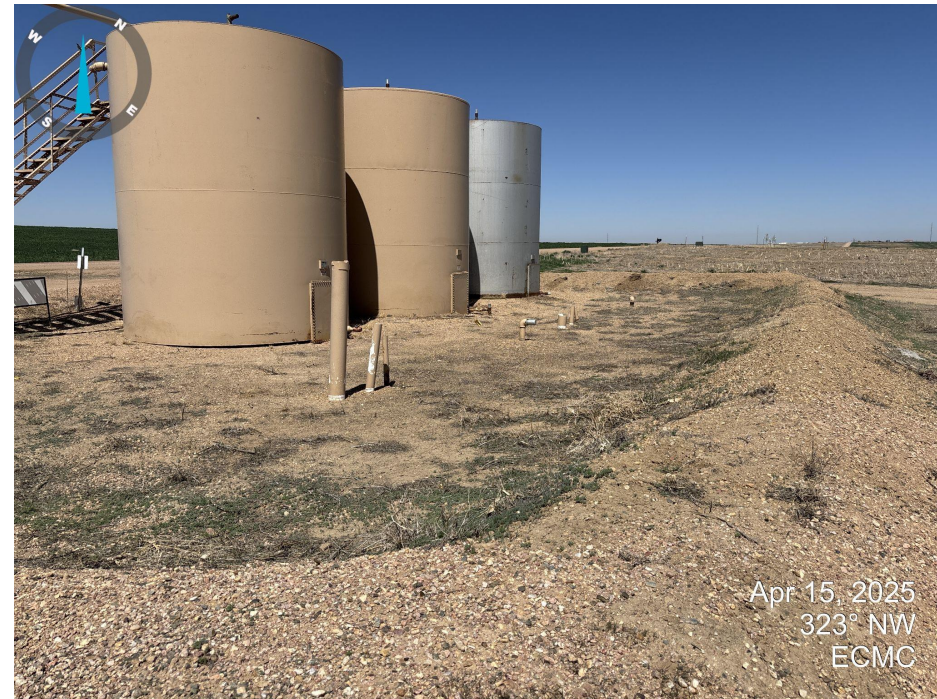
Photo 2. Looking at the east side of the tank battery. Weeds have been mowed on location and in secondary containment. Trash has been removed.

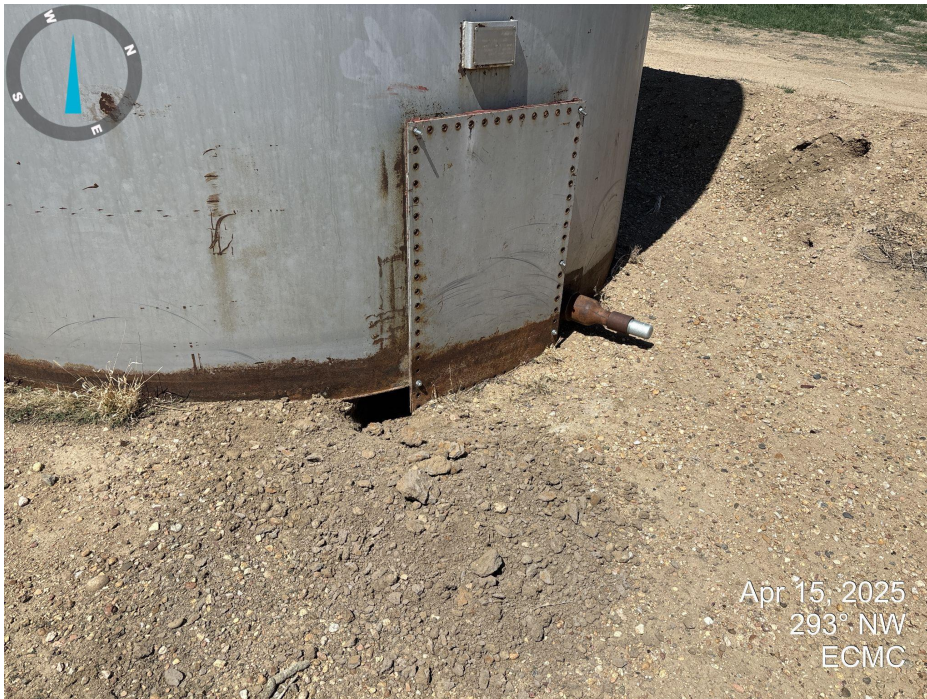
Photo 3. Looking at the east side of the northern tank. Animal holes are present underneath the tank.

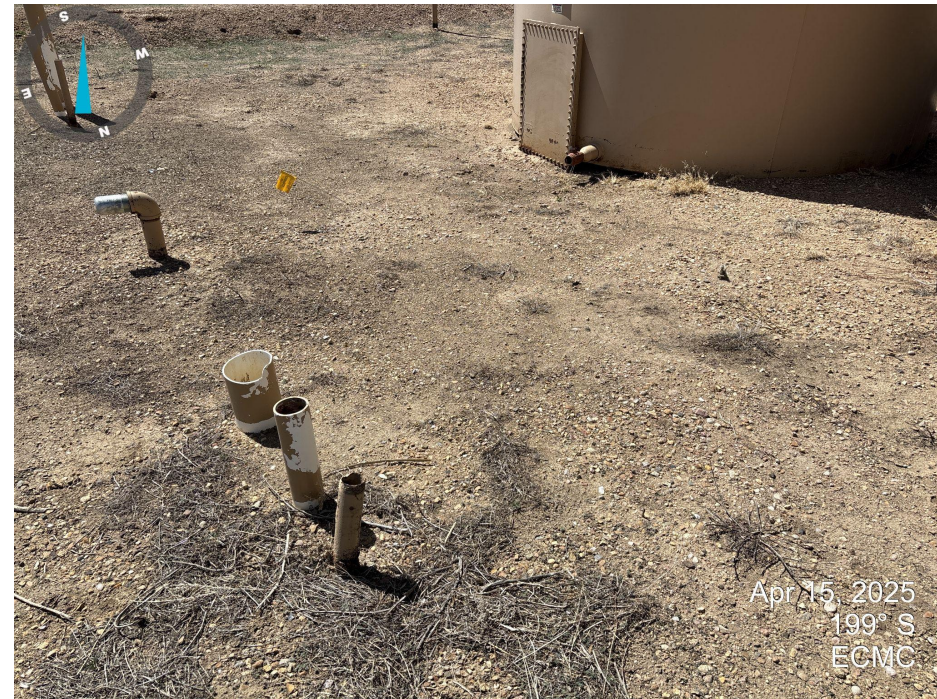
Photo 4. Photo taken on the east side of location. PVC pipes behind the tanks do not have wildlife exclusion devices installed.
