Final Reclamation Inspection

Operator: KERR MCGEE OIL & GAS ONSHORE LP - 47120

Location ID: 318101

Inspection Photos
Location Name: WILLIAM WETHINGTON GAS
UNIT #1
Location ID: 318101

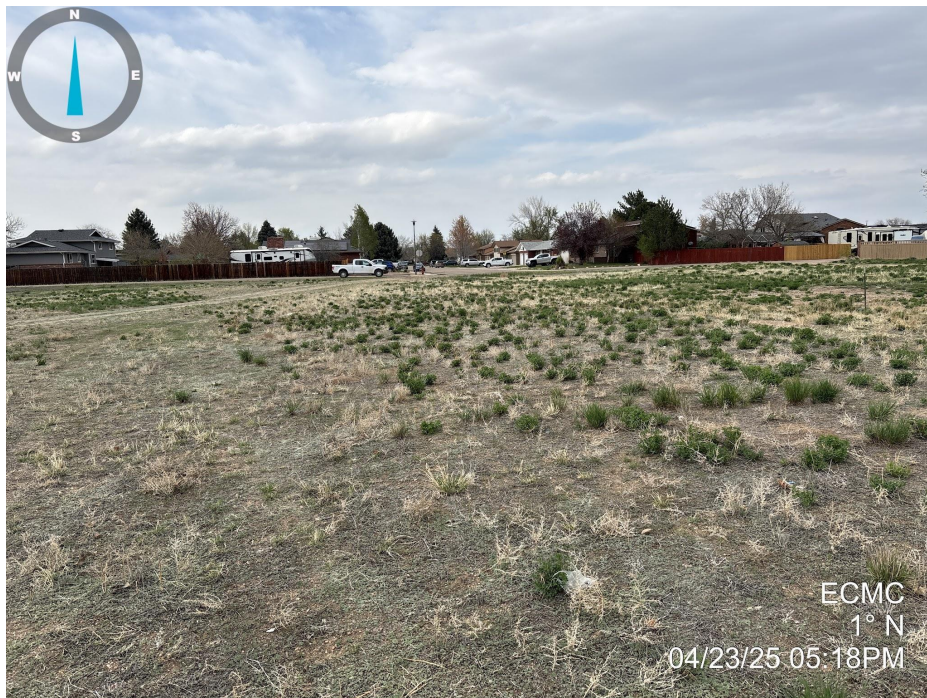
Photo 1. Photo taken from the well location, facing North. Photo illustrates that vegetation establishment across the well location does not meet Rule 1004 reclamation standards.

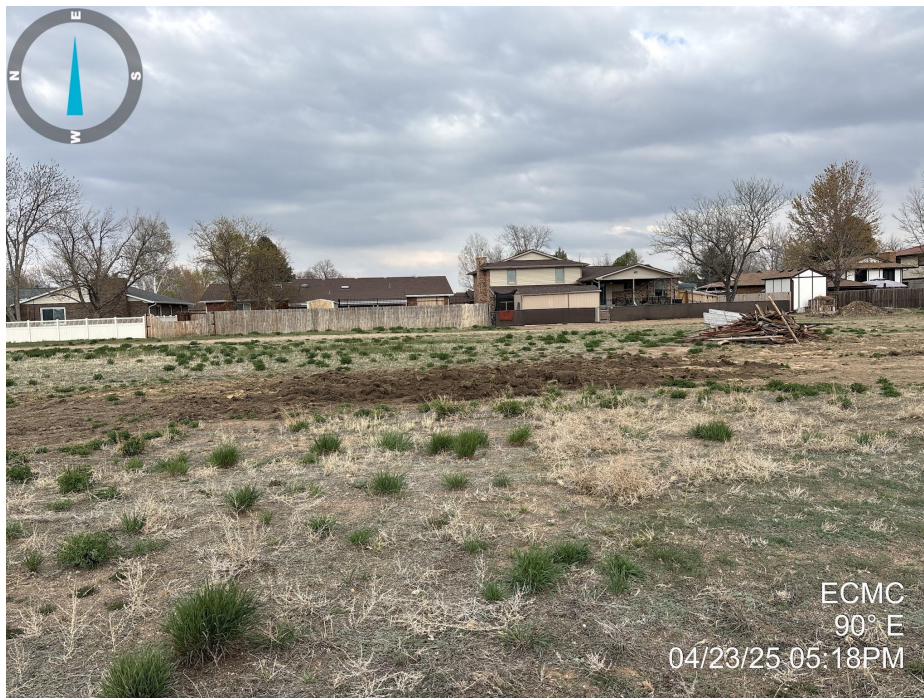
Photo 2. Photo taken from the well location, facing East. See comments under Photo 1.

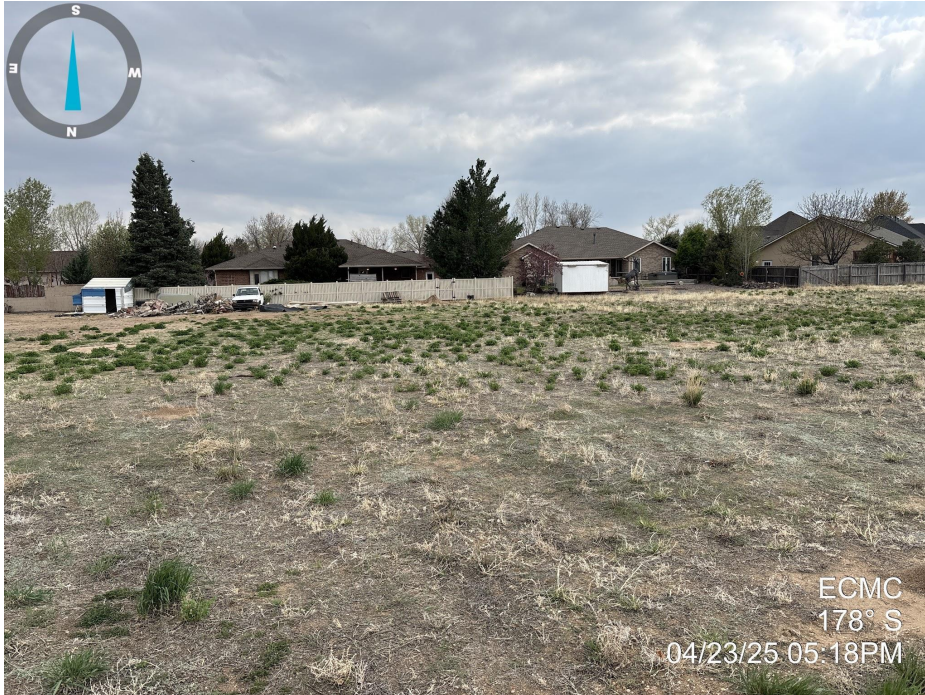
Photo 3. Photo taken from the well location, facing South. See comments under Photo 1.

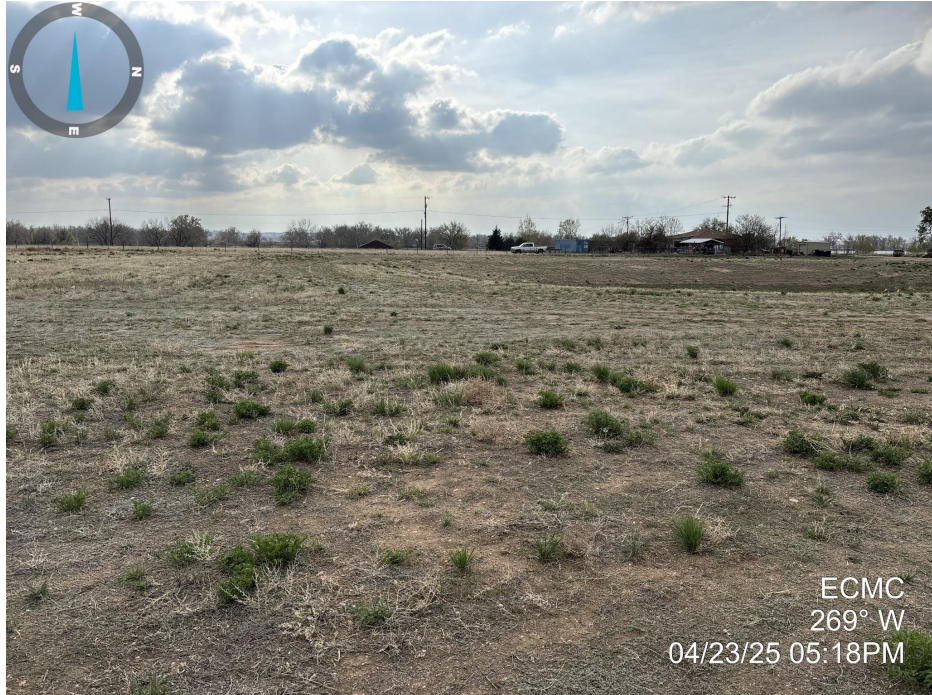
Photo 4. Photo taken from the well location, facing West. See comments under Photo 1.

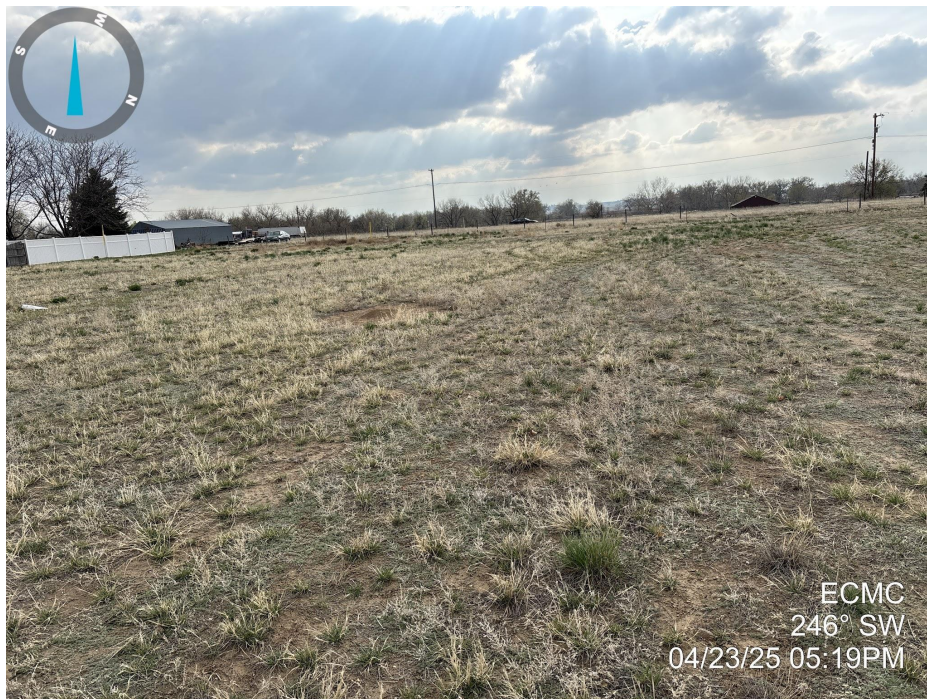
Photo 5. Photo taken of the tank battery location, facing Southwest. Photo illustrates that the tank battery location meets Rule 1004 reclamation standards.

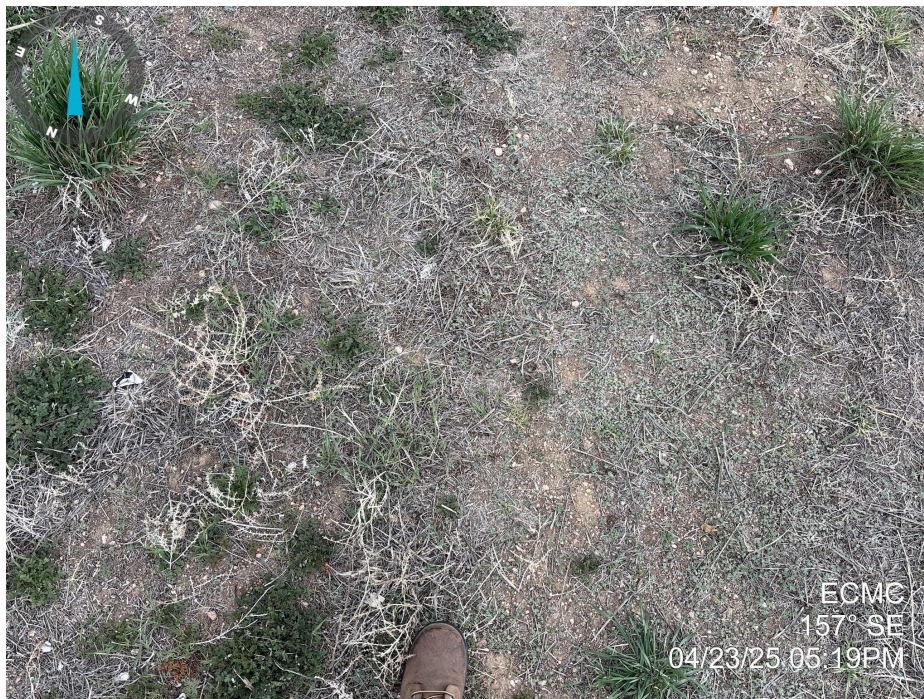
Photo 6. Photo taken of the well location. Photo illustrates that some perennial grass vegetation has established at the well location, but vegetation does not meet Rule 1004 reclamation standards. Refer to reference area conditions in Photo 9.

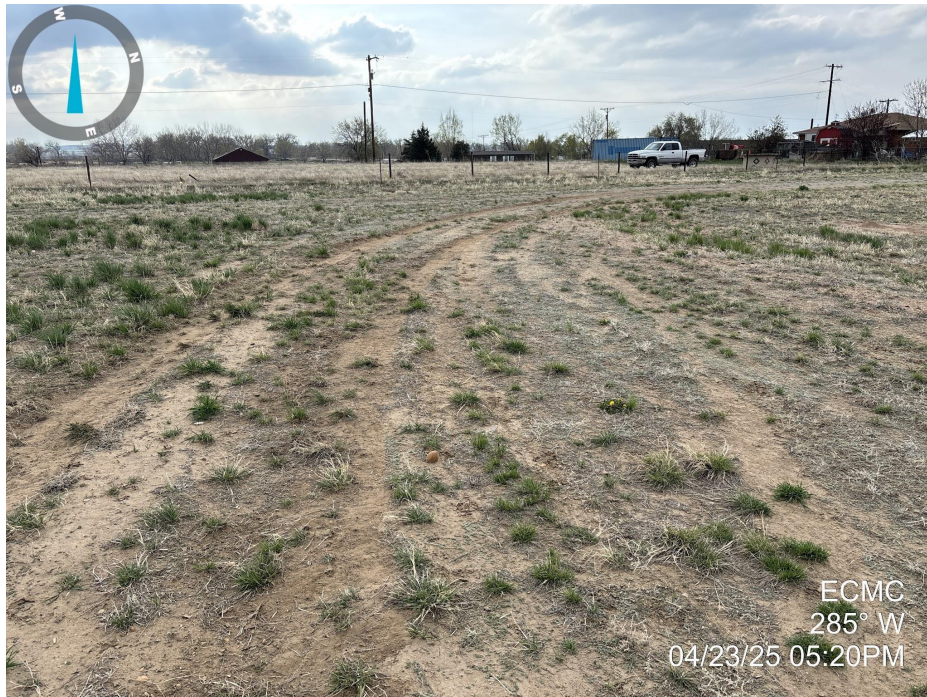
Photo 7. Photo taken from the access road, facing West, away from the location. Photo illustrates evidence of disturbance from oil and gas operations remains along the access road. Google Earth aerial imagery also shows that access road was not reclaimed to Rule 1004 standards.

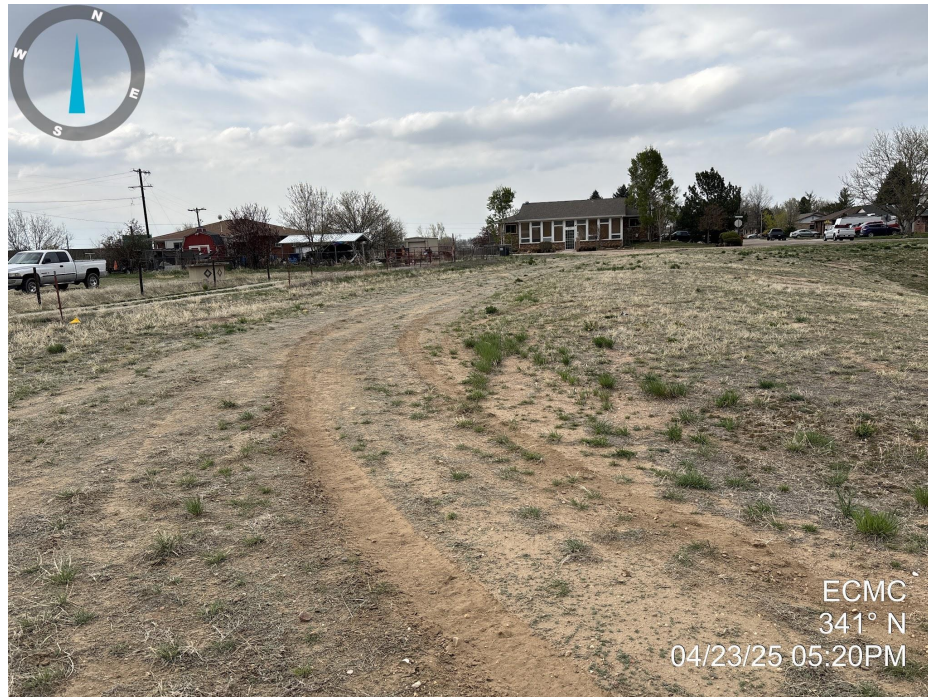
Photo 8. Photo taken from the access road, facing North. See comments under Photo 7.

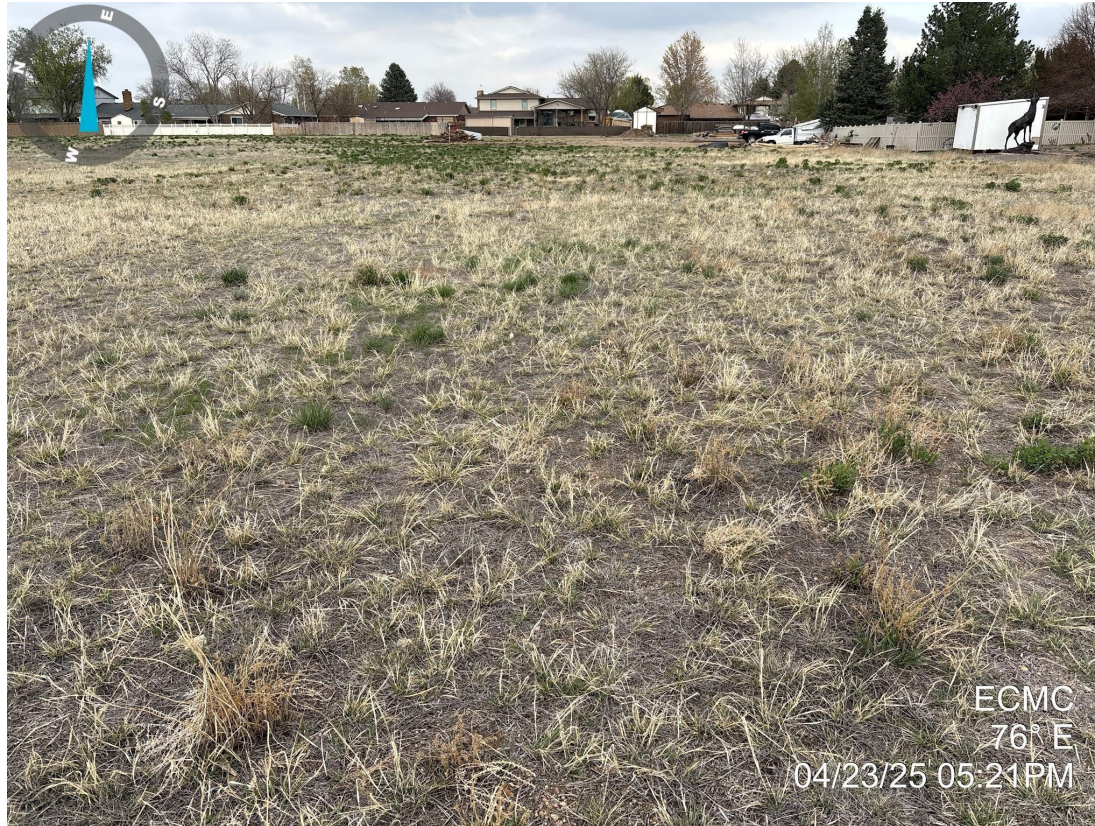
Photo 9. Photo taken of the reference area, southwest of the location, facing Southwest. Photo illustrates perennial grass vegetation.
