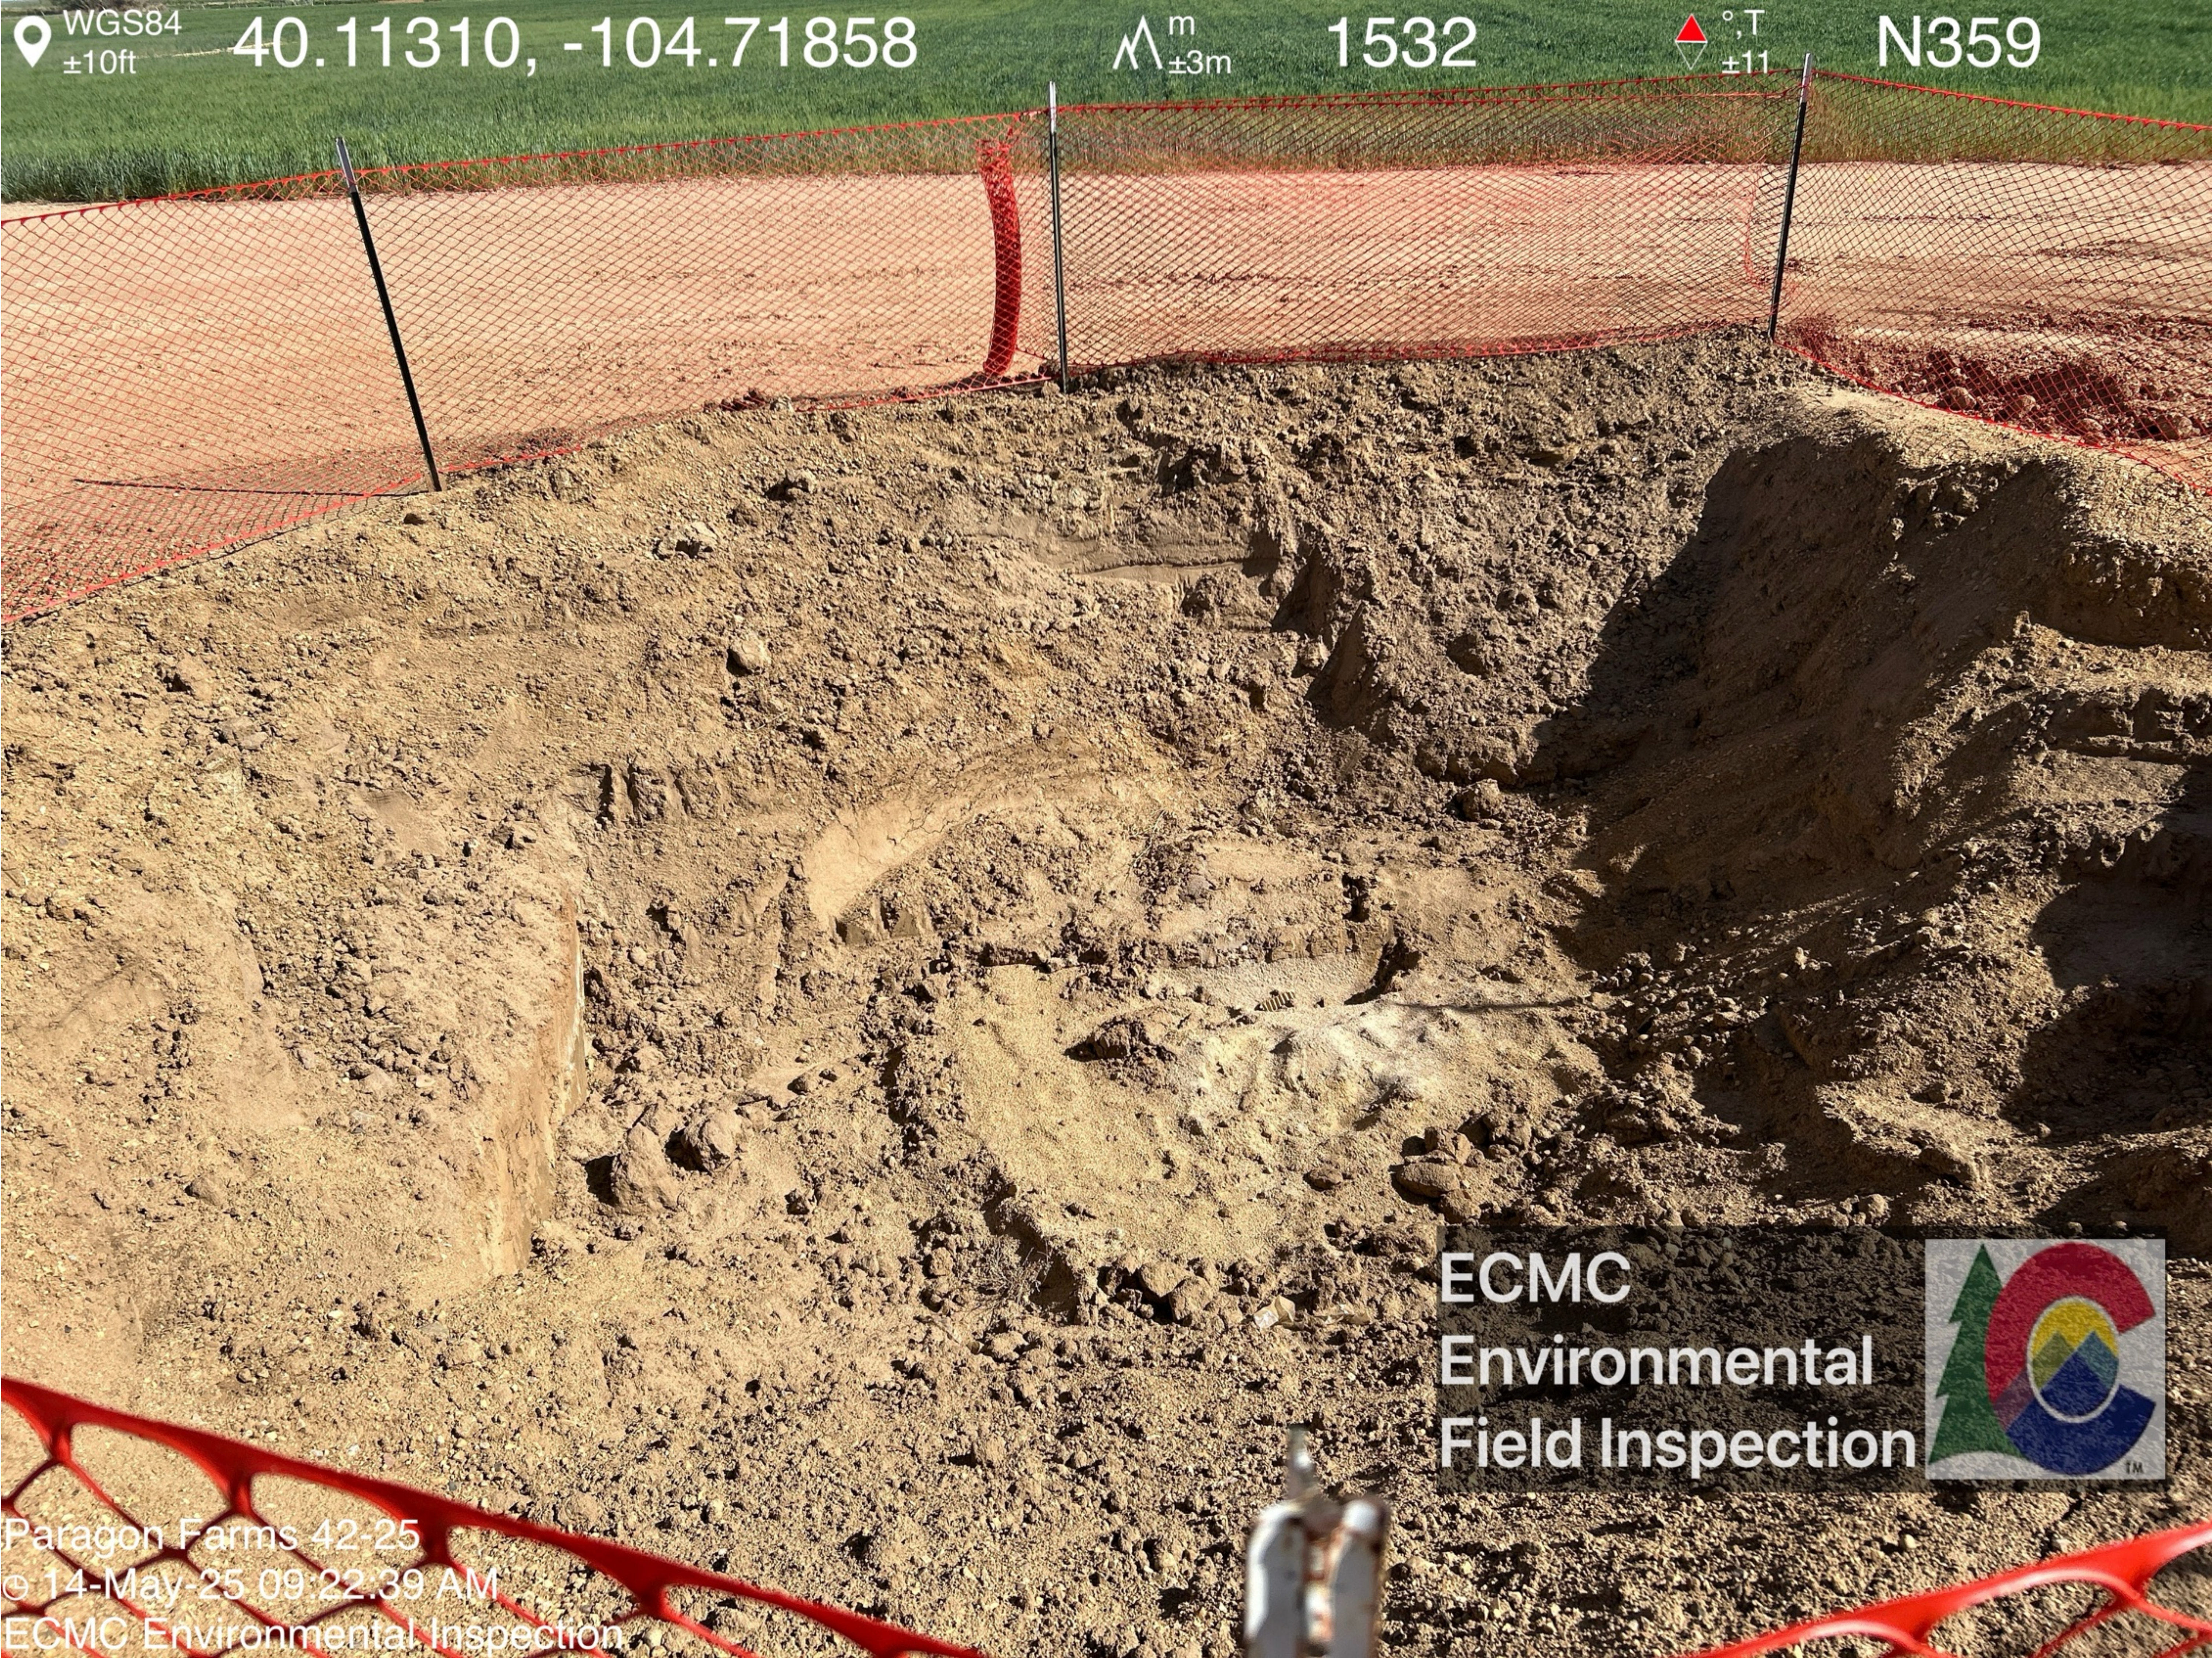
Produced water vessel excavation. No environmental impacts were visible in situ and no groundwater was observed in the open excavation. Orange construction fencing surrounds the excavation.
