Final Reclamation Inspection

Operator: NOBLE ENERGY INC - 100322

Location ID: 447341

Inspection Photos
Location Name: BOHLENDER D 20-3,4,6,2J
Location ID: 447341

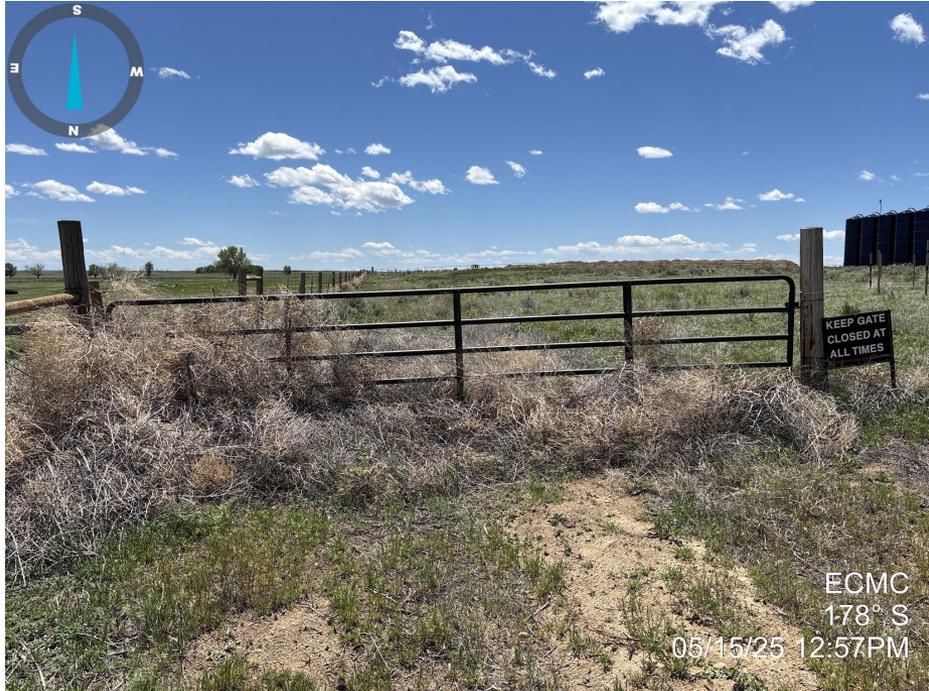
Photo 1. Photo taken from access road, at the entrance to the location. Photo illustrates weedy vegetation at the location.

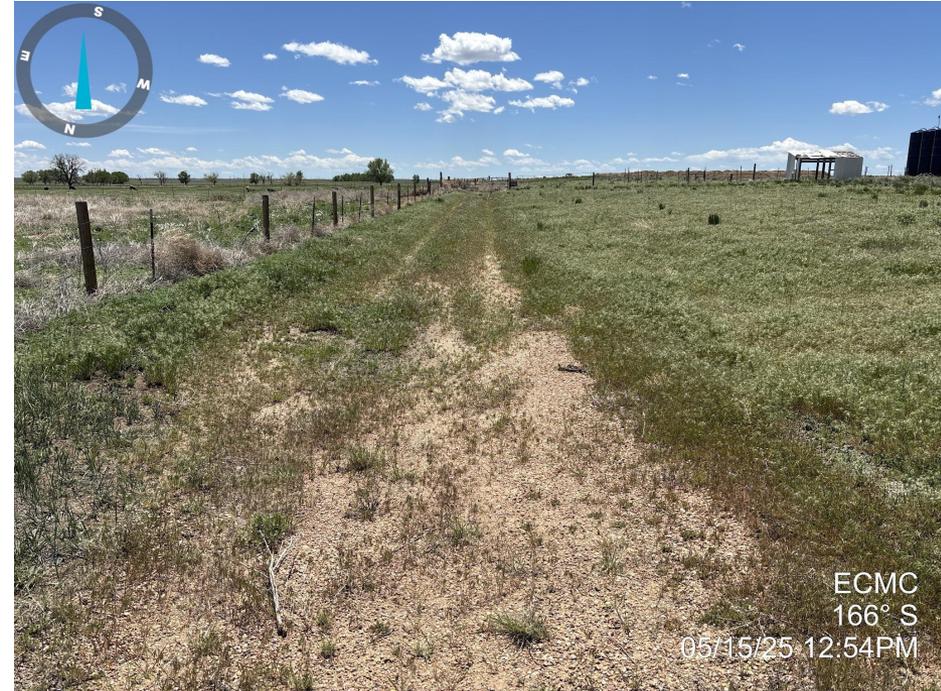
Photo 2. Photo taken from the access road, facing South. Photo illustrates that gravel remains across the access road and vegetation establishment does not meet Rule 1004 standards.

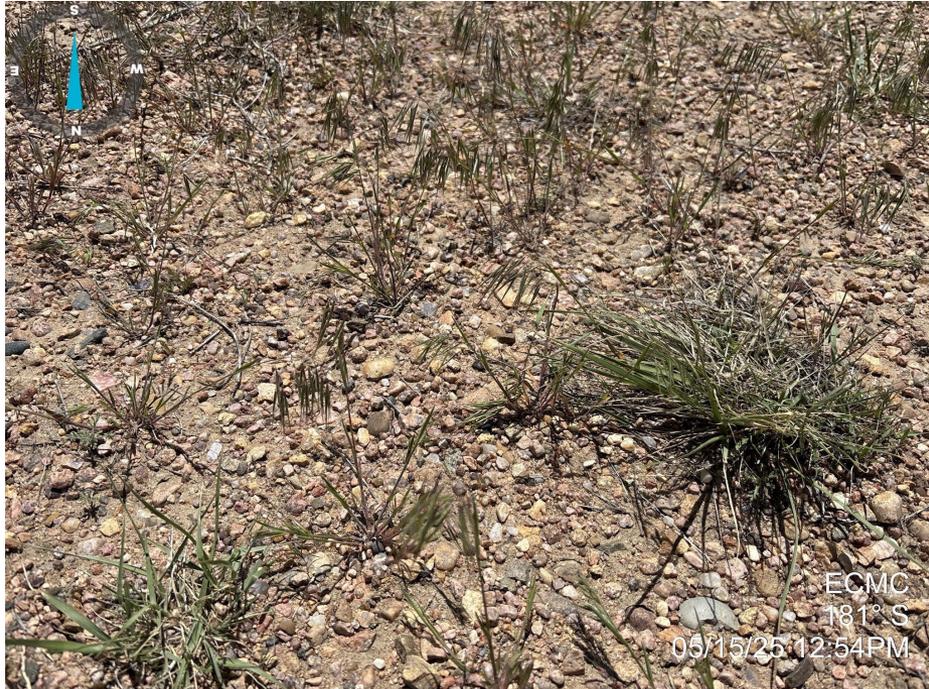
Photo 3. Photo taken of the access road. Photo illustrates that gravel remains and cheatgrass (*Bromus tectorum*) is present across the location and is a List C noxious weed species.

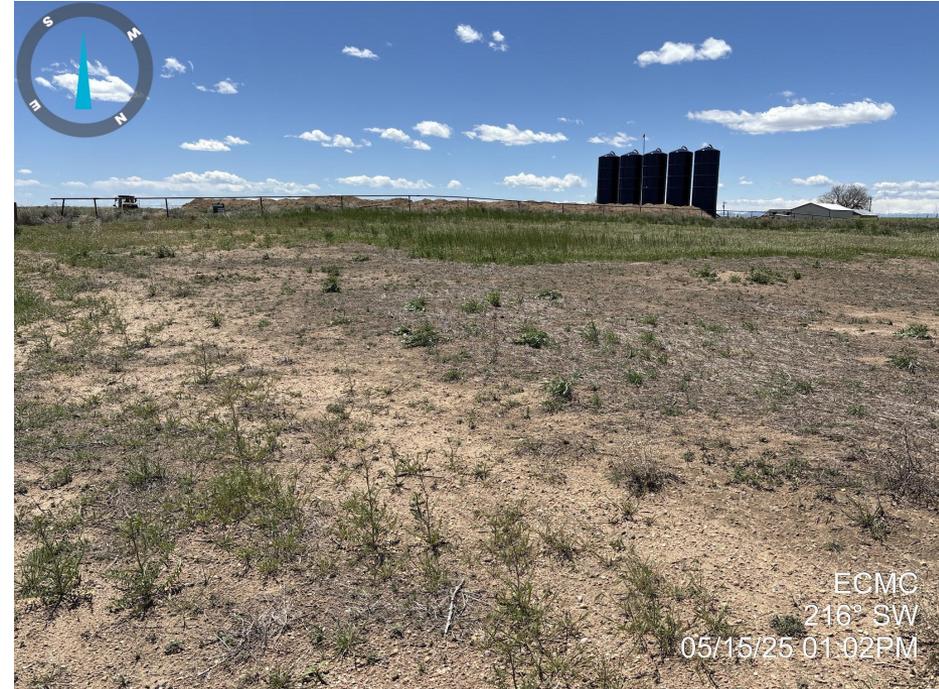
Photo 4. Photo taken from the well location, facing Southwest. Photo illustrates that the location does not meet Rule 1004 standards as there is insufficient vegetation cover, the location is dominated by weedy annual vegetation, and gravel remains across the location.

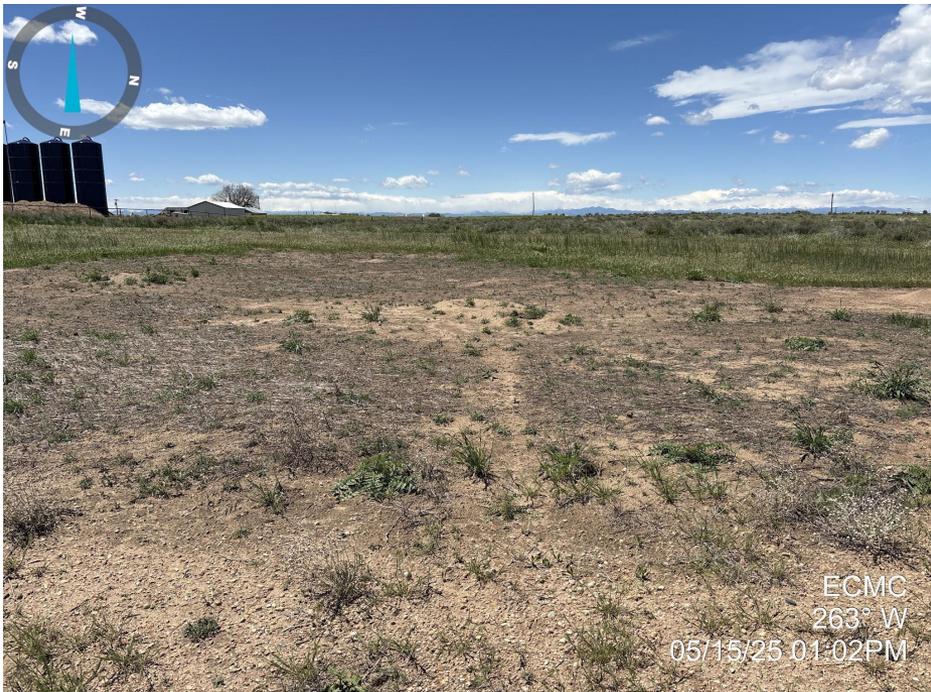
Photo 5. Photo taken from the tank battery location, facing West. See comments under Photo 4.

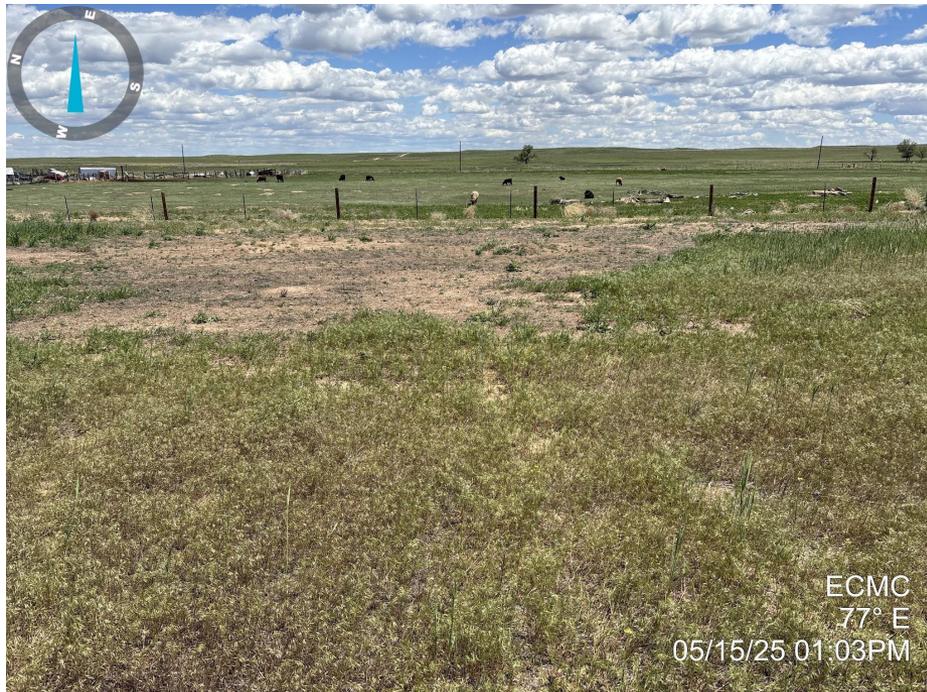
Photo 6. Photo taken from the tank battery location, facing East. See comments under Photo 4.

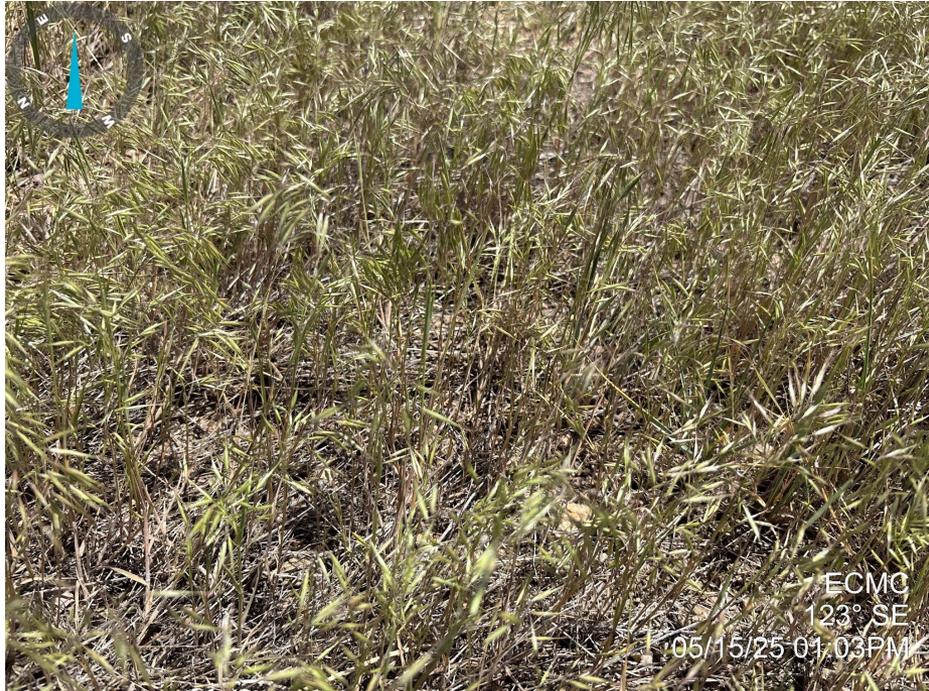
Photo 7. Photo taken of vegetation at the tank battery location. Photo illustrates that cheatgrass (*Bromus tectorum*) is present across the location and is a List C noxious weed species.

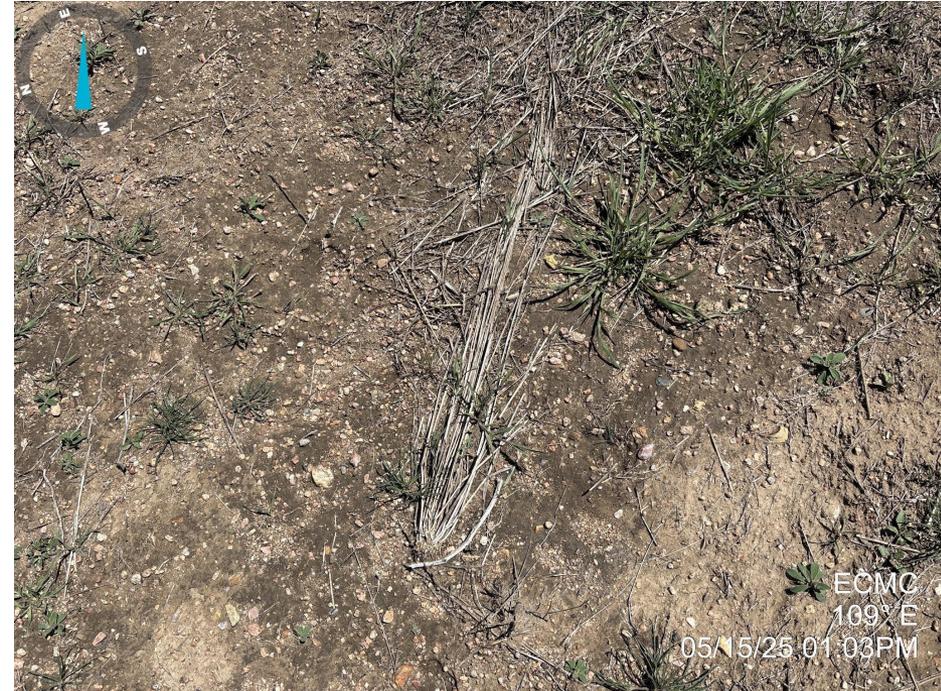
Photo 8. Photo taken of the tank battery location. Photo illustrates that gravel remains on the location.

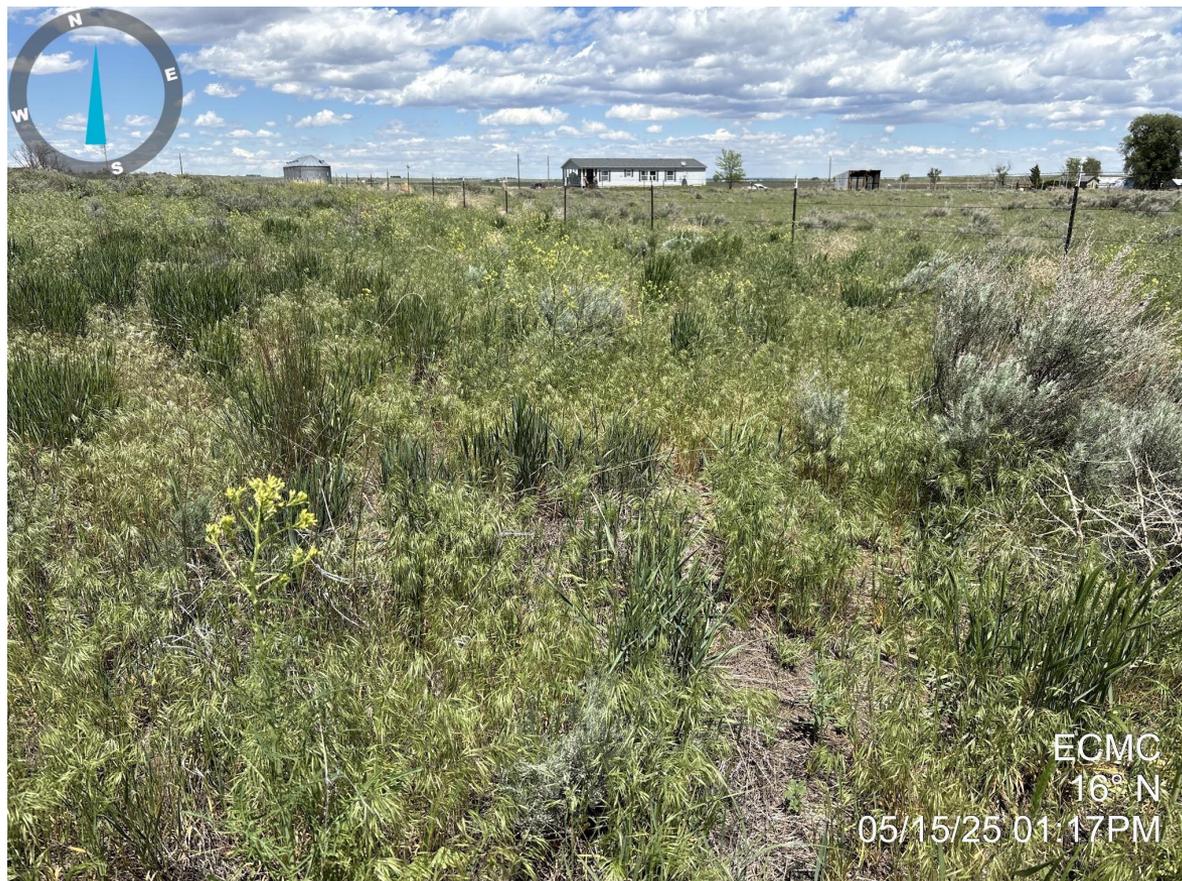
Photo 9. Photo taken of the reference area, west of the location, facing North. Photo illustrates some perennial vegetation and weedy annual growth including cheatgrass (*Bromus tectorum*).
