Final Reclamation and Stormwater Inspection

Operator: RAMPART ENERGY COMPANY - 5685

Location ID: 387264

Inspection Photos
Location Name: Schrader J12
Location ID: 387264

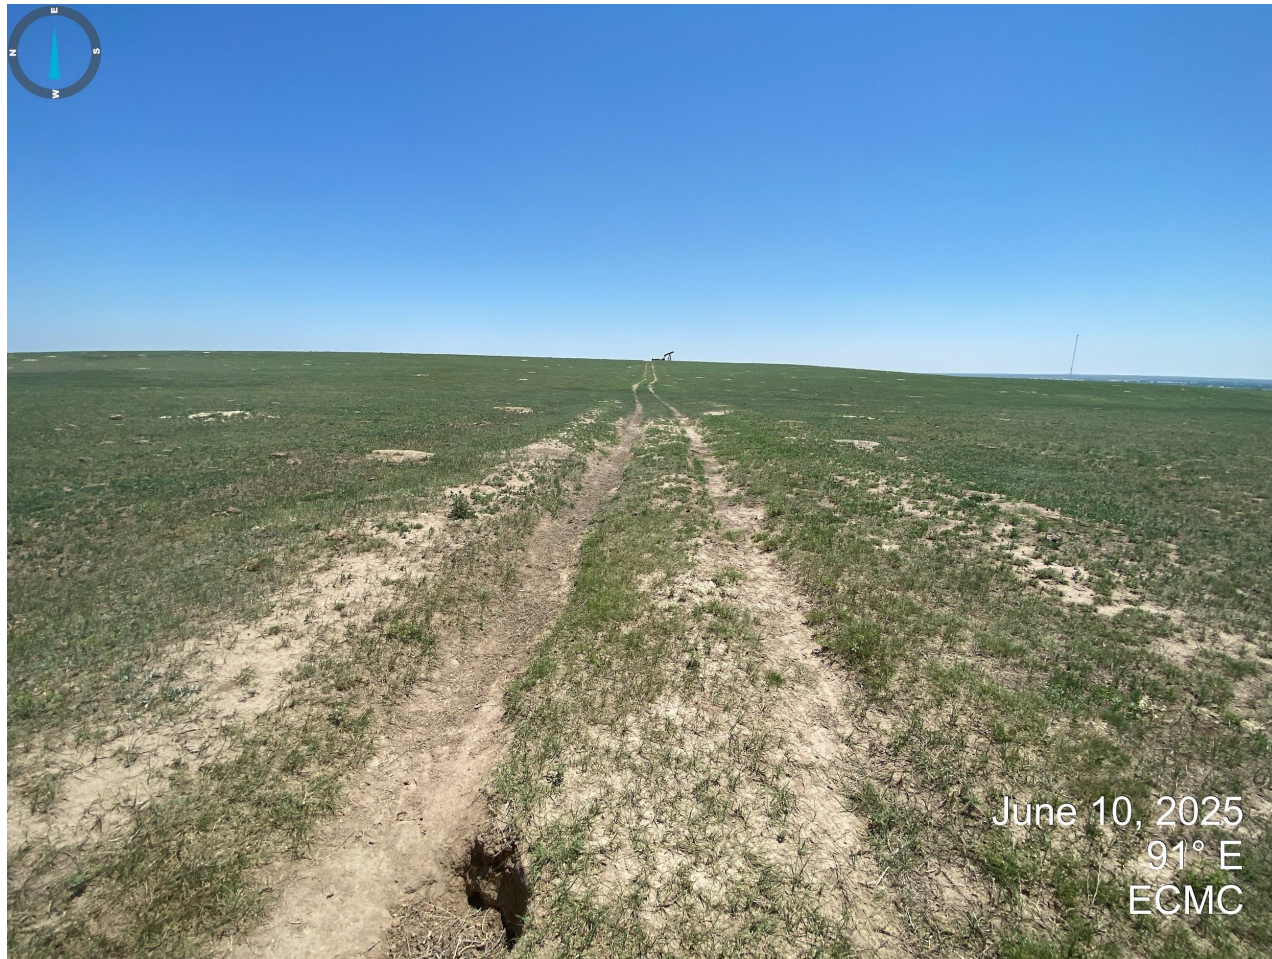
Photo 1. It appears that the piping observed in previous inspections has been removed.

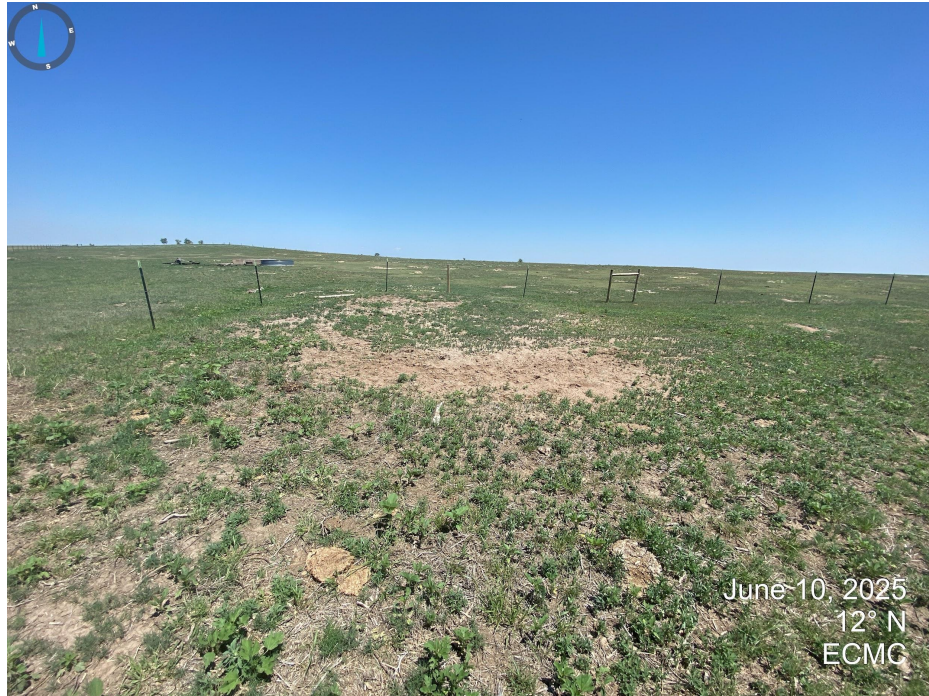
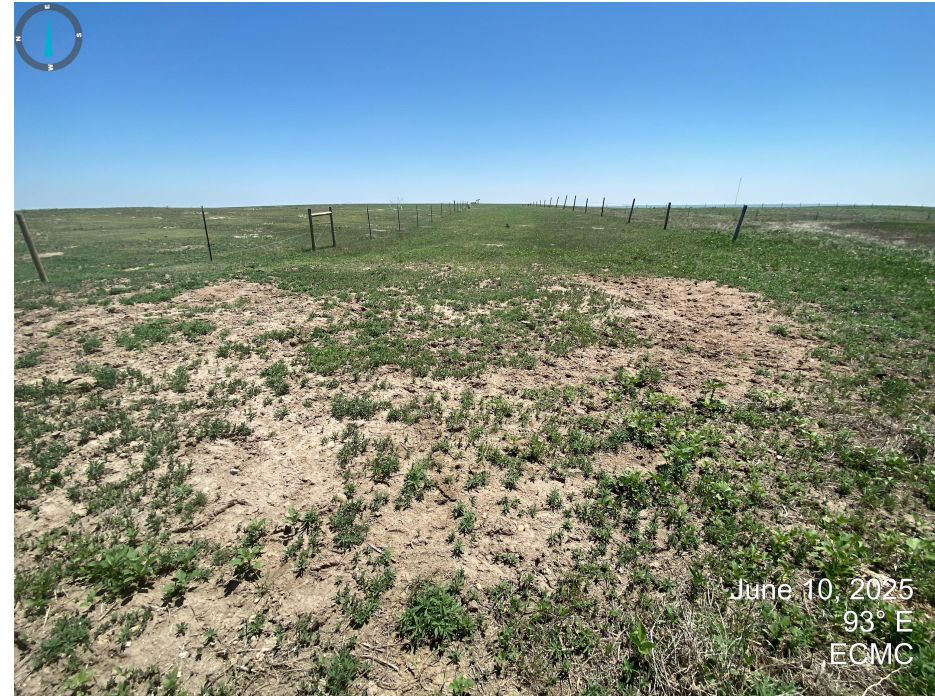
Photos 2 & 3. Taken near the former well location. It appears that the concrete base has been removed. However, the reclaimed area does not appear to be progressing towards reclamation standards with evidence of bare/unstabilized soils and undesirable vegetation (CO List C Noxious Weed - Cheatgrass, and kochia).

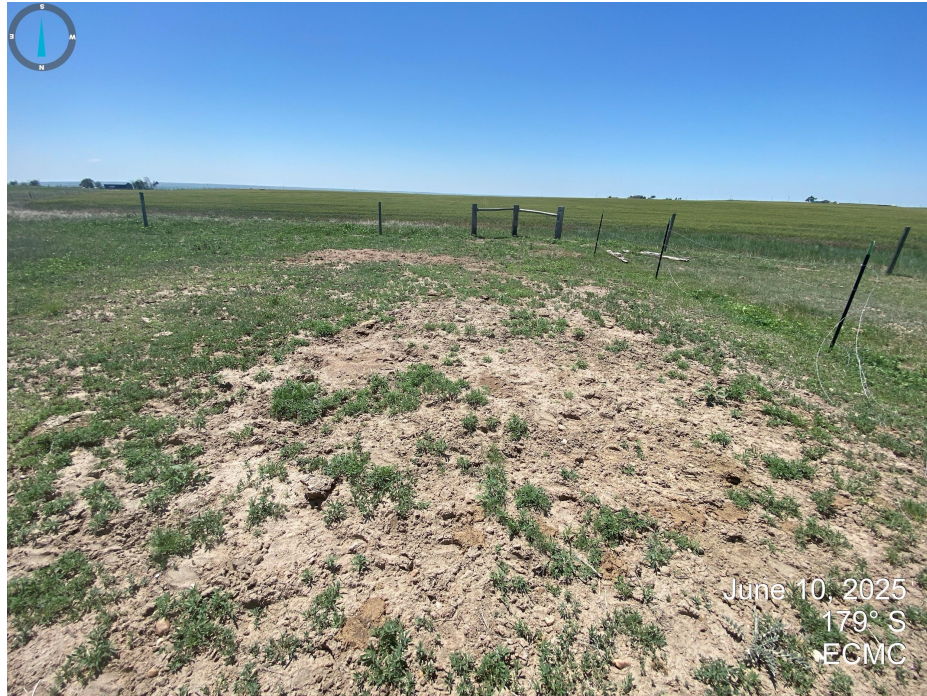
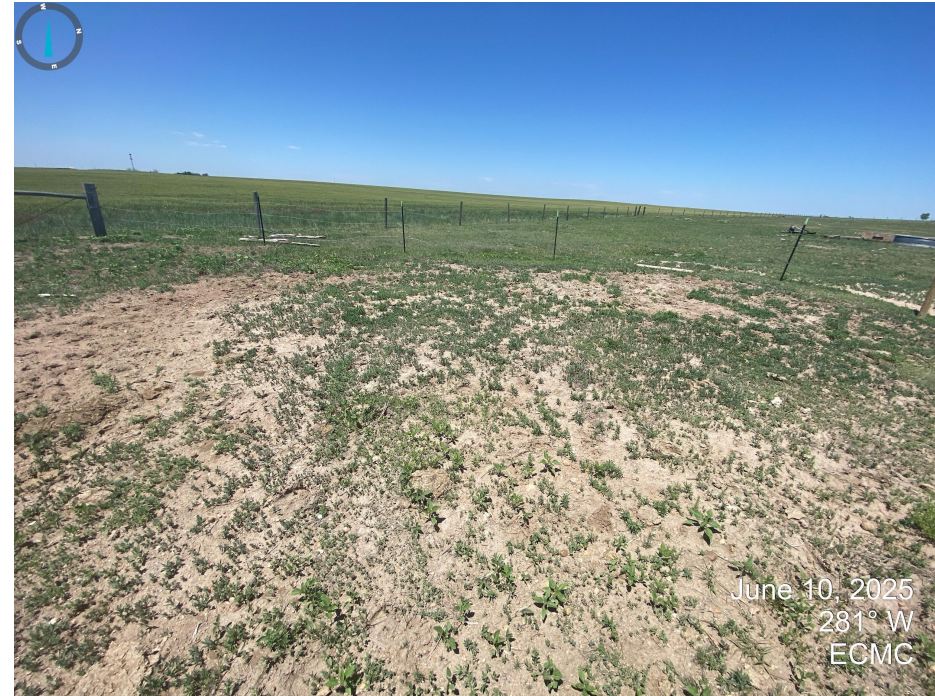
Photos 4 & 5. Taken near the former well location facing south (Photo 4; left) and west (Photo 5; right). See Photos 2 & 3 for additional information.

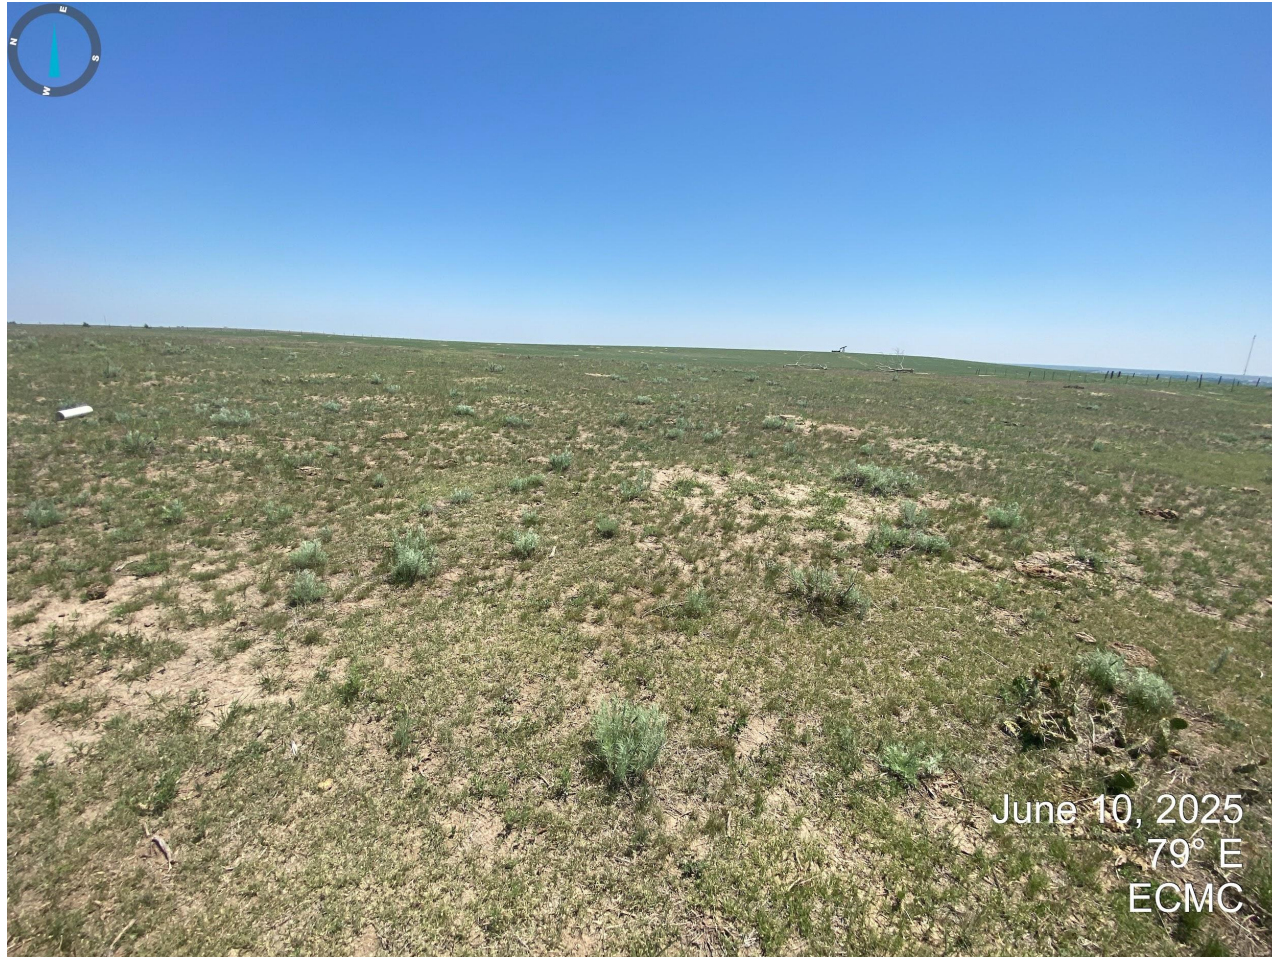
Photo 6. Adjacent reference area northeast of the former well location.
