Final Reclamation Inspection

Operator: NOBLE ENERGY INC - 100322

Location ID: 328806

Inspection Photos
Location Name: CAMENISCH - SUPREME CAMP #5-3
Location ID: 328806

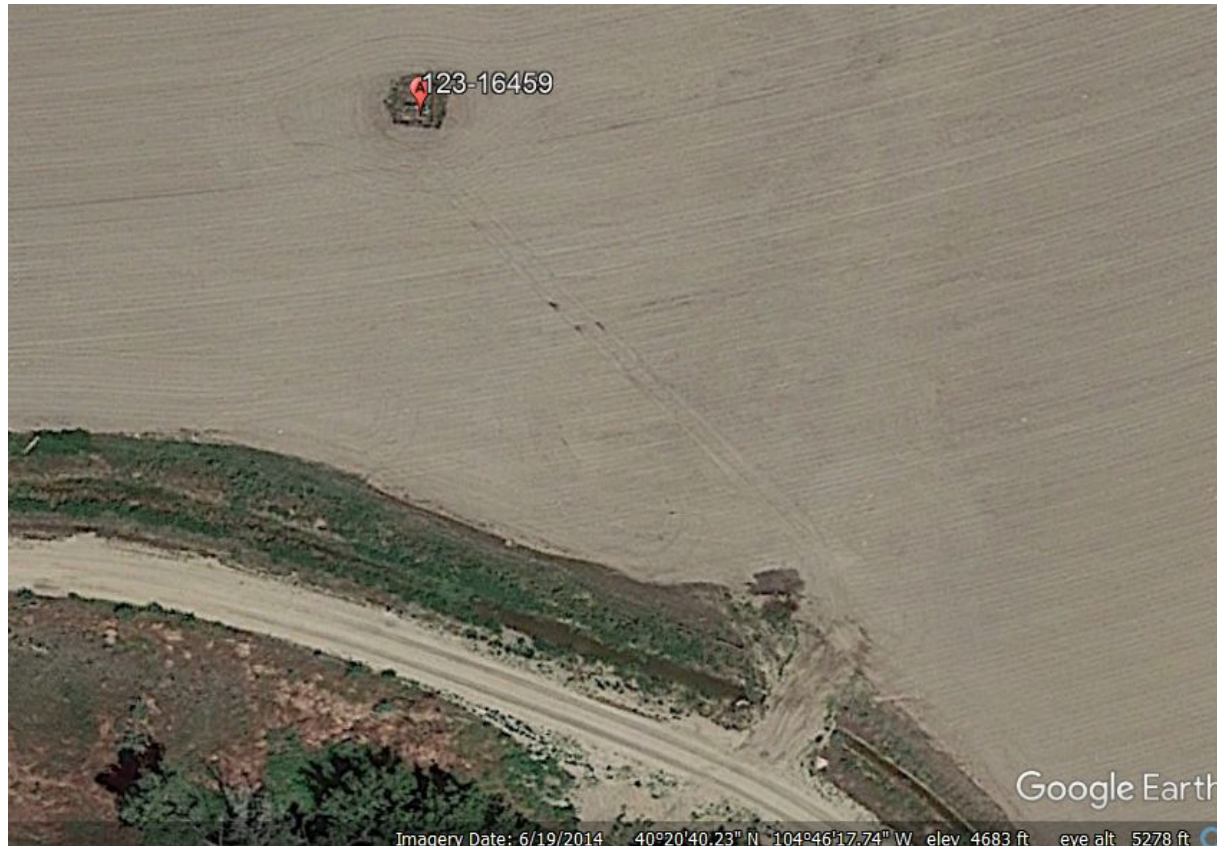
Photo 1. Google Earth aerial imagery from June 19, 2014. Photo illustrates the well location and access road during active operations.

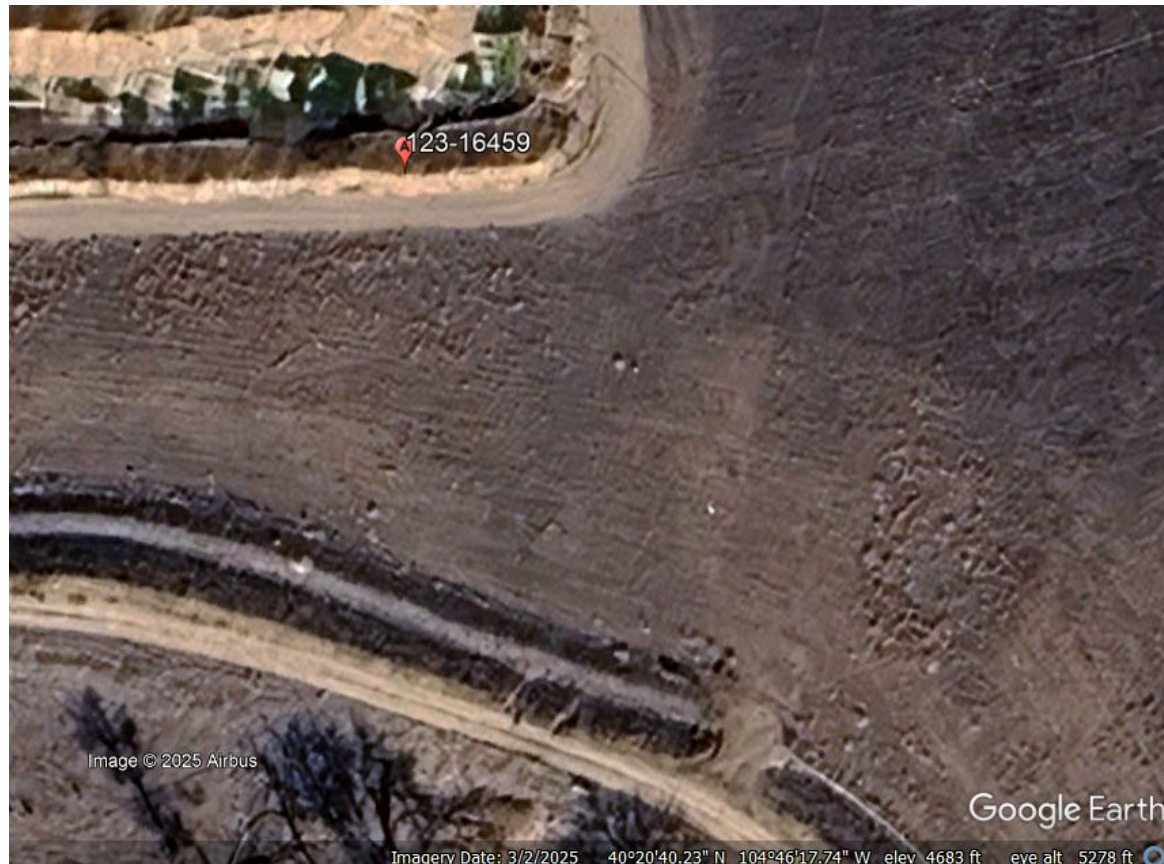
Photo 2. Google Earth Aerial Imagery from March 2, 2025. Photo illustrates the well location and access road after plugging operations. The well location is contained within a land use change.

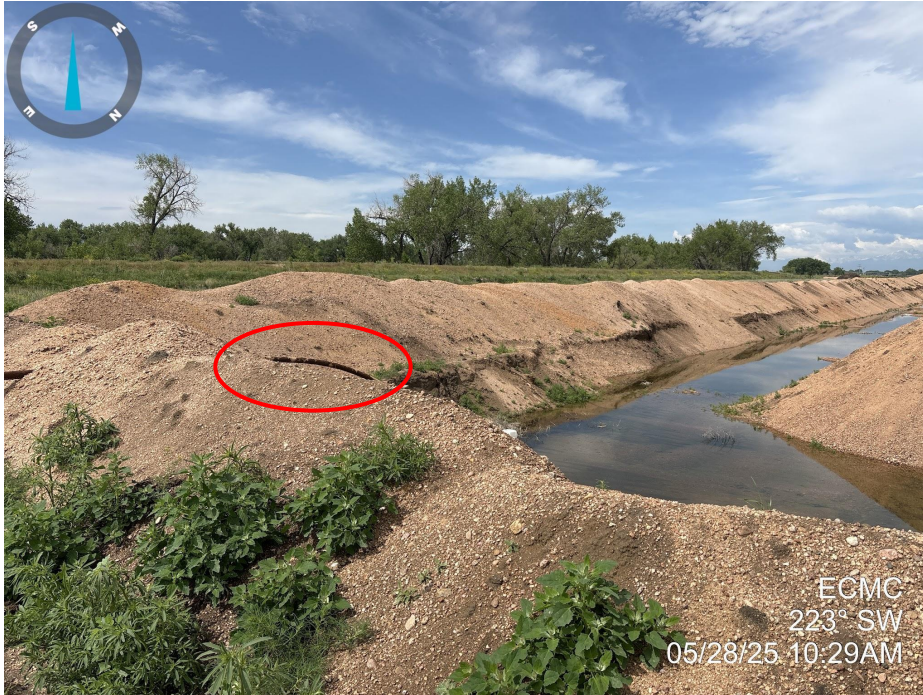
Photo 3. Photo taken of the well location, facing Southwest. Photo illustrates that the location is contained within a land use change. A flowline was abandoned in place, but has been exposed at the site and requires removal (highlighted in red circle).

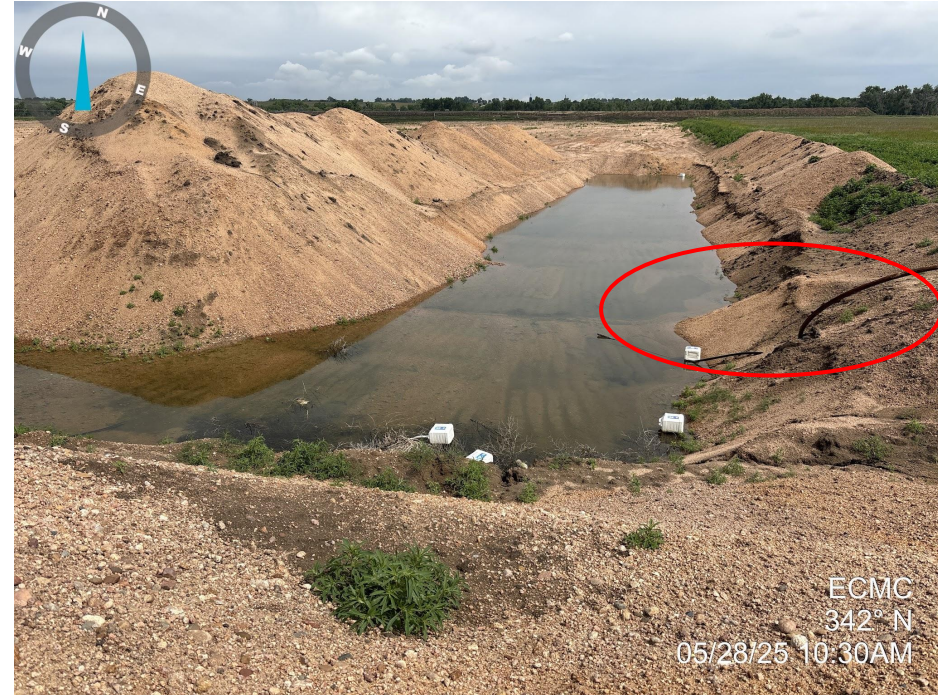
Photo 4. Photo taken of the well location, facing North. See comments under Photo 3.

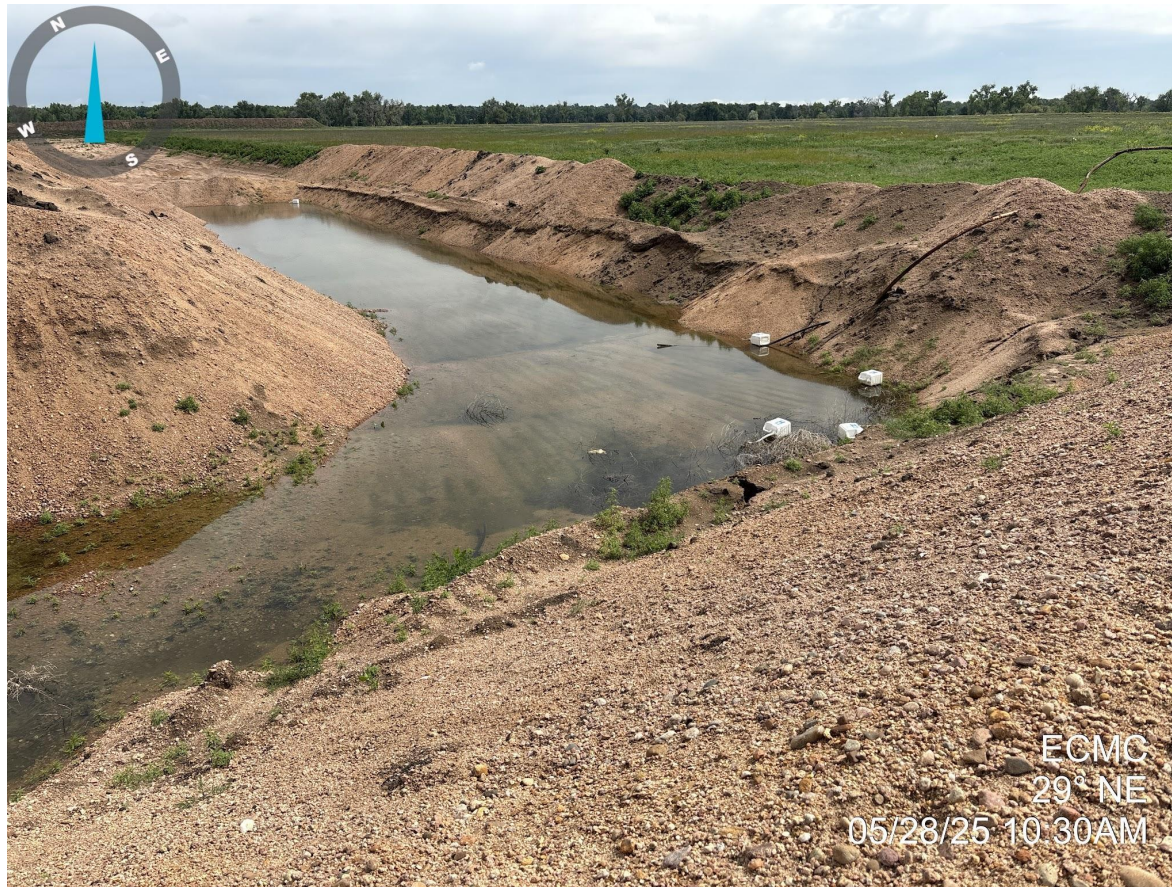
Photo 5. Photo taken of the well location, facing Northeast. See comments under Photo 3.
