# Inspection Photos

Operator: Highpoint Operating

Location ID: 322138

Location Name: Johnson 16H-12-39-18

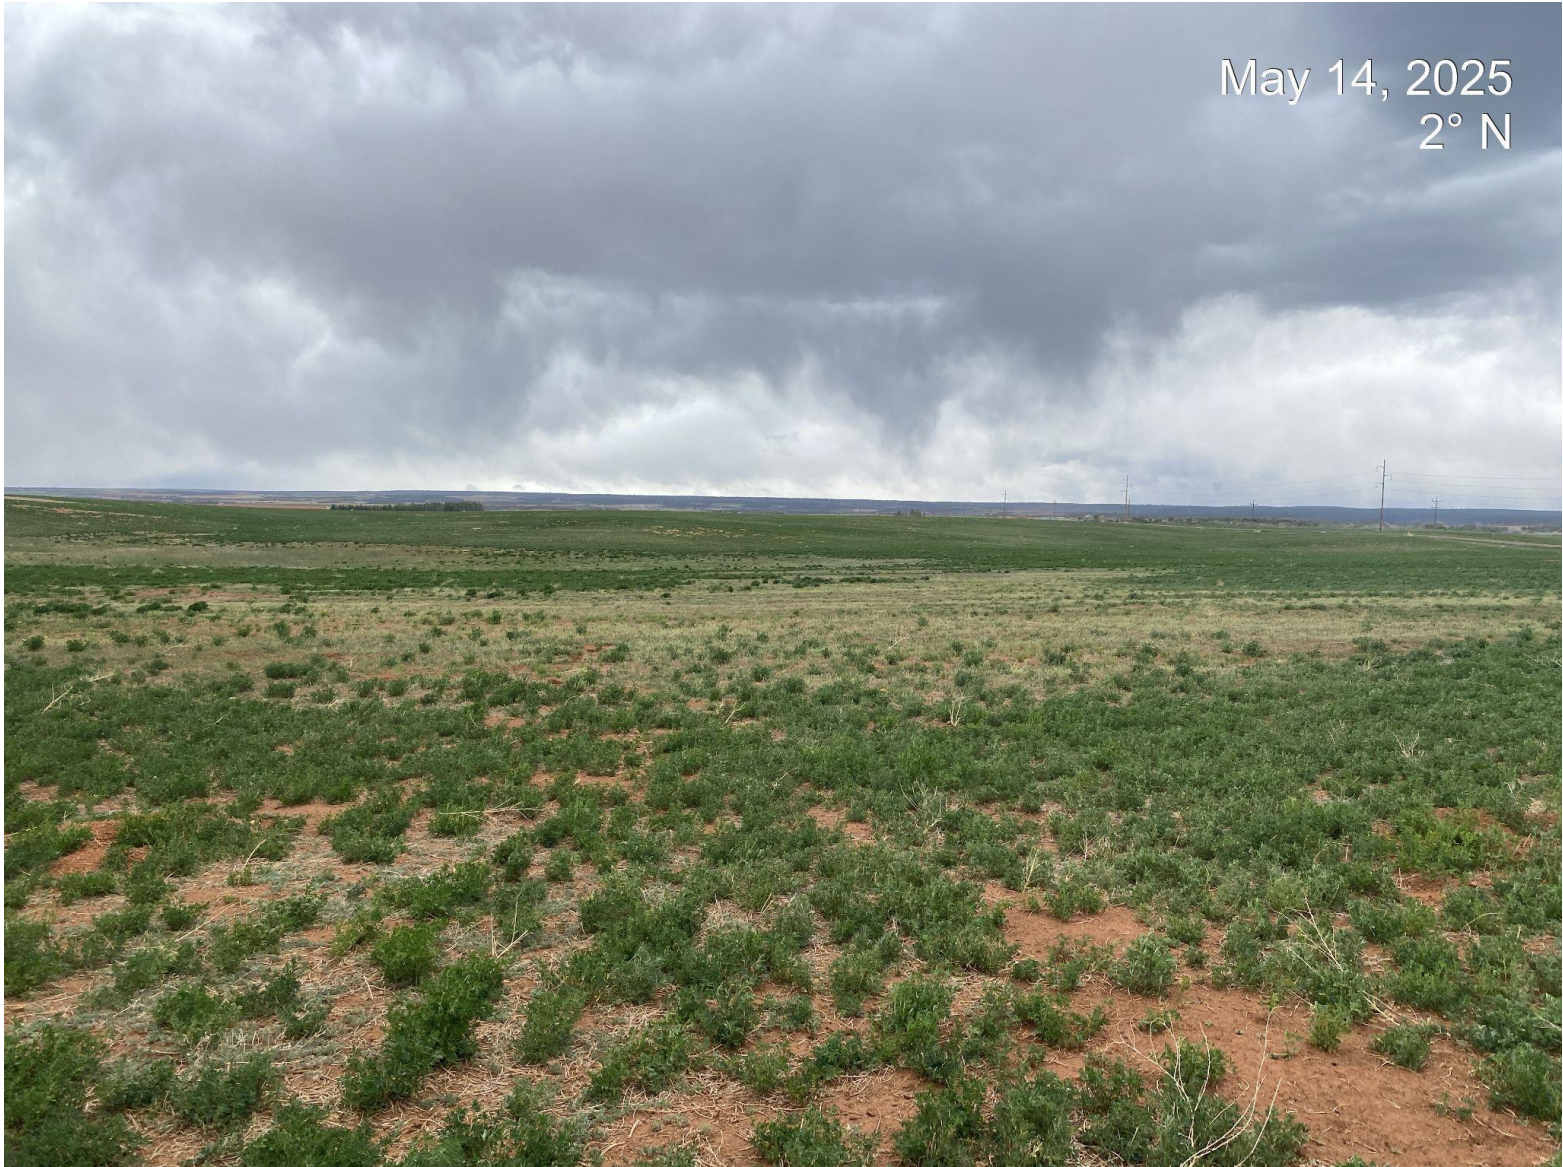
May 14, 2025  
2° N

**Photo 1.** View of the reclaimed project area taken from the southern edge facing center.

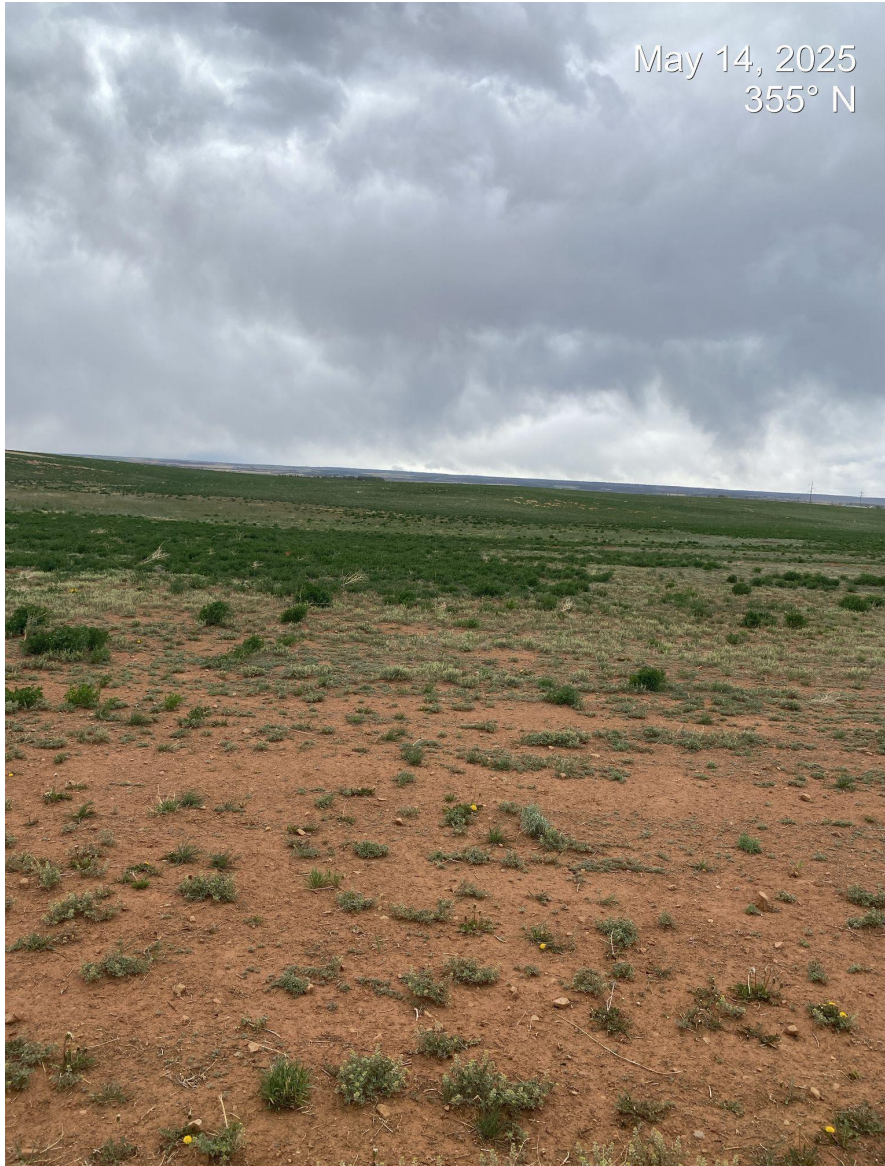
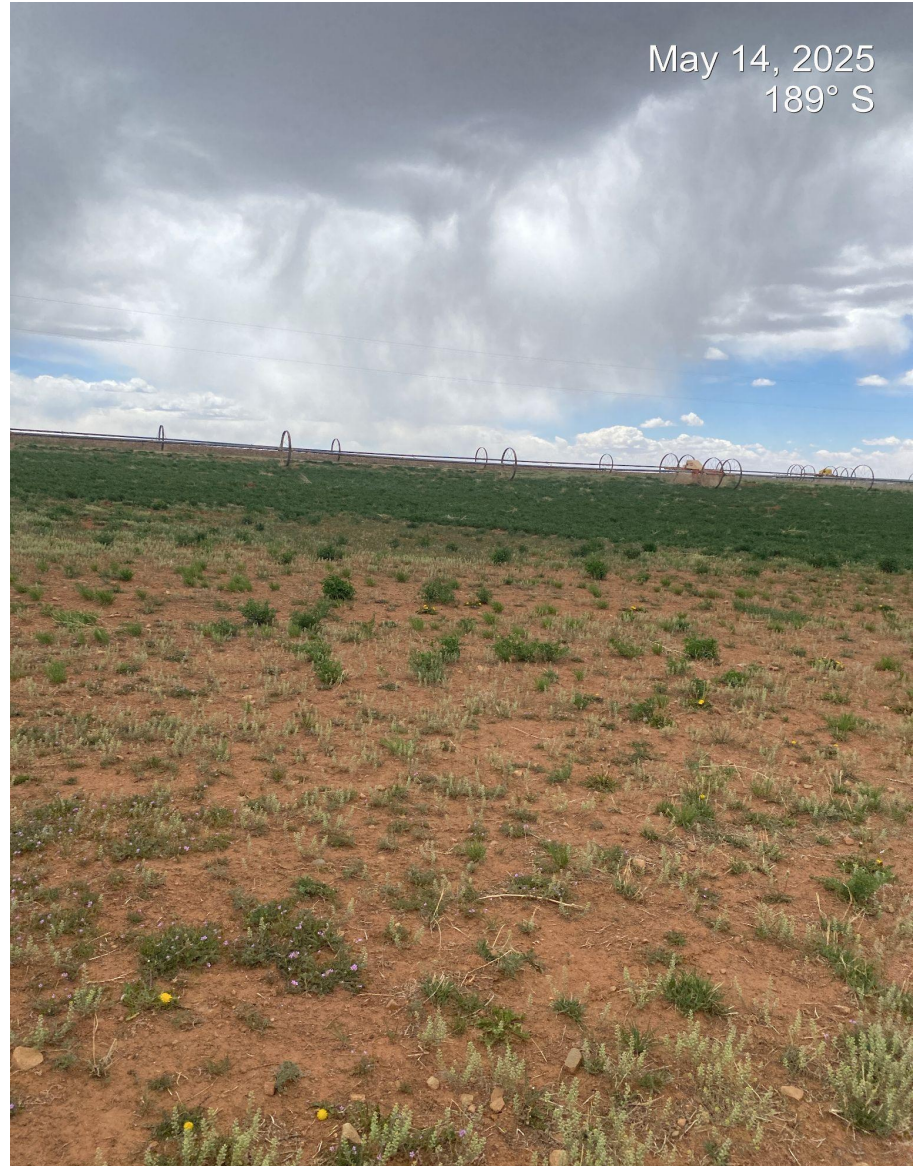
**Photo 2.** Cardinal photos taken from the center of the project area, left photo facing north right photo facing south. Minimal crop establishment was observed at the project area compared to adjacent alfalfa crop reference area.

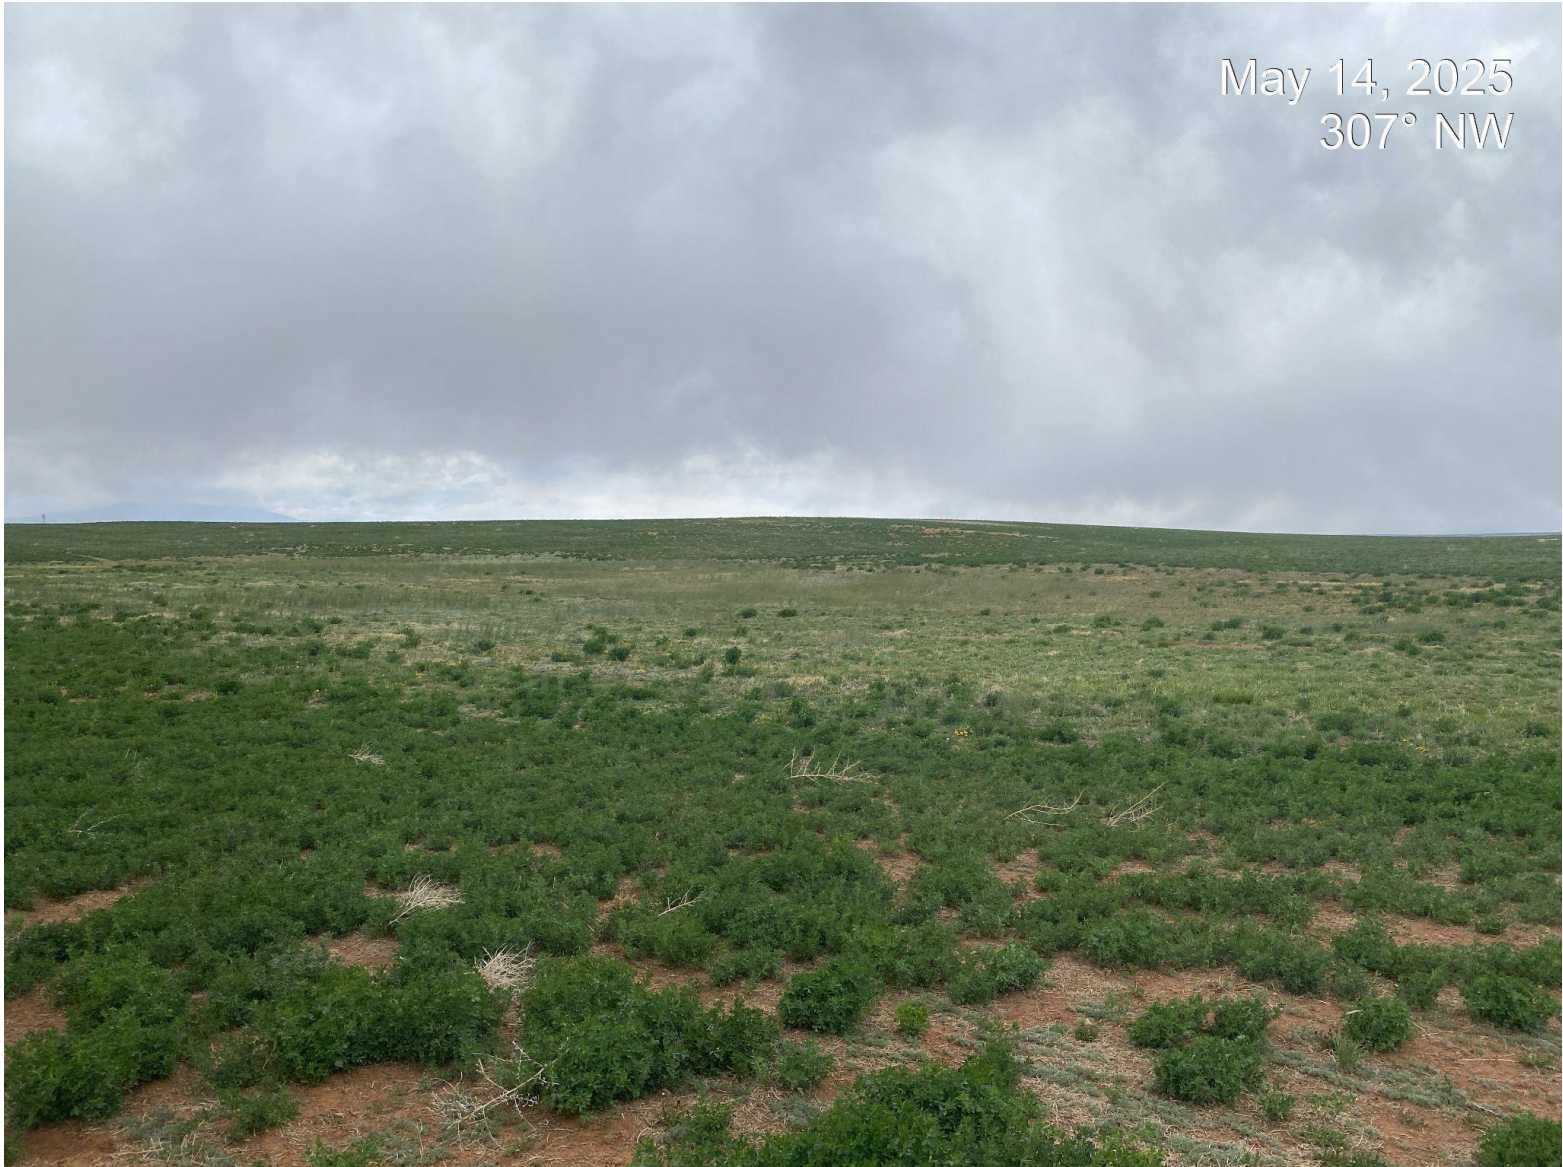
May 14, 2025  
307° NW

**Photo 3.** Area directly north of the reclamation area shows minimal crop establishment and weedy vegetation dominant including Canada thistle and Kochia. Impacts are suspected for this area.

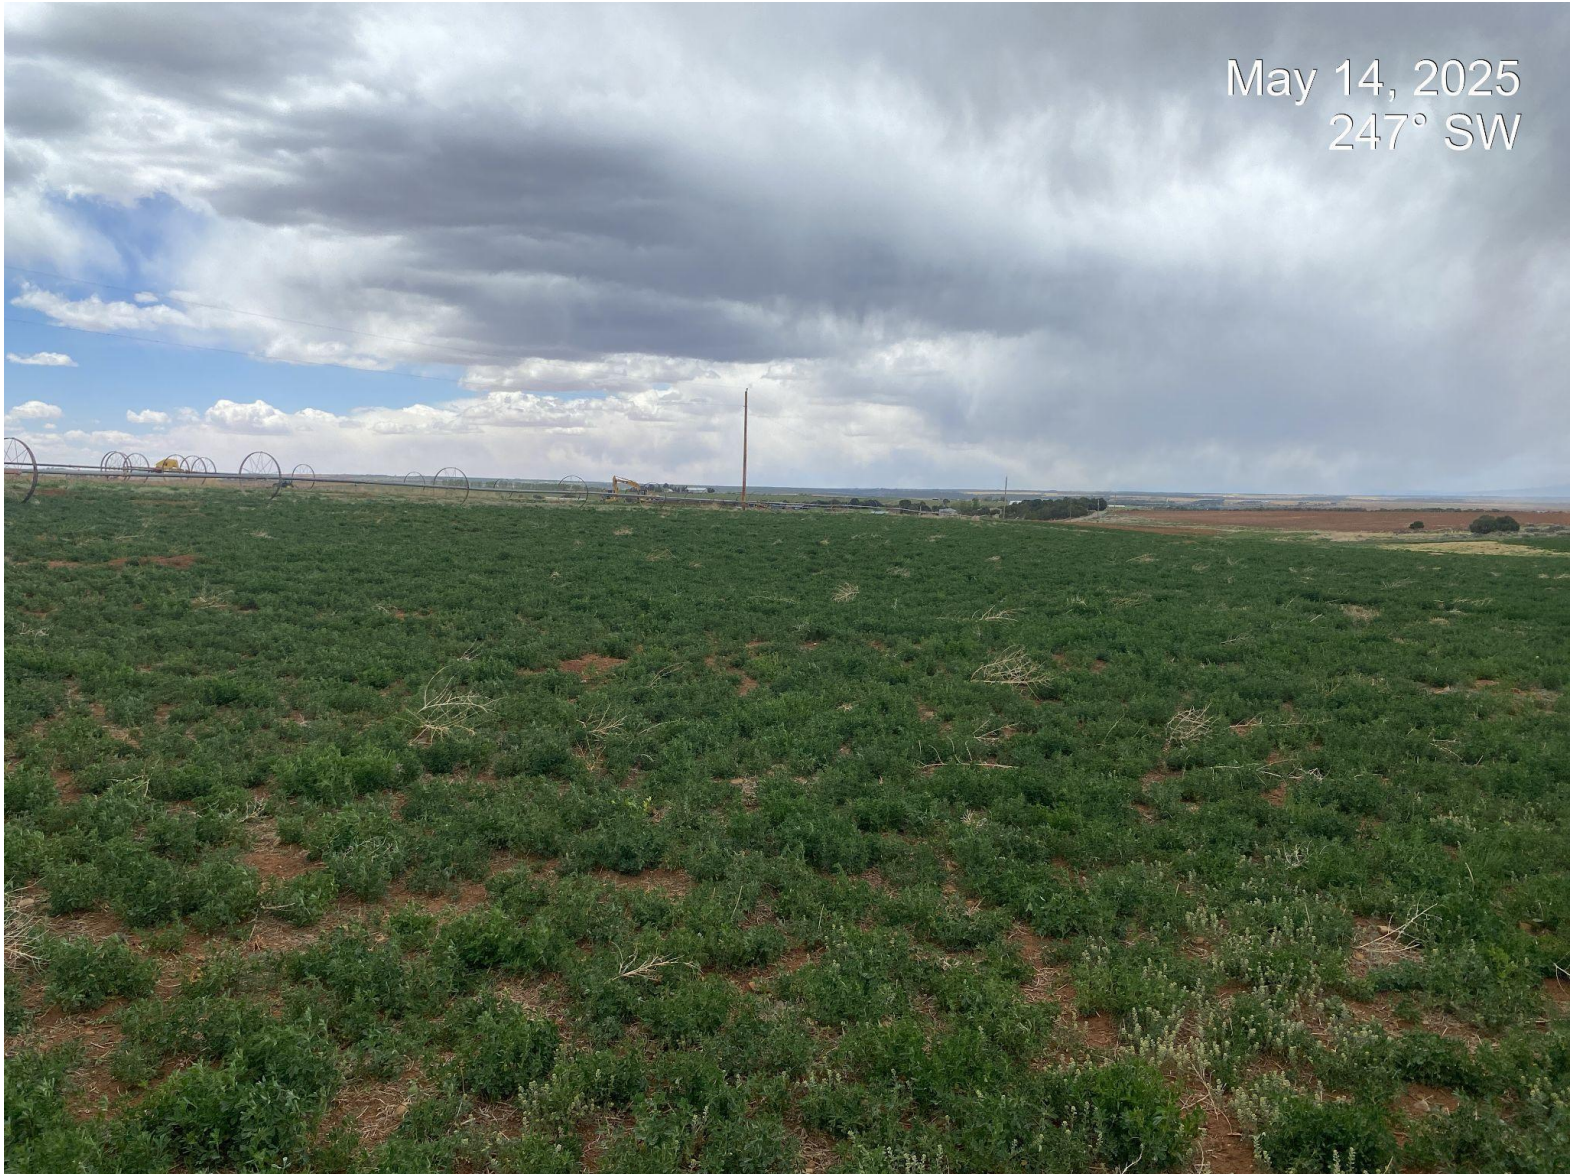
May 14, 2025  
247° SW

**Photo 4.** Adjacent reference area.

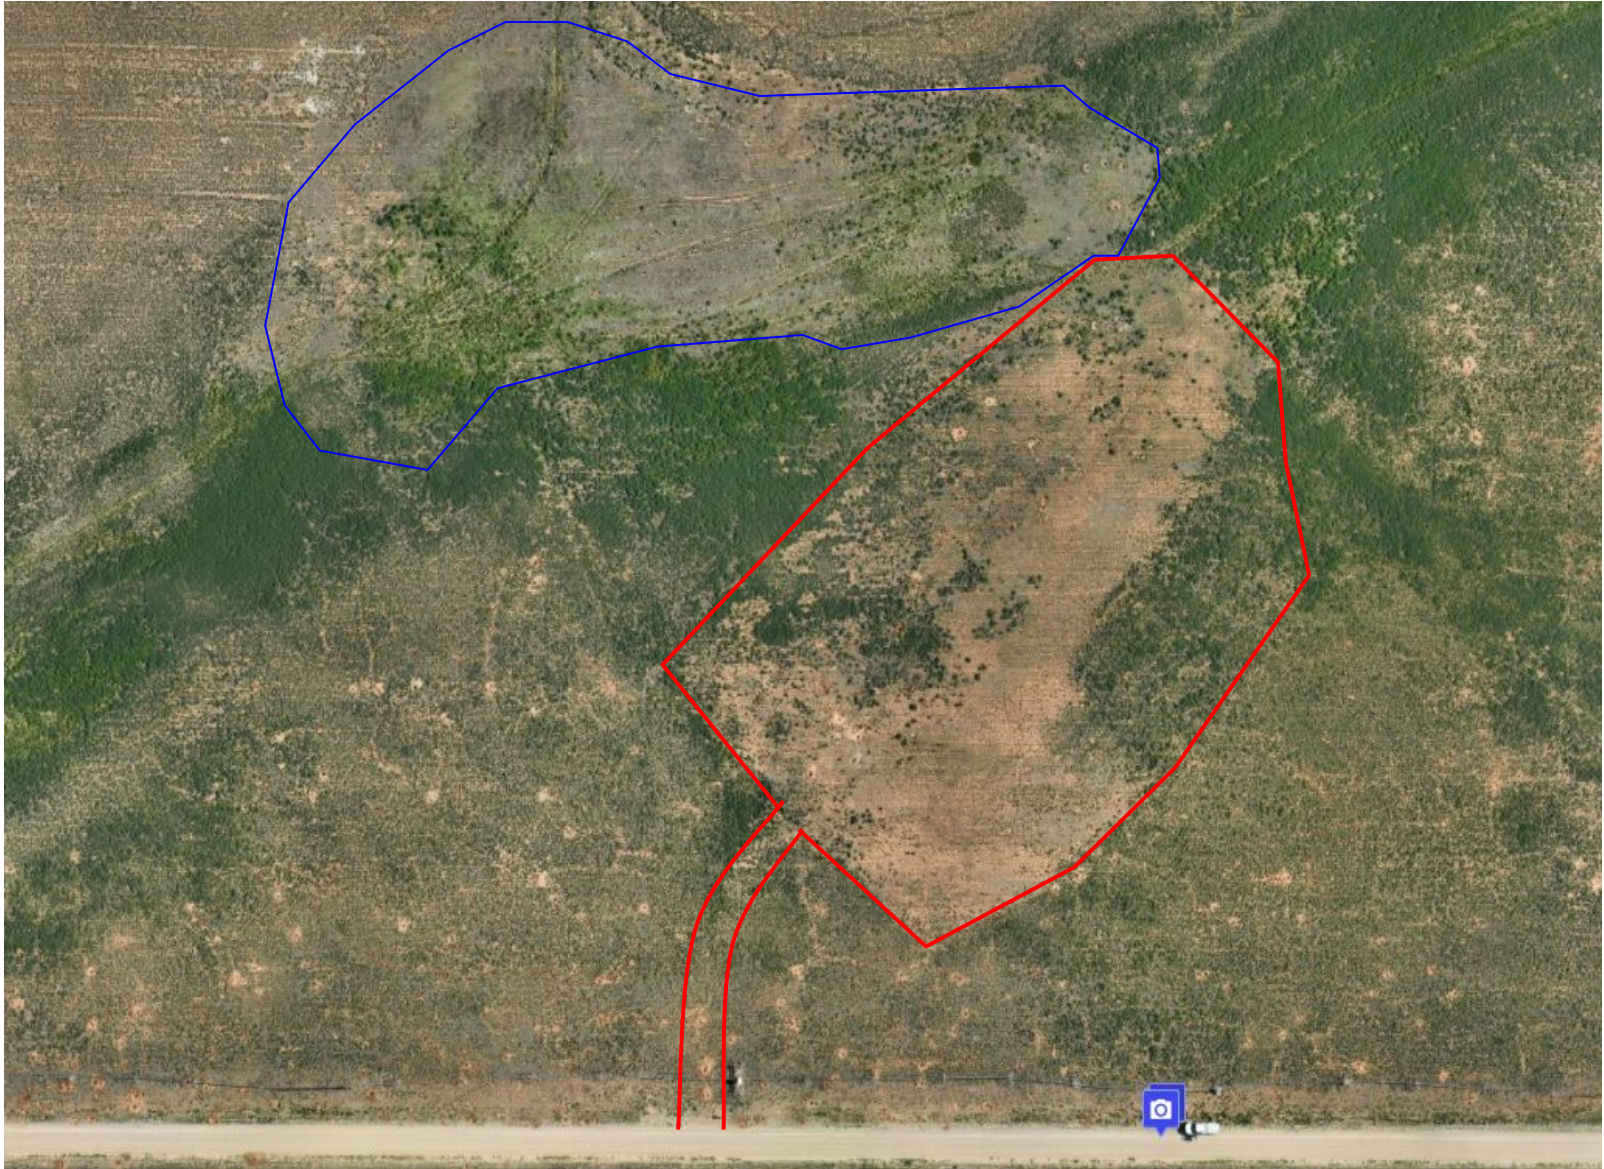
**Photo 5.** Drone imagery of project area taken on 6/12/2025. Aerial imagery shows lack of crop establishment at the project area (outlined in red), as well as suspected impacted area to the north of the project area (outlined in blue).
