WELL NAME: SPHINX 22-36, API #: 071-08941, INSP. # 716301204

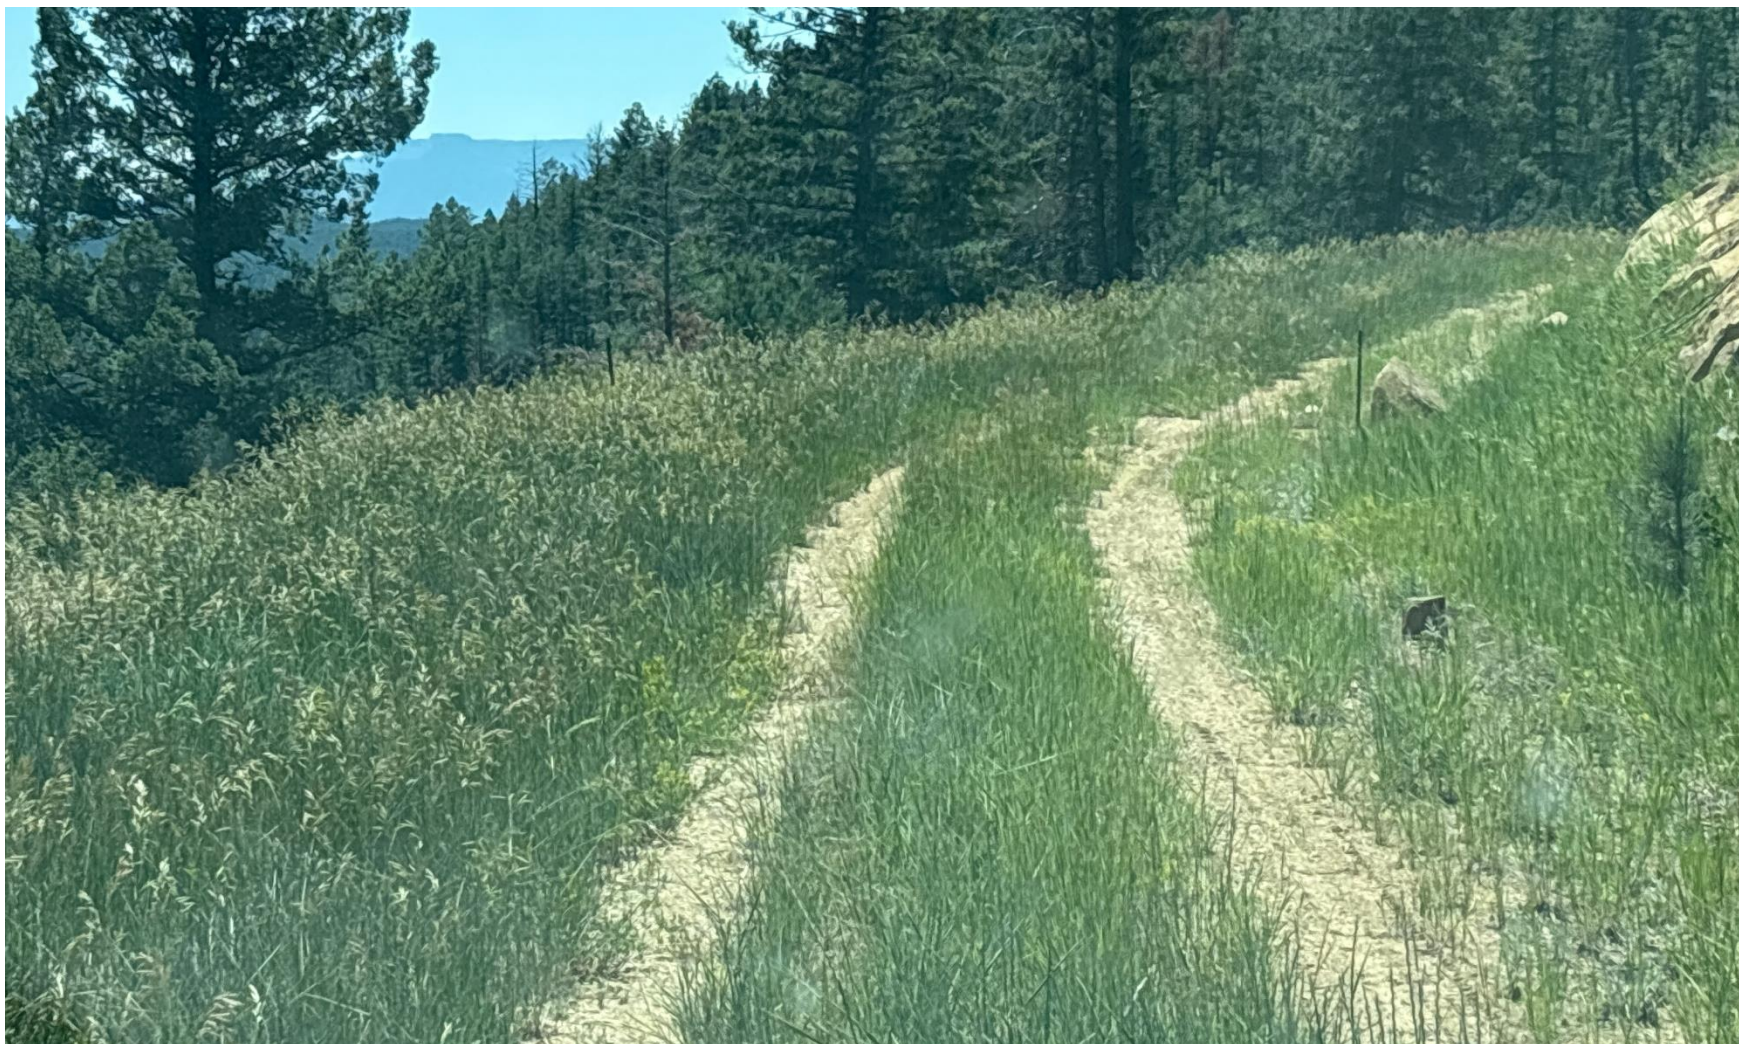
**PHOTO 4: WEEDS NOT MAINTAINED ALONG ROW AND ON LOCATION (SEE PHOTO ON FOR WEEDS ON LOCATION). **MAINTAIN WEEDS PER RULE 606. CA DATE 7-14-2025.****
