Operator: HIGHPOINT OPERATING CORPORATION

Location Name: CVR Production Pad 5-63-32

Loc ID: 332204

Inspection: 717900247

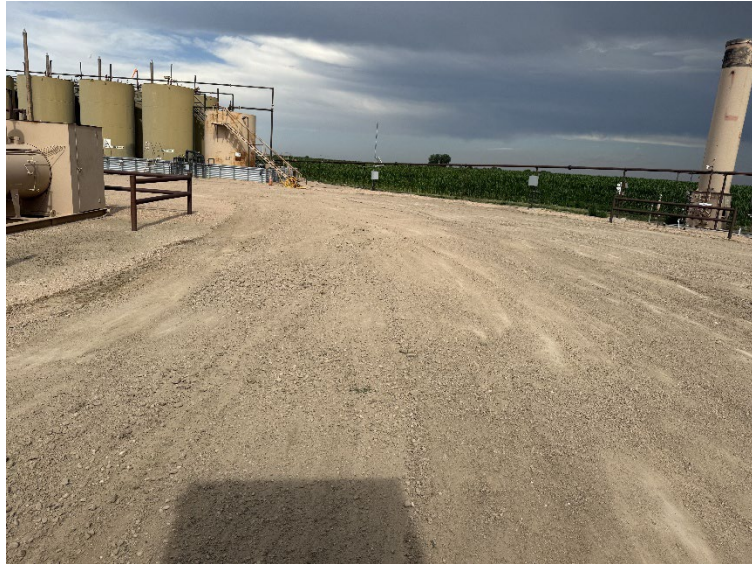
Exhibit A

CA: Tire rutting on site due to recent storm event. Operator to regrade site. Comply with Rule 1002.f.(2)

CA Resolution: Operator has addressed the areas with rutting in the road in order to comply with Rule 1004.
