WELL NAME: ZUESS FEDERAL 11-10, API #: 071-09529, INSP. # 716301216

COLORADO  
Energy & Carbon Management  
Commission  
Department of Natural Resources

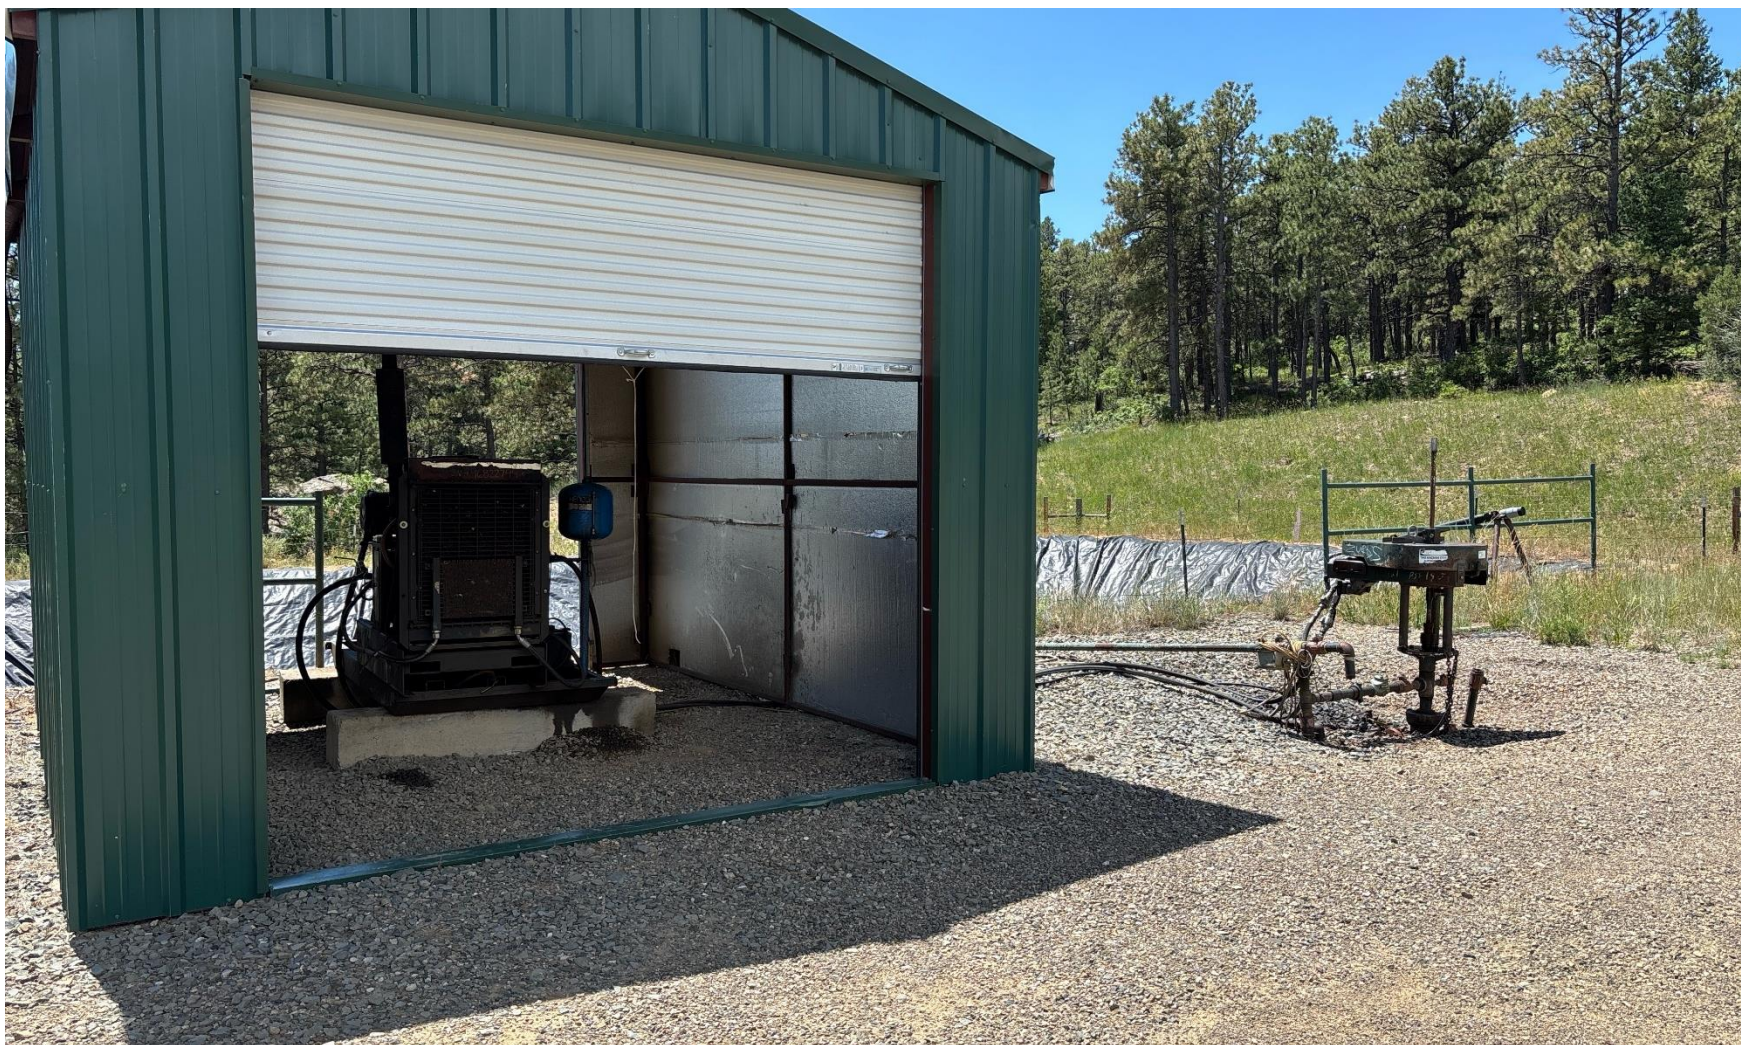
**PHOTO 3: WELLHEAD AND EQUIPMENT.**

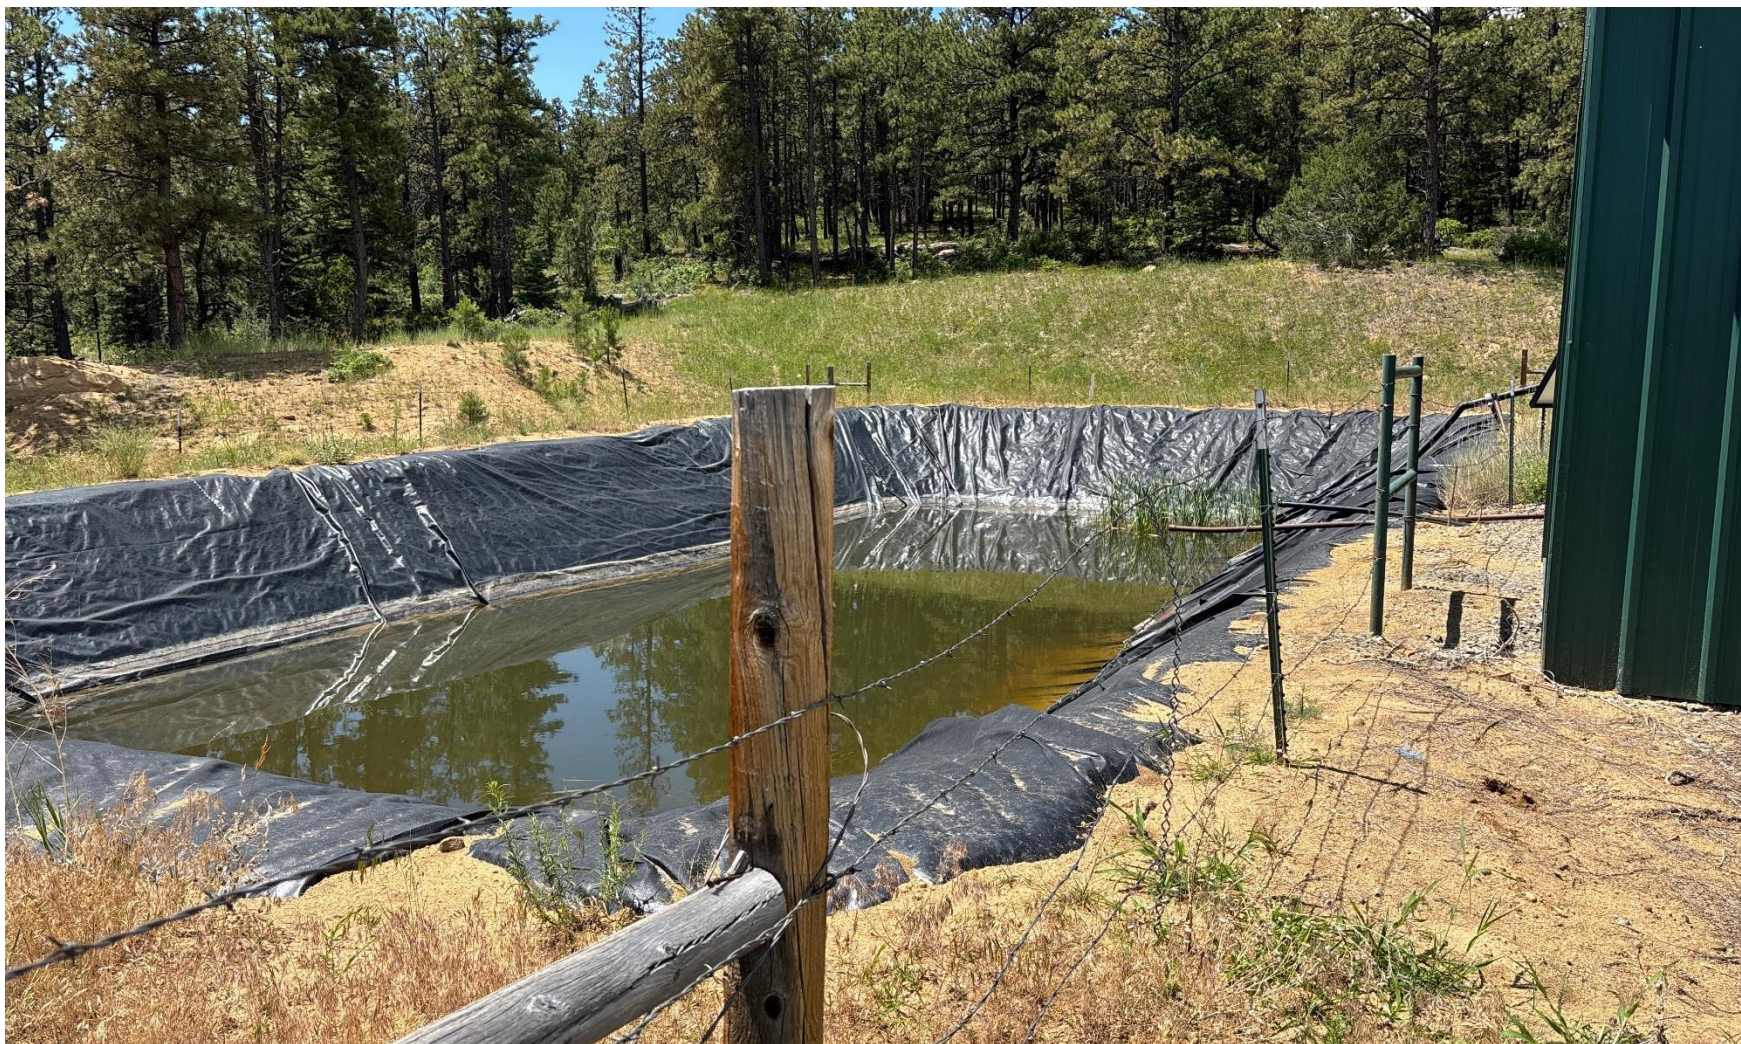
**PHOTO 4: PRODUCED WATER PIT.**

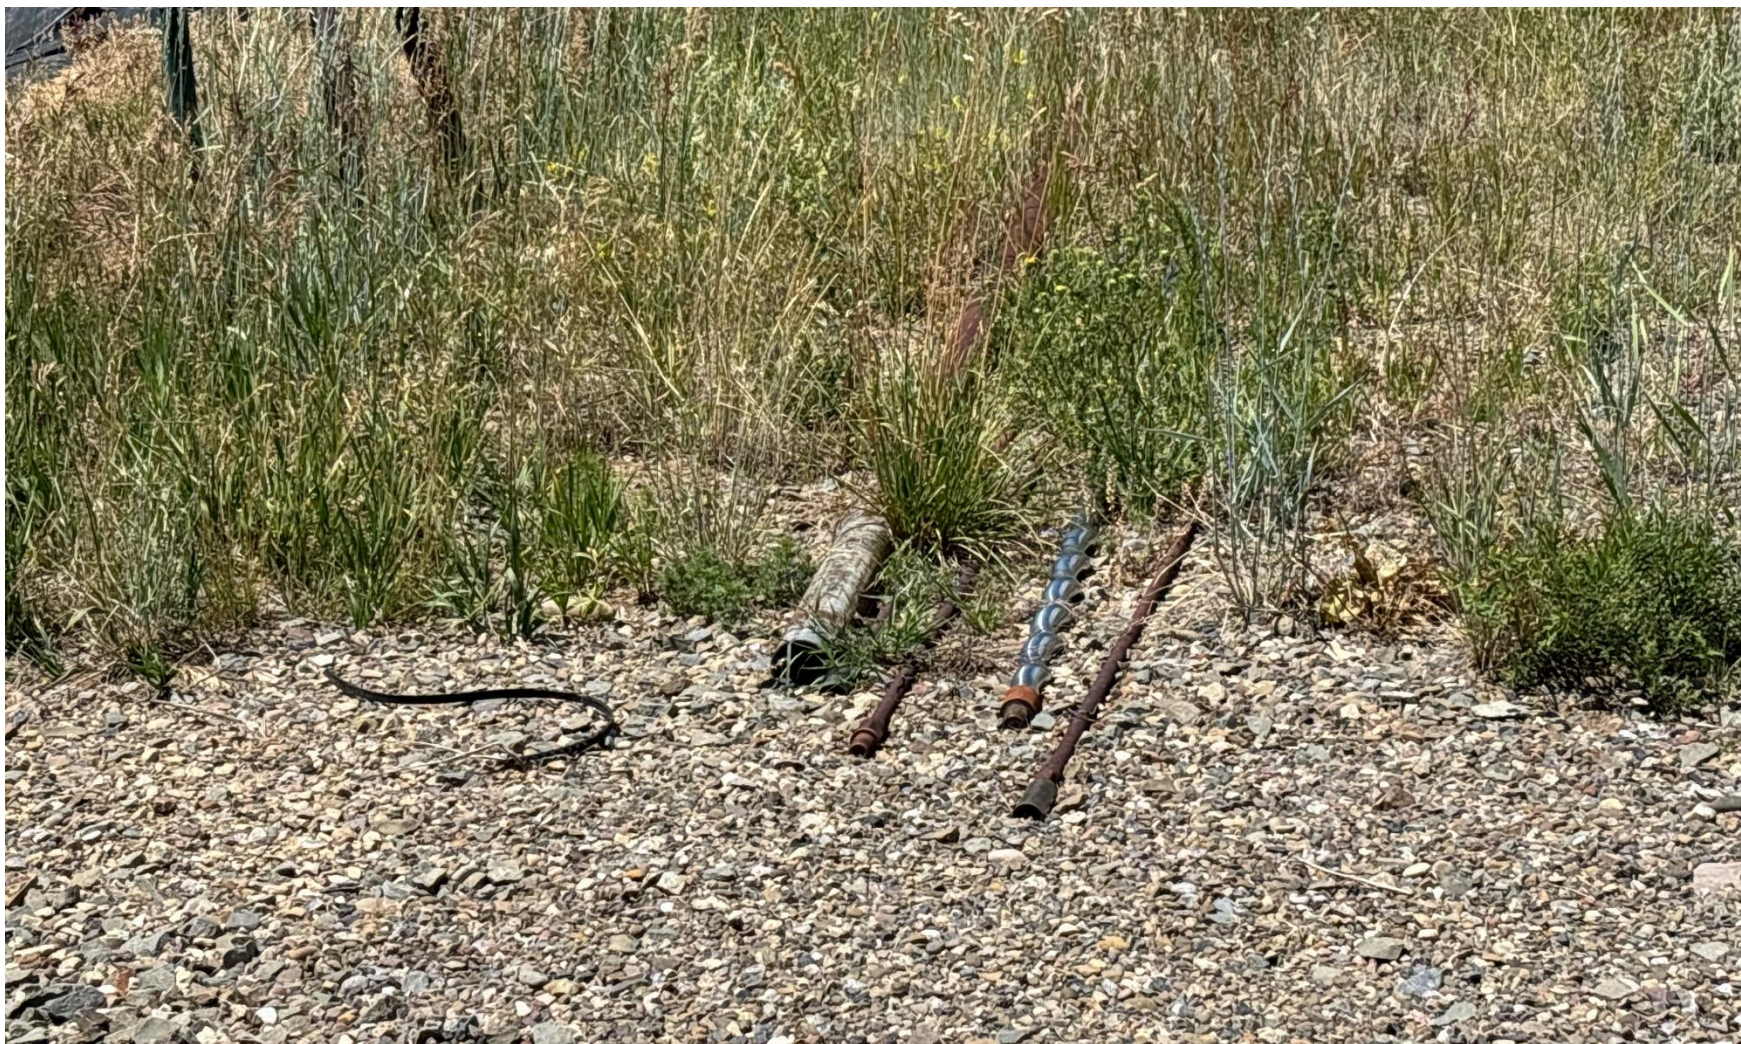
**PHOTO 5: UNUSED EQUIPMENT STORED ON LOCATION (PUMP, POLISH ROD AND RODS). REMOVE UNUSED EQUIPMENT PER RULE 606. CA DATE 7-25-2025.**

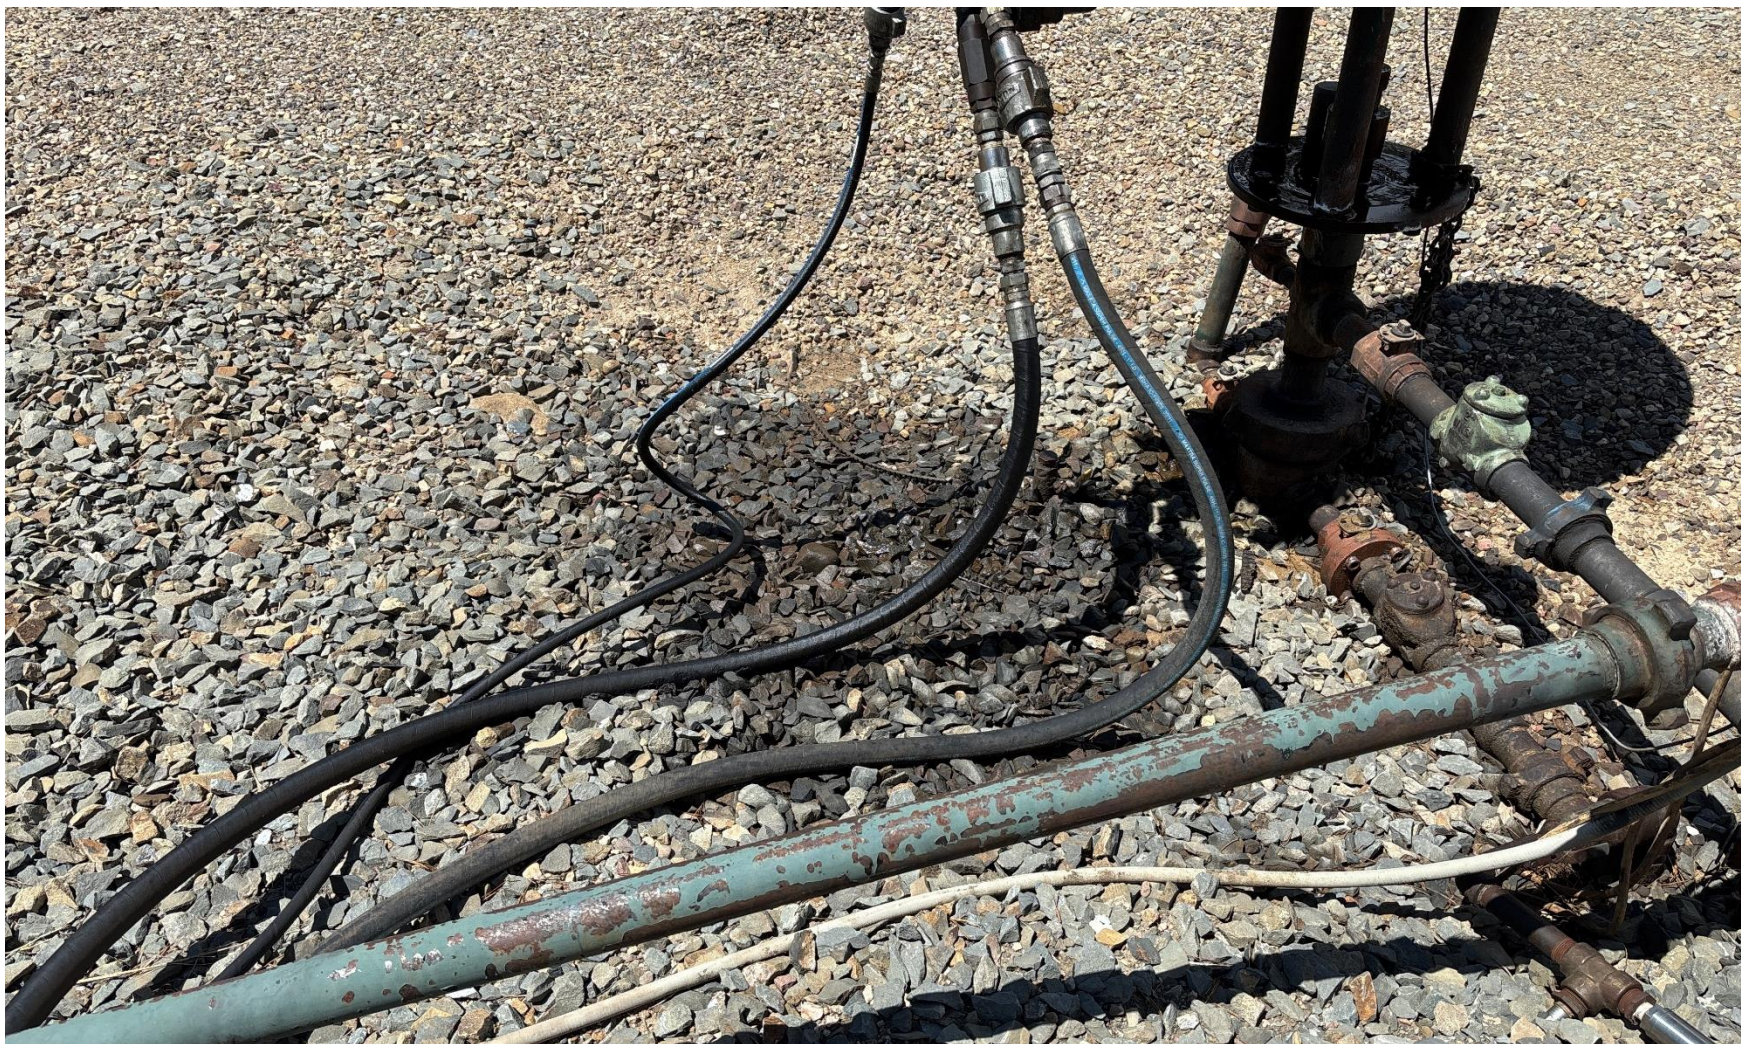
**PHOTO 6: AREA OF IMPACTED SOIL NEAR WELLHEAD. Conduct maintenance on equipment, cleanup stained material and review self inspection processes. COMPLY WITH RULE 1002,.(2).D. CA DATE 7-25-2025.**

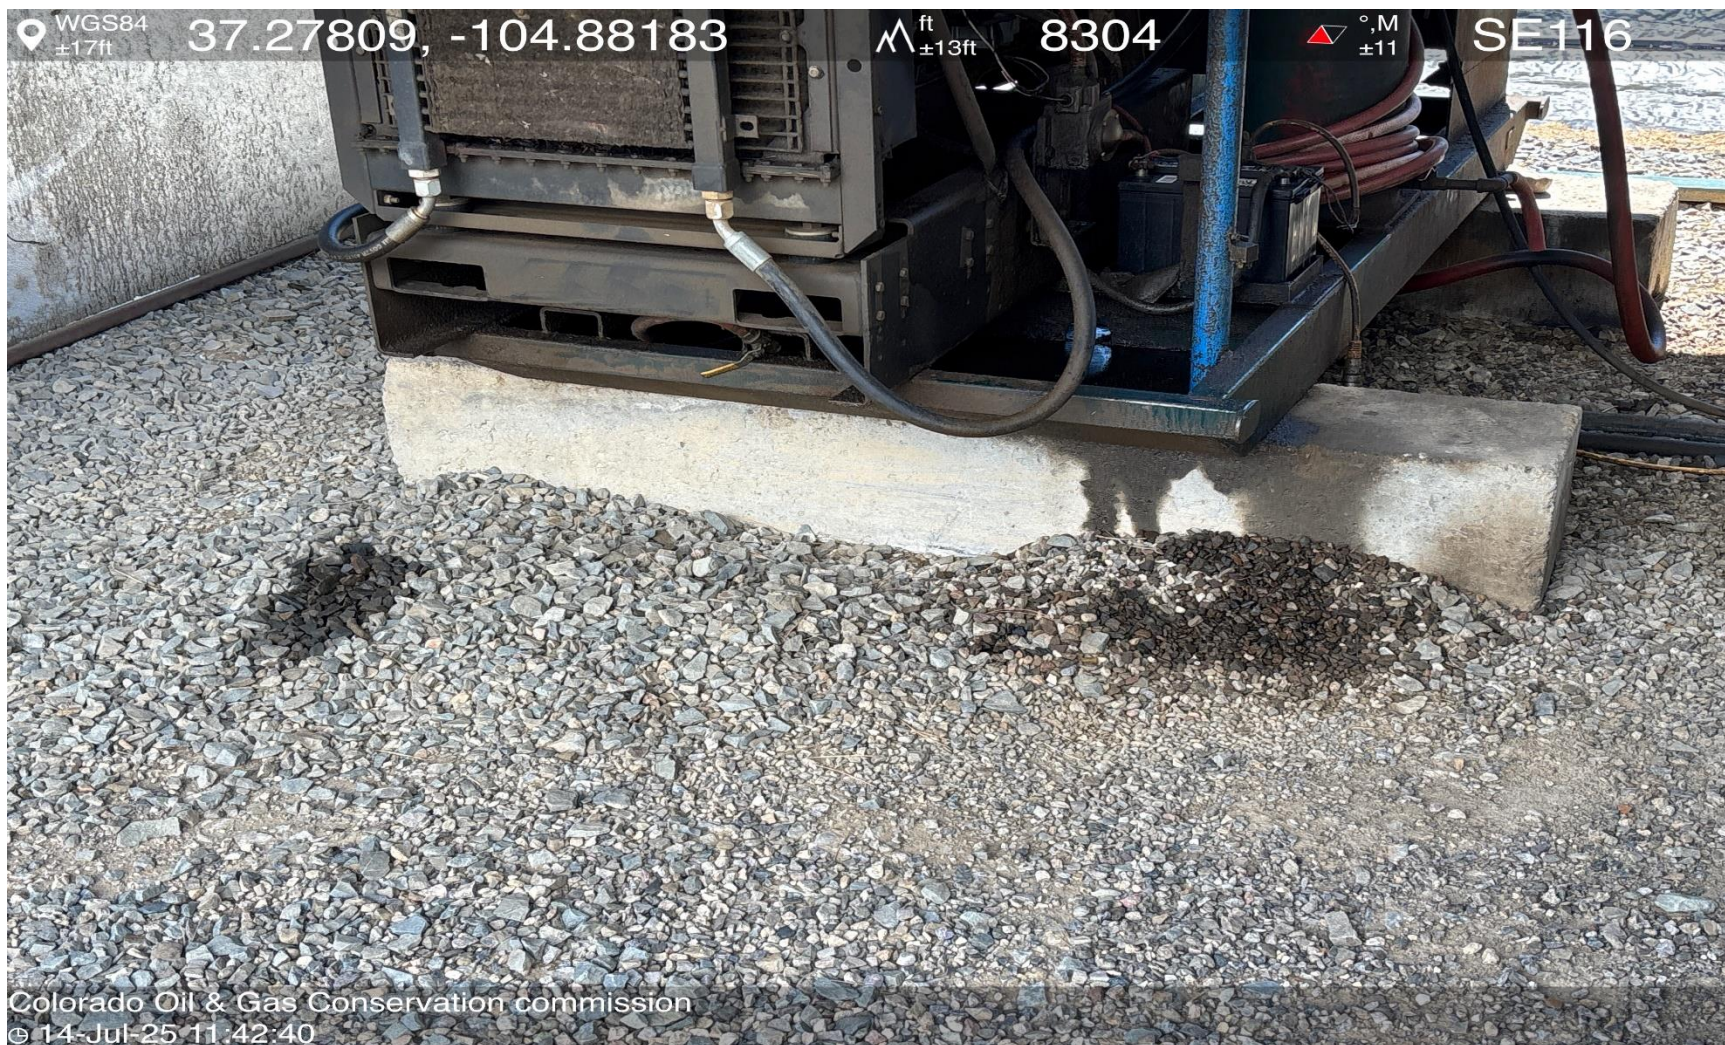
**PHOTO 7: AREA OF IMPACTED SOIL PRIME MOVER ENGINE SKID. Conduct maintenance on equipment, cleanup stained material and review self inspection processes. COMPLY WITH RULE 1002,(2).D. CA DATE 7-25-2025.**

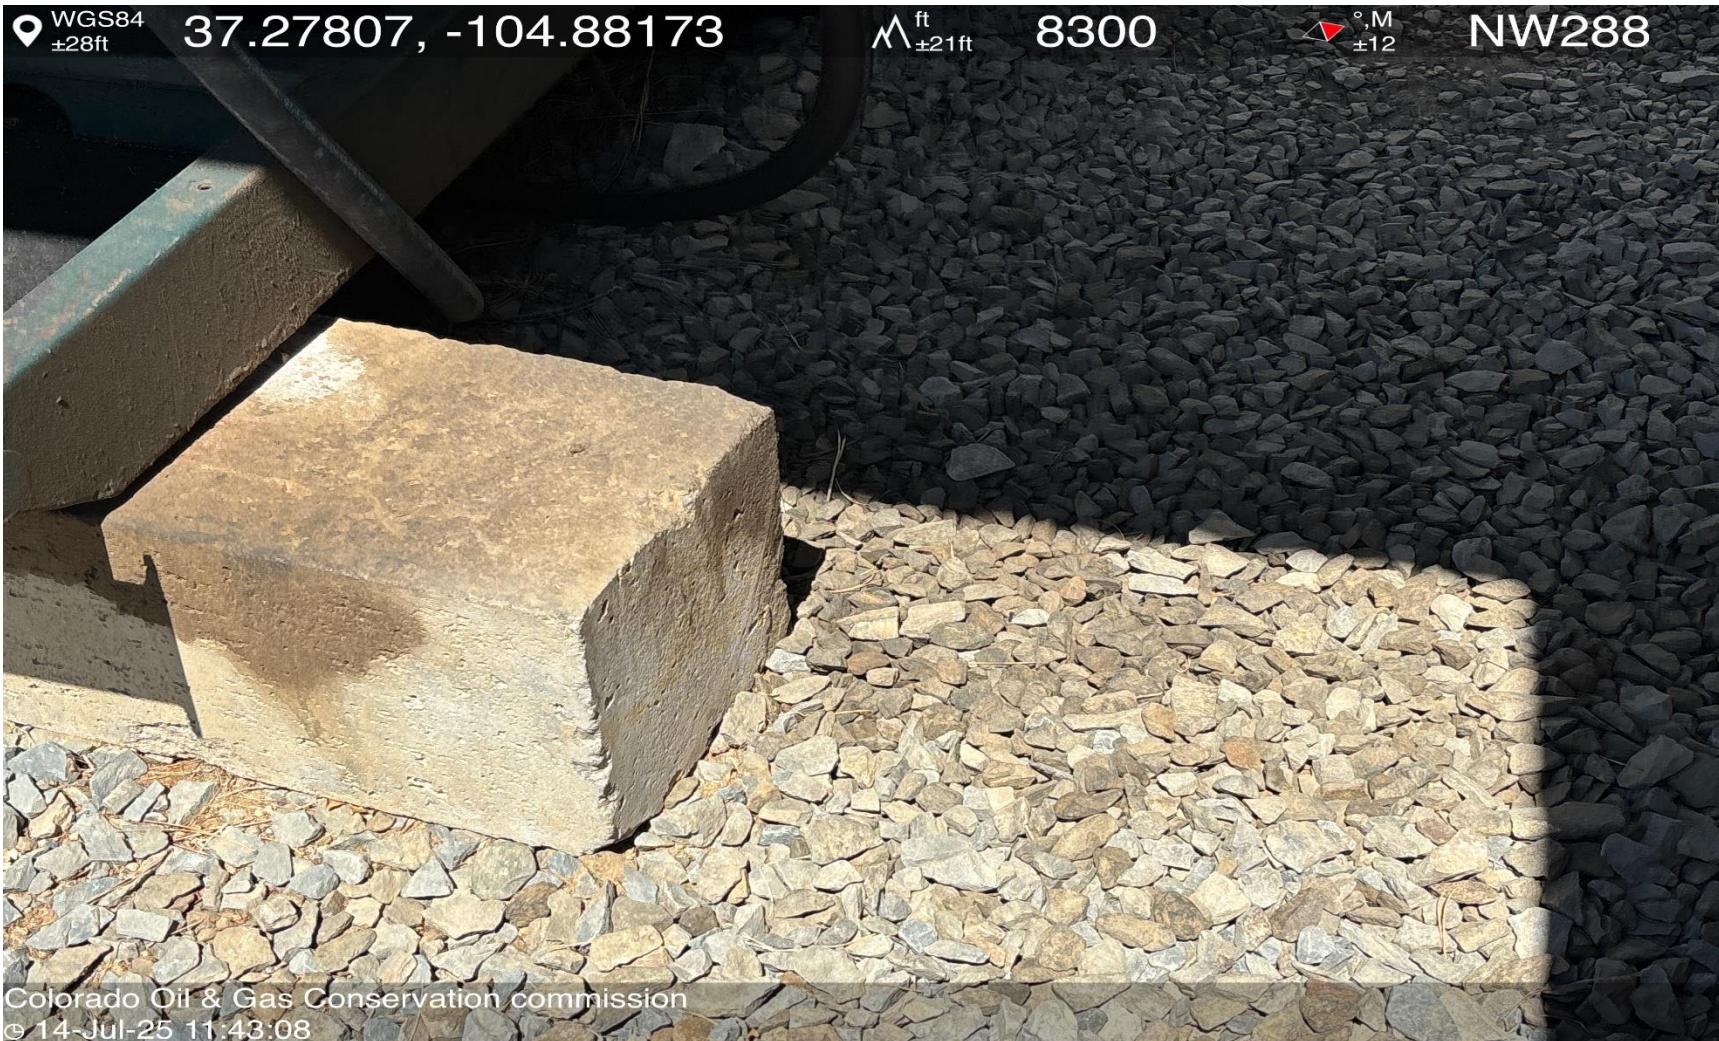
**PHOTO 8: AREA OF IMPACTED SOIL PRIME MOVER ENGINE SKID. Conduct maintenance on equipment, cleanup stained material and review self inspection processes. COMPLY WITH RULE 1002,.(2).D. CA DATE 7-25-2025.**

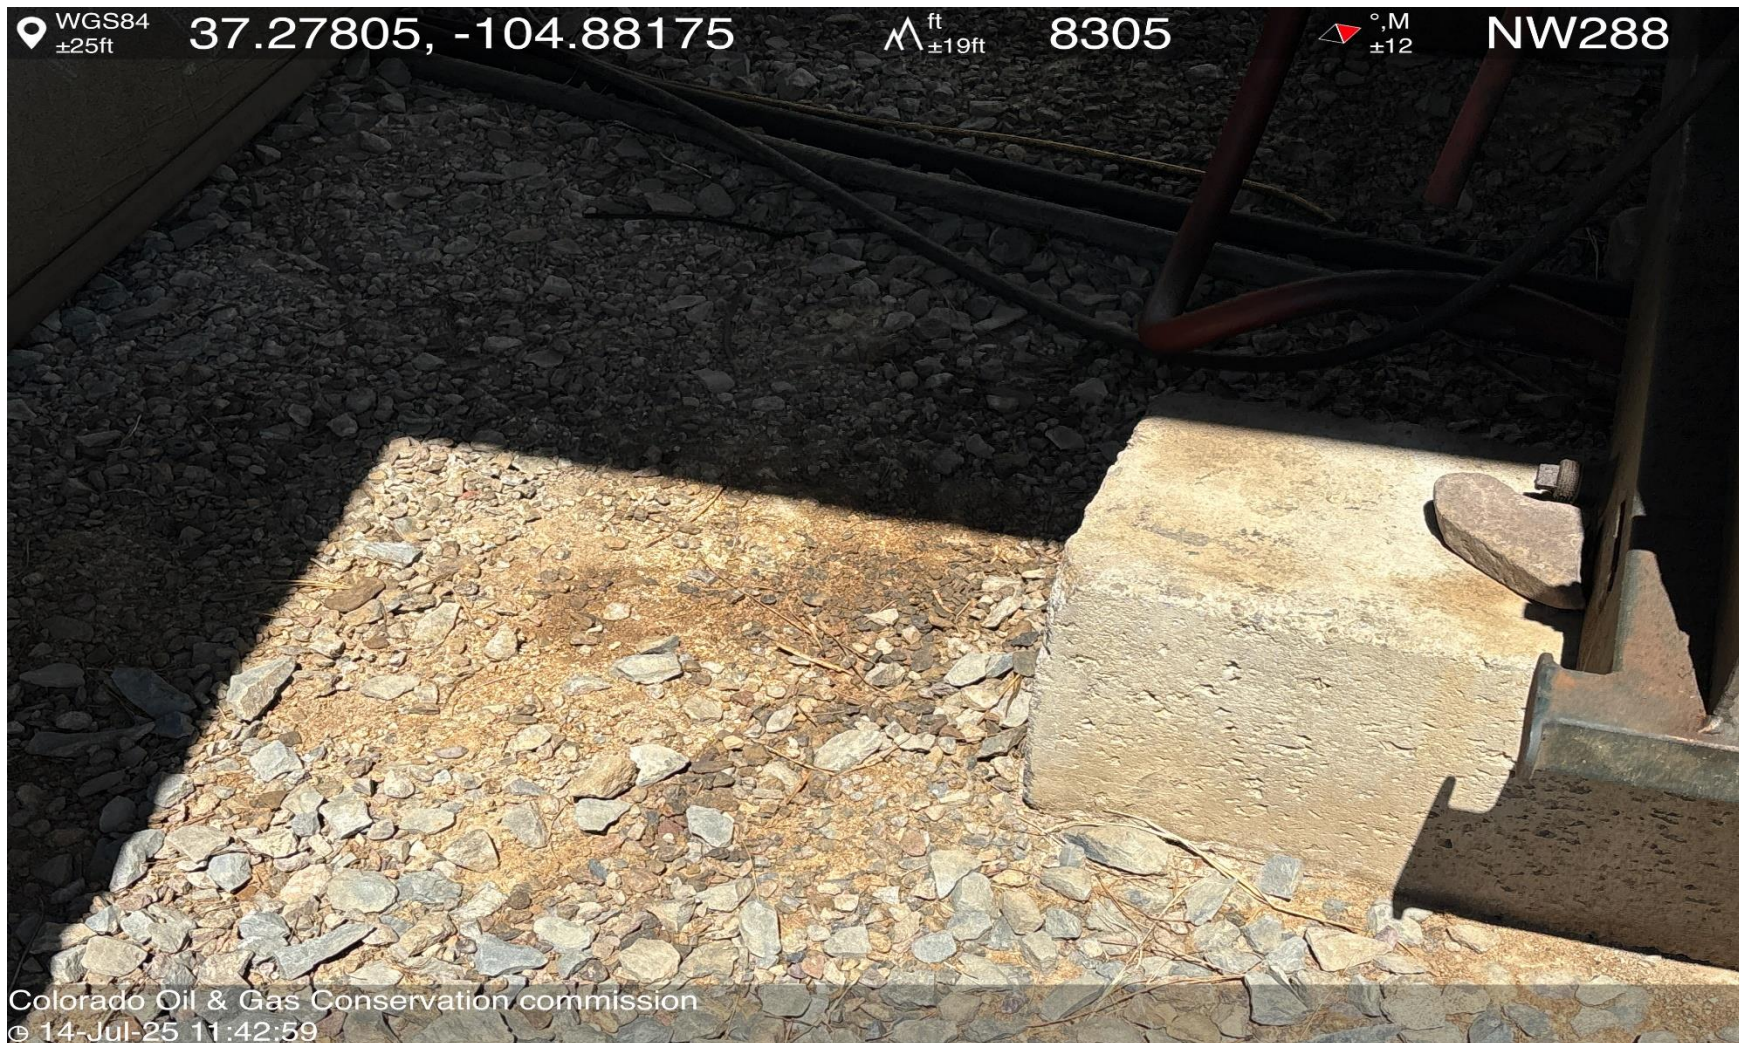
**PHOTO 9: AREA OF IMPACTED SOIL PRIME MOVER ENGINE SKID. Conduct maintenance on equipment, cleanup stained material and review self inspection processes. COMPLY WITH RULE 1002,.(2).D. CA DATE 7-25-2025.**
