# Inspection Photos

Operator: FOUNDATION ENERGY  
MANAGEMENT LLC - 10112

Location ID: 447523

Inspection Doc. Number: 682503847  
Weld County, CO

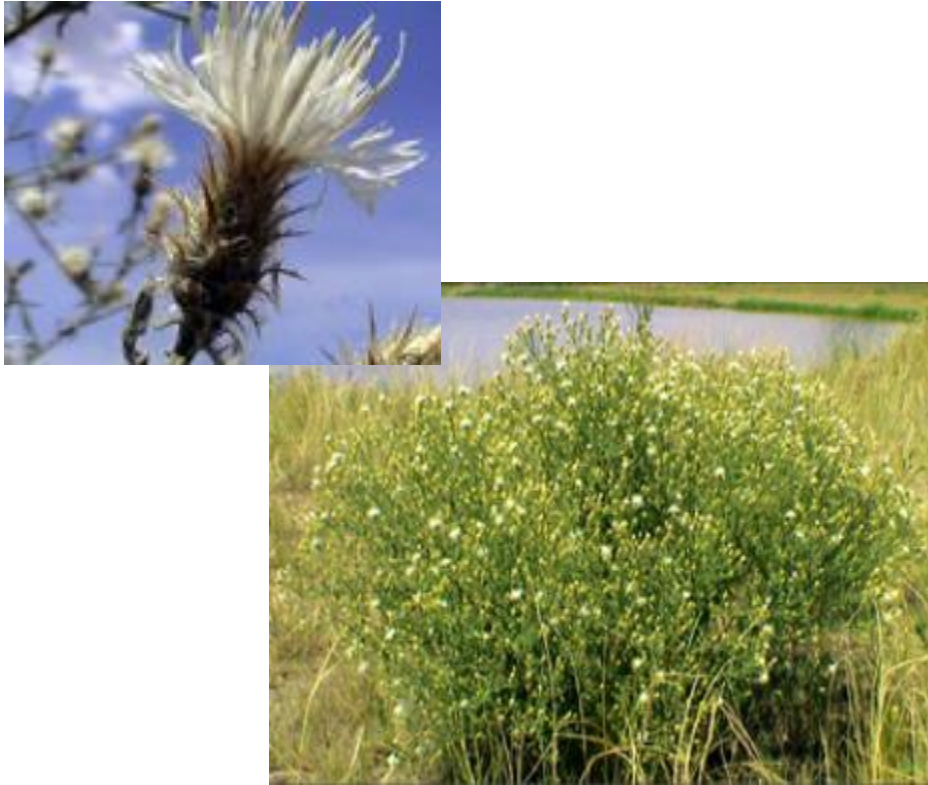
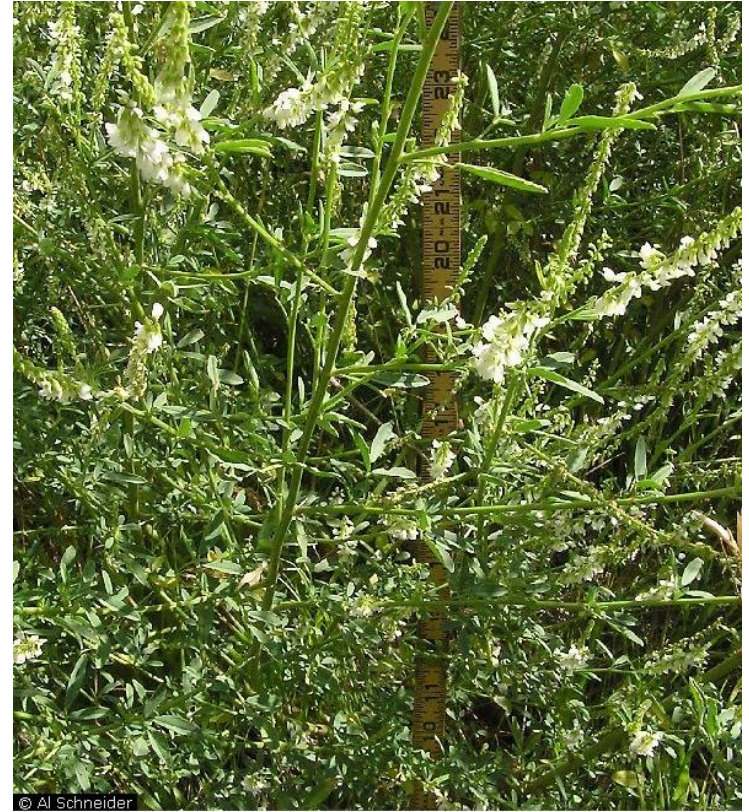
The photos within this document identify Yellow Sweet clover within the location and reference area, as well as Diffuse Knapweed. For documentation purposes as it may be difficult to distinguish between the two in the photo document, the above picture are to compare and contrast the visible differences between Diffuse Knapweed (Two photos to the left) and Yellow Sweet Clover (Single photo on the right). Photos curtesy of CO Department of Ag, and USDA Plants Database.

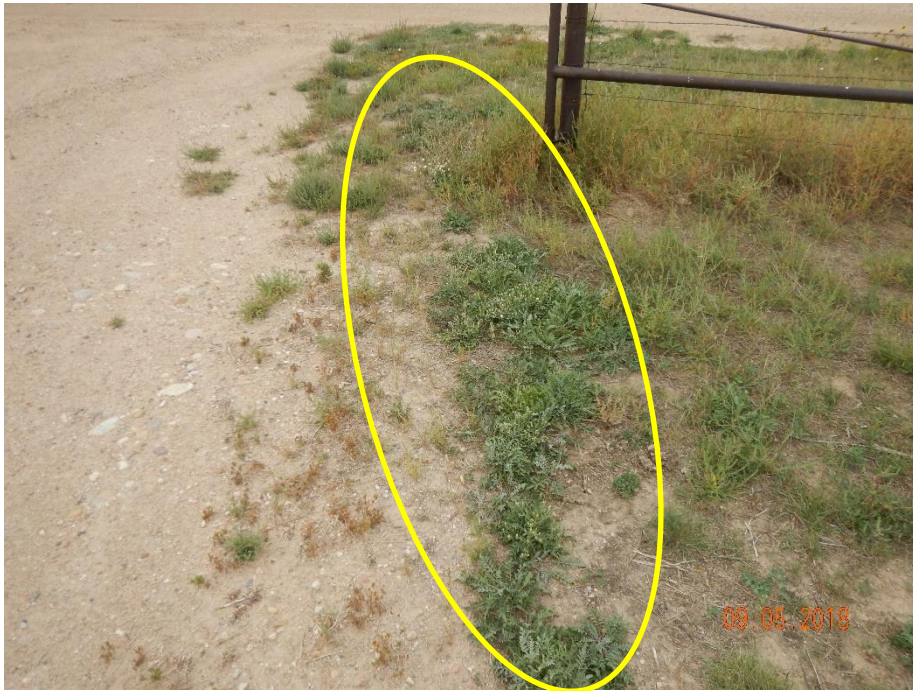
**Photo 15:** Photo taken from the northwest end of the location, facing west. Photo shows Diffuse Knapweed remains on location

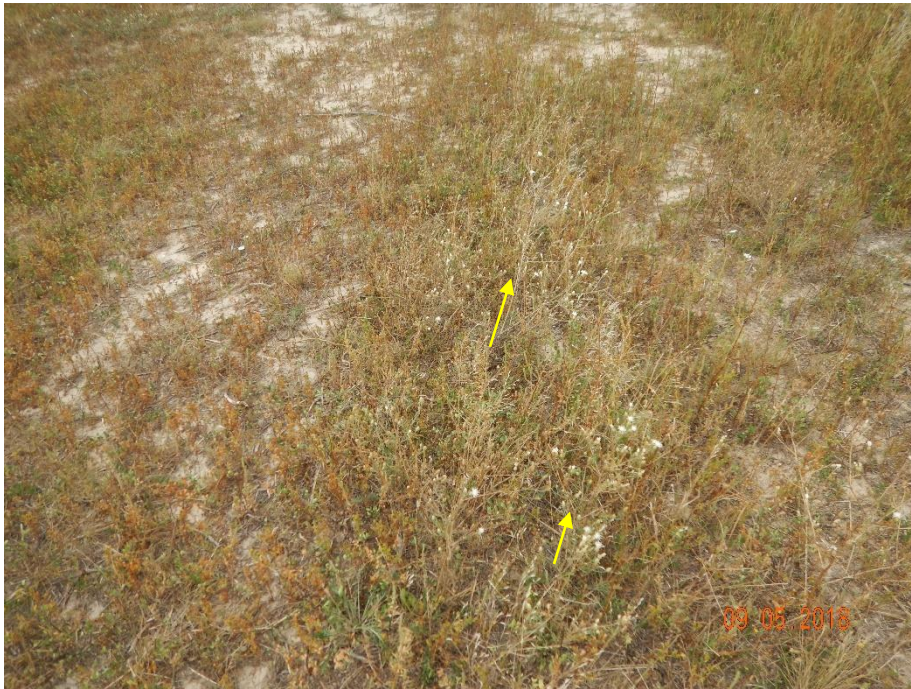
**Photo 19:** Photo taken from the east of the location, facing south. Previous inspection required operator to conduct weed management in these area due to noxious weeds spreading from the location onto the adjacent lands. Hundreds of individual Diffuse Knapweed remain evident and dense in these areas. White flowers observed in the photo Diffuse Knapweed. Unable to find evidence that sufficient weed management has been conducted. Diffuse knapweed evident in all areas of the foreground in this photo

**Photo 21:** See comments under photo 19.

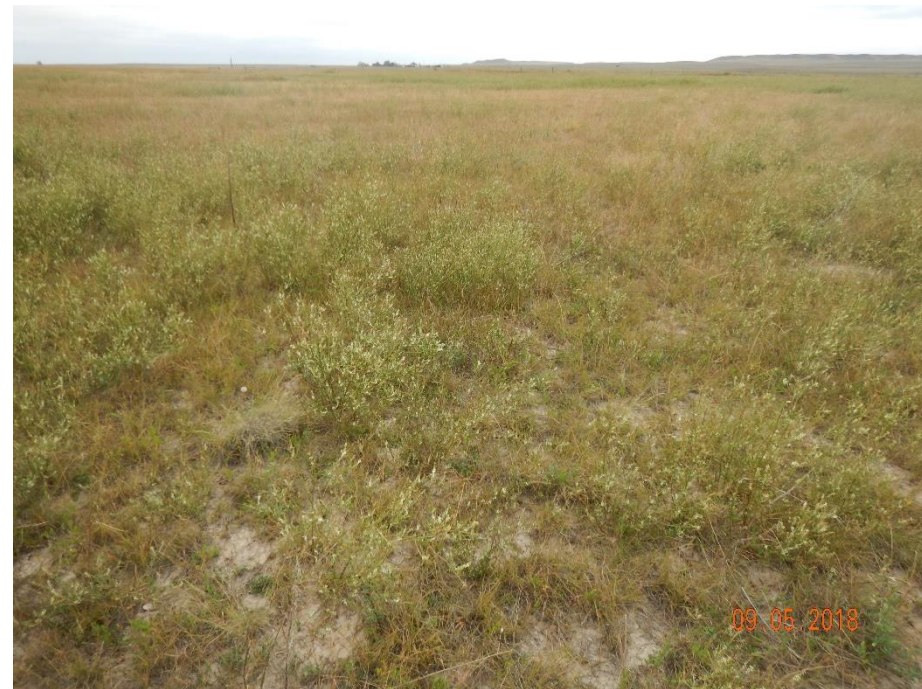
**Photo 26:** Photo taken from the adjacent lands, facing north. See photo 127 for additional details. Individual Diffuse Knapweed was observed in this area. Photo shows adjacent lands do not have the population densities of noxious weeds compared to areas within the locations and its immediate surrounding; noxious weed population densities decrease as the distance away from the locations increase.

**Photo 27:** Photo taken from the adjacent lands, facing east. See comments under photo 26

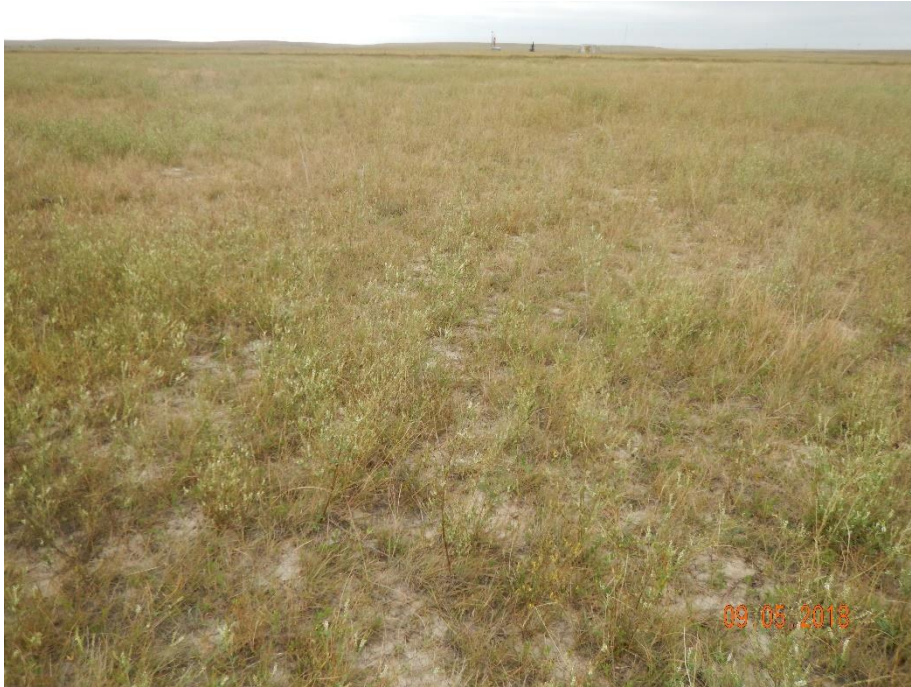
**Photo 28:** Photo taken from the adjacent lands, facing south. See comments under photo 26

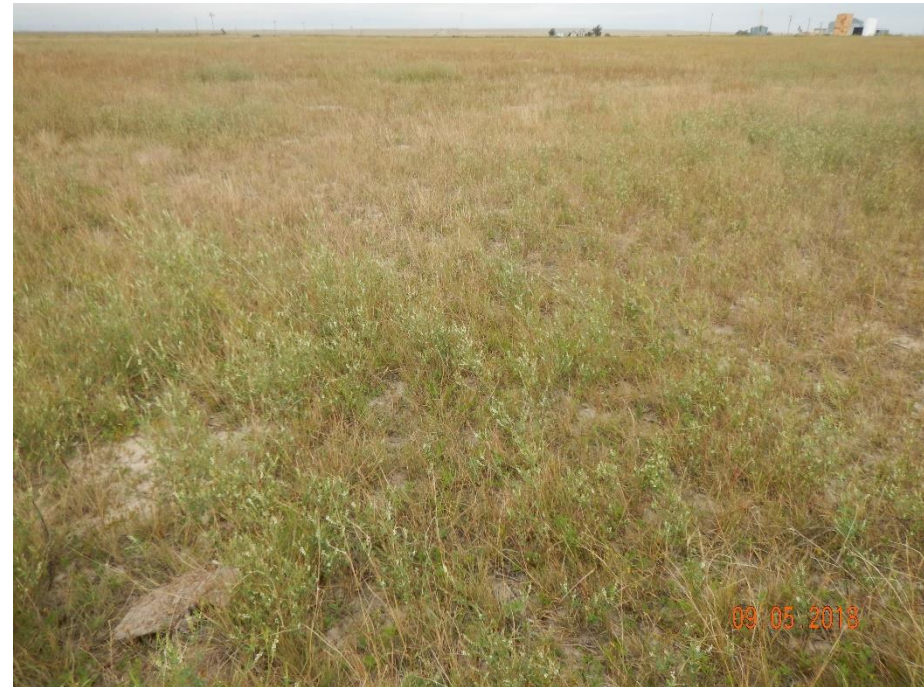
**Photo 29:** Photo taken from the adjacent lands, facing west. See comments under photo 26

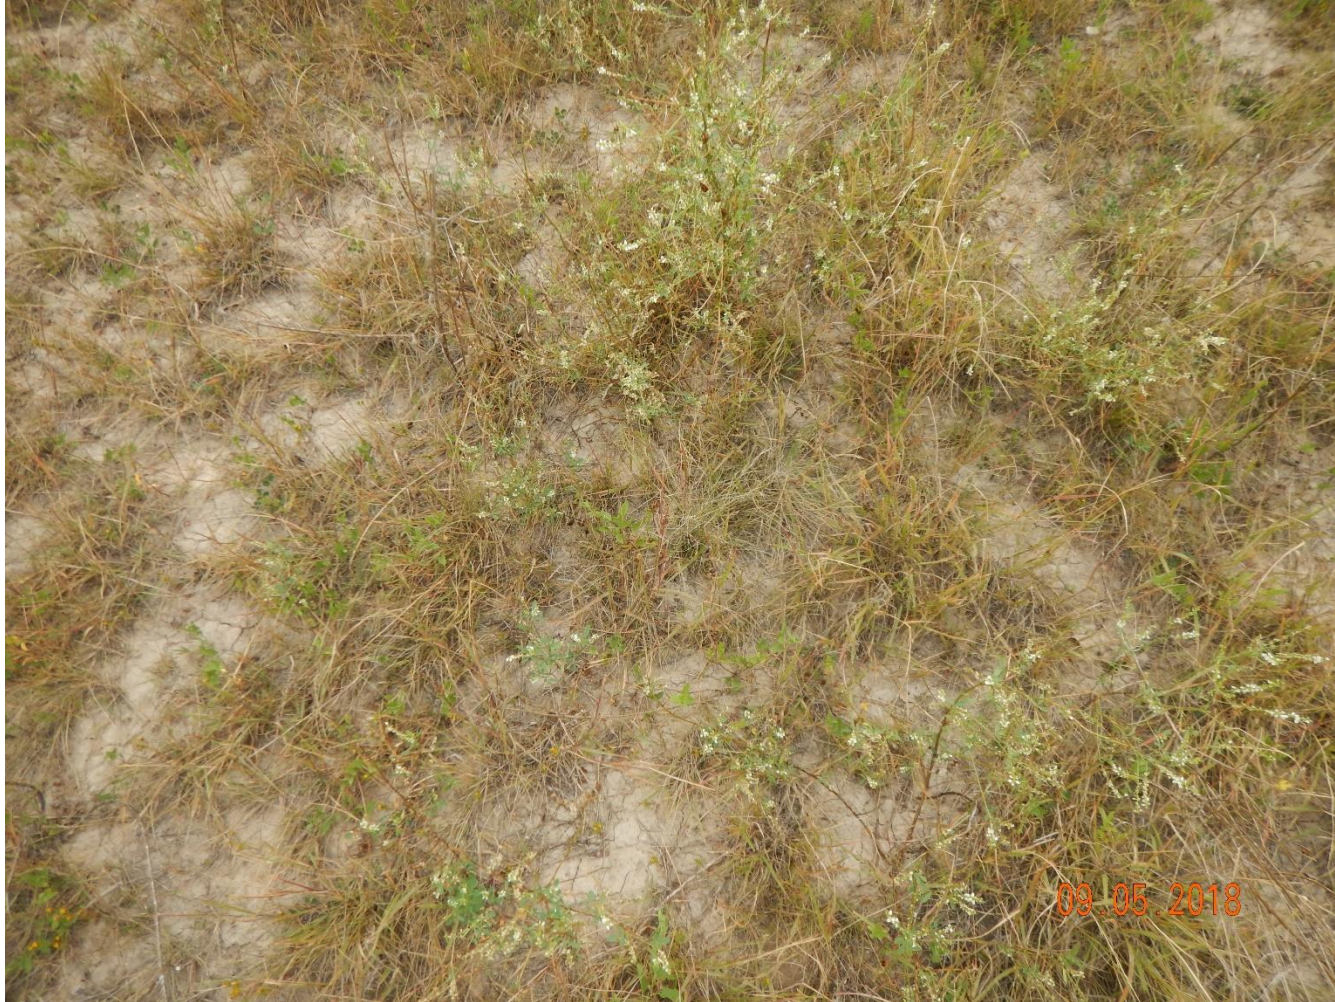
**Photo 30:** Photo taken from the adjacent lands. Photo shows dominant vegetation observed in this immediate area to be Sand Dropseed, Blue Grama and Yellow Sweet clover (white flower)

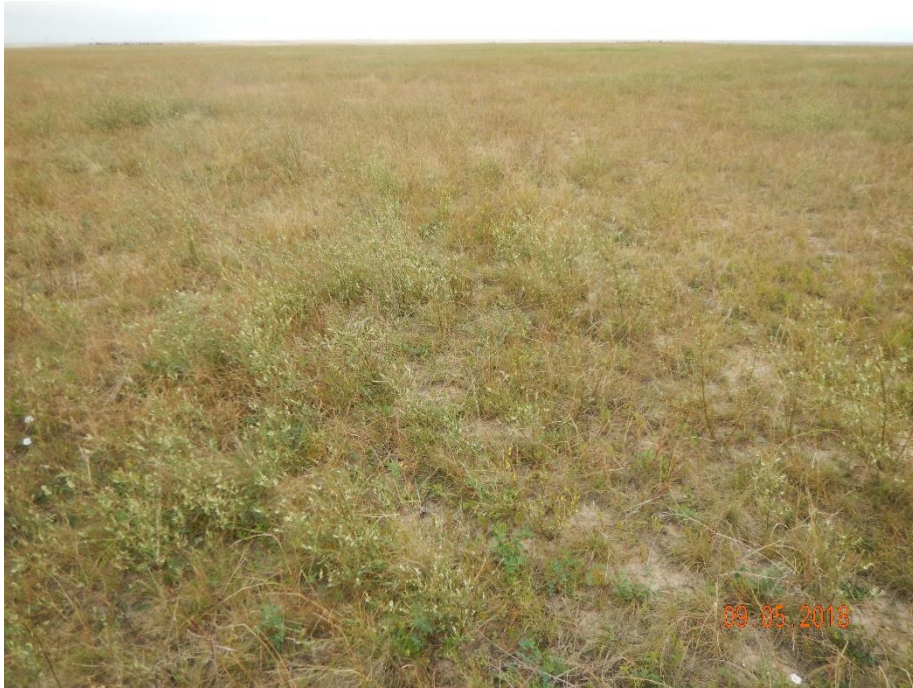
**Photo 31:** Photo taken from the adjacent lands, facing north. See photo 127 for additional details. Diffuse Knapweed was not observed in this area. Photo shows adjacent lands do not have the population densities of noxious weeds compared to areas within the locations and its immediate surrounding; noxious weed population densities decrease as the distance away from the locations increase.

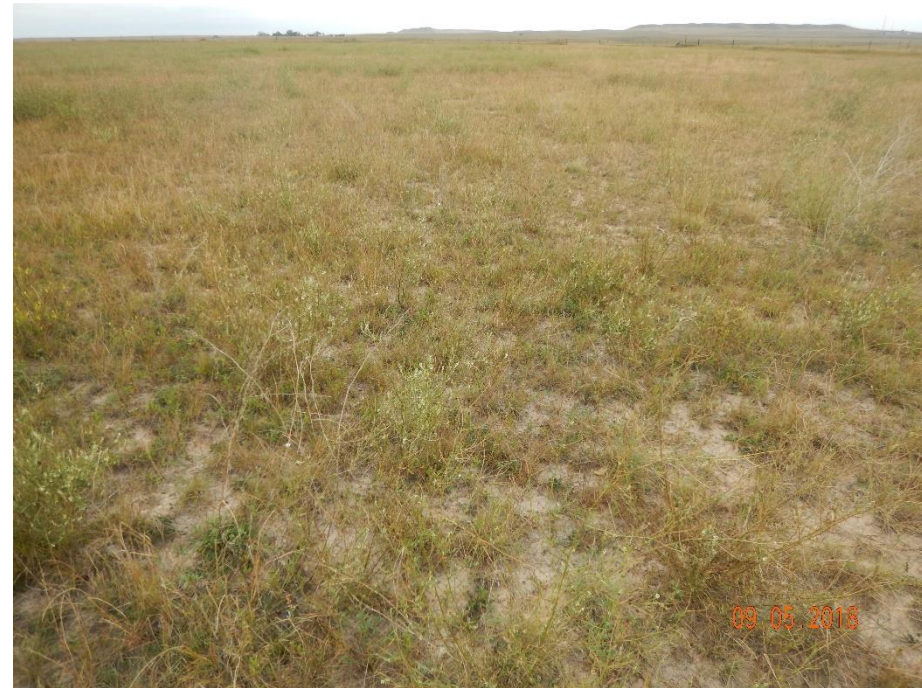
**Photo 32:** Photo taken from the adjacent lands, facing east. See comments under photo 31

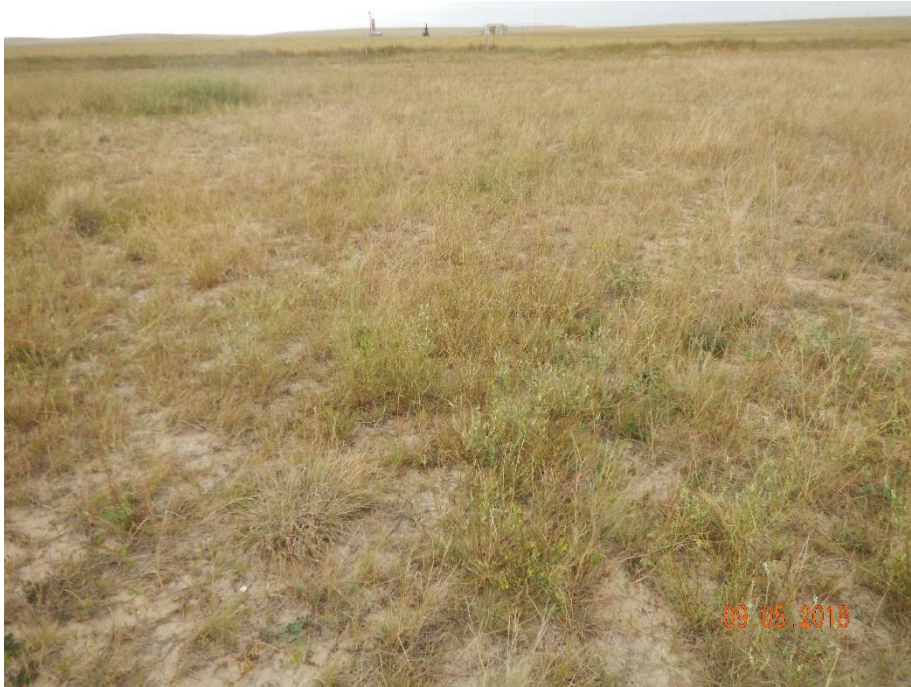
**Photo 33:** Photo taken from the adjacent lands, facing south. See comments under photo 31

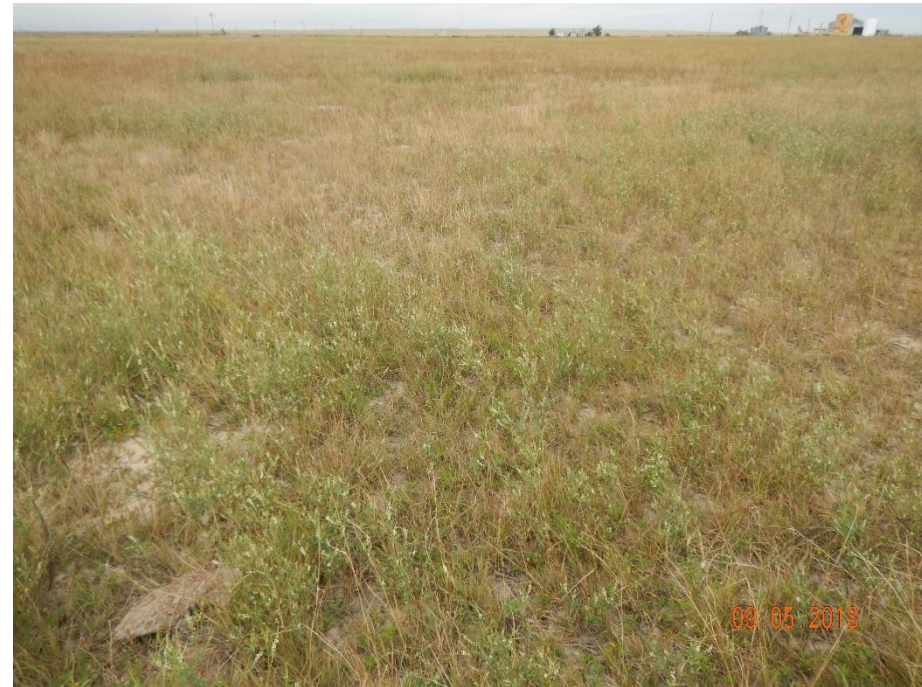
**Photo 34:** Photo taken from the adjacent lands, facing west. See comments under photo 31

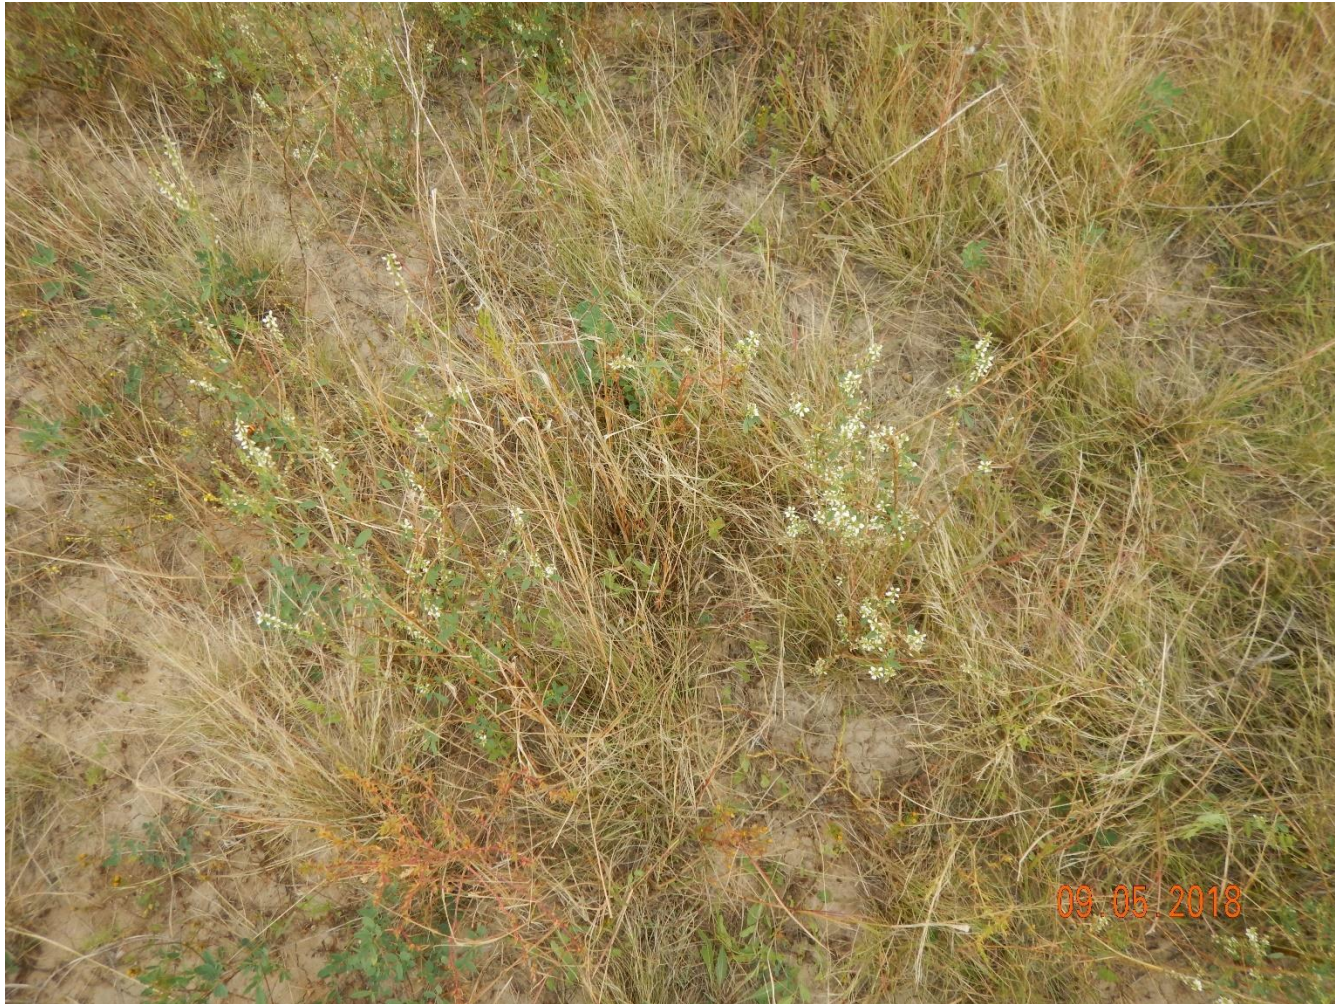
**Photo 35:** Photo taken from the adjacent lands. Photo shows dominant vegetation observed in this immediate area to be Sand Dropseed, Blue Grama and Yellow Sweet clover (white flower)

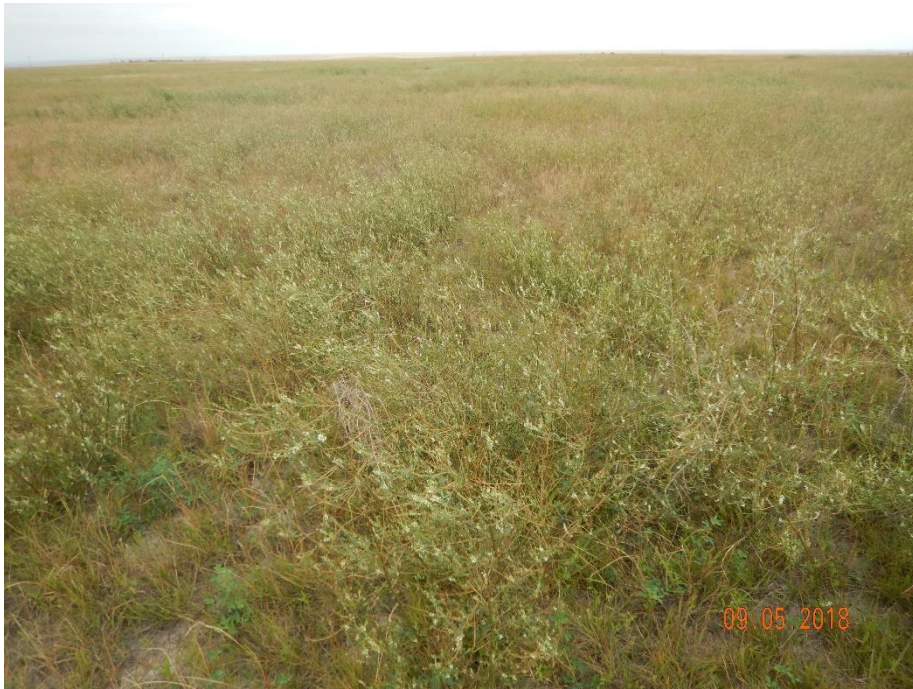
**Photo 36:** Photo taken from the adjacent lands, facing north. See photo 127 for additional details. Diffuse Knapweed was not observed in this area. Photo shows adjacent lands do not have the population densities of noxious weeds compared to areas within the locations and its immediate surrounding; noxious weed population densities decrease as the distance away from the locations increase.

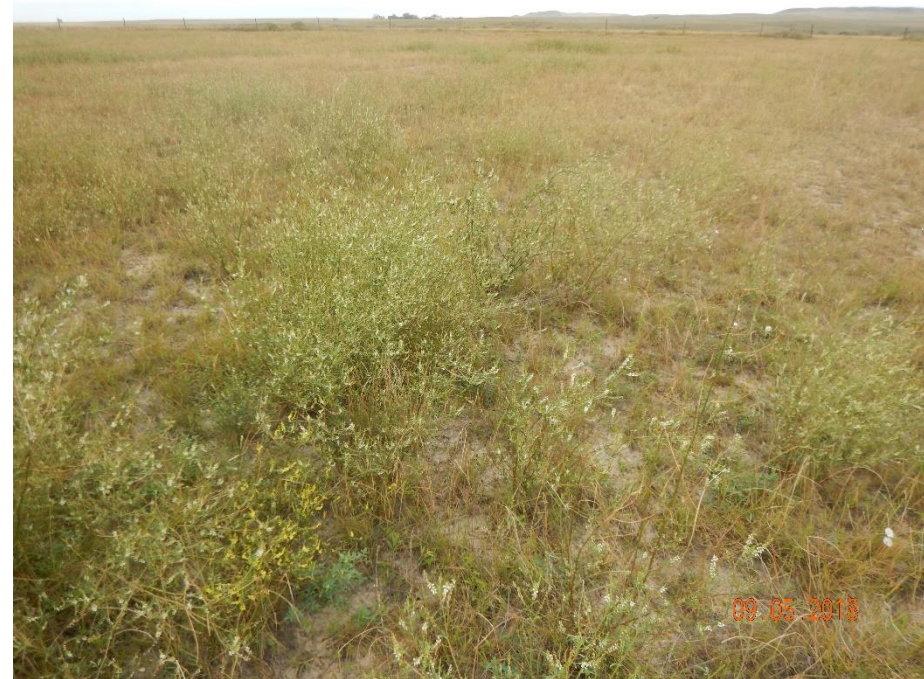
**Photo 37:** Photo taken from the adjacent lands, facing east. See comments under photo 36

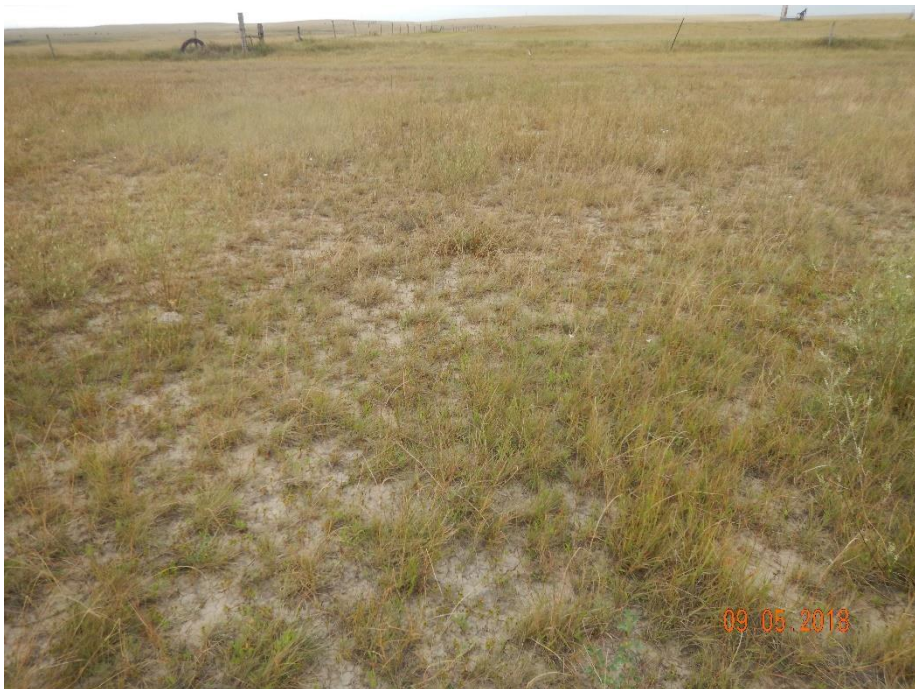
**Photo 38:** Photo taken from the adjacent lands, facing south. See comments under photo 36

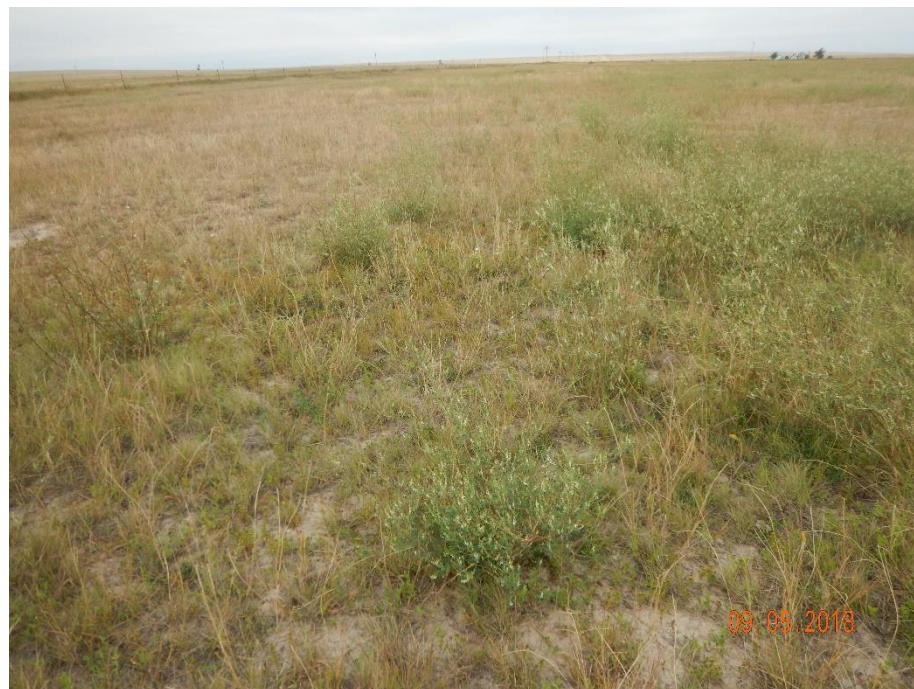
**Photo 39:** Photo taken from the adjacent lands, facing west. See comments under photo 36.

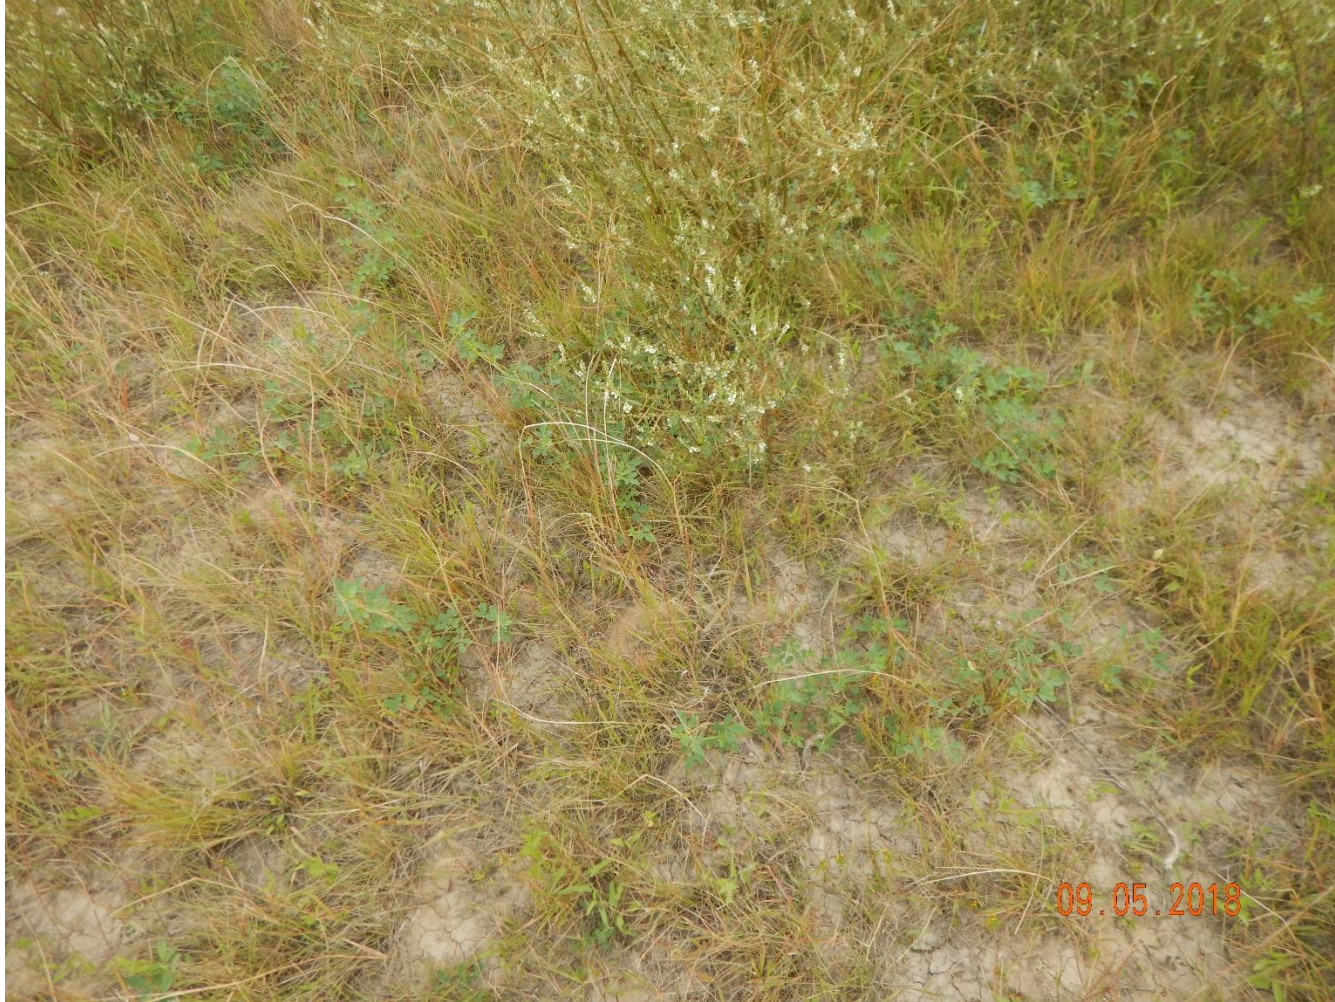
**Photo 40:** Photo taken from the adjacent lands. Photo shows dominant vegetation observed in this immediate area to be Sand Dropseed, Blue Grama and Yellow Sweet clover (white flower)

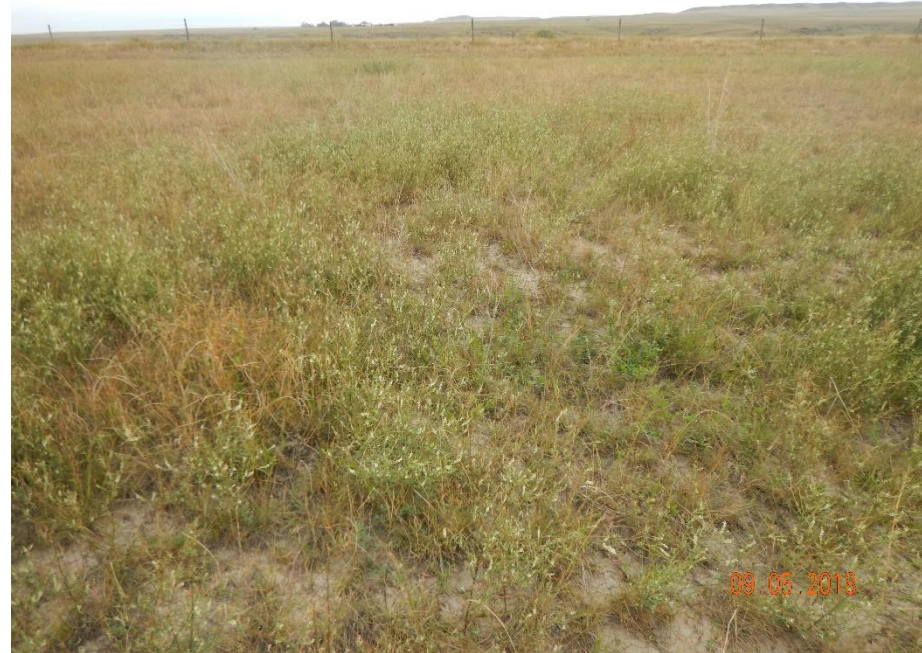
**Photo 41:** Photo taken from the adjacent lands, facing north. See photo 127 for additional details. An individual Diffuse Knapweed was observed in this area. Photo shows adjacent lands do not have the population densities of noxious weeds compared to areas within the locations and its immediate surrounding; noxious weed population densities decrease as the distance away from the locations increase.

**Photo 42:** Photo taken from the adjacent lands, facing east. See comments under photo 41

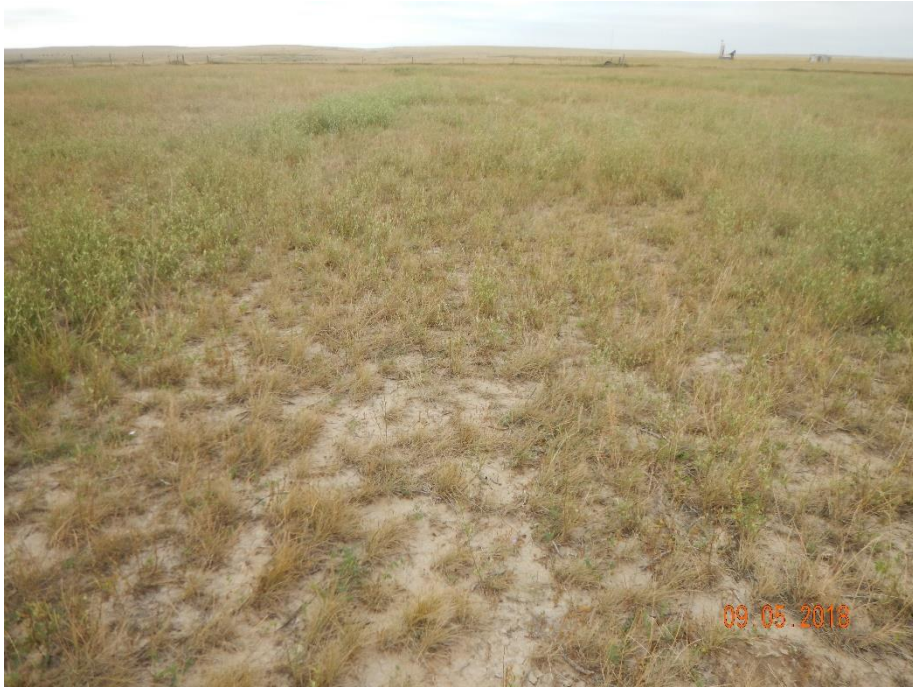
**Photo 43:** Photo taken from the adjacent lands, facing south. See comments under photo 41

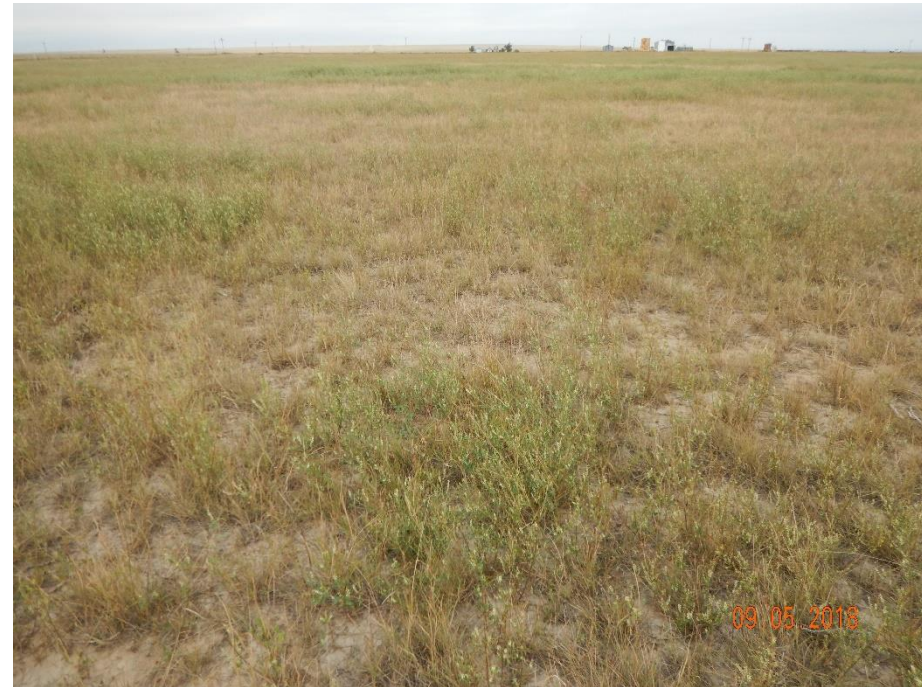
**Photo 44:** Photo taken from the adjacent lands, facing west. See comments under photo 41

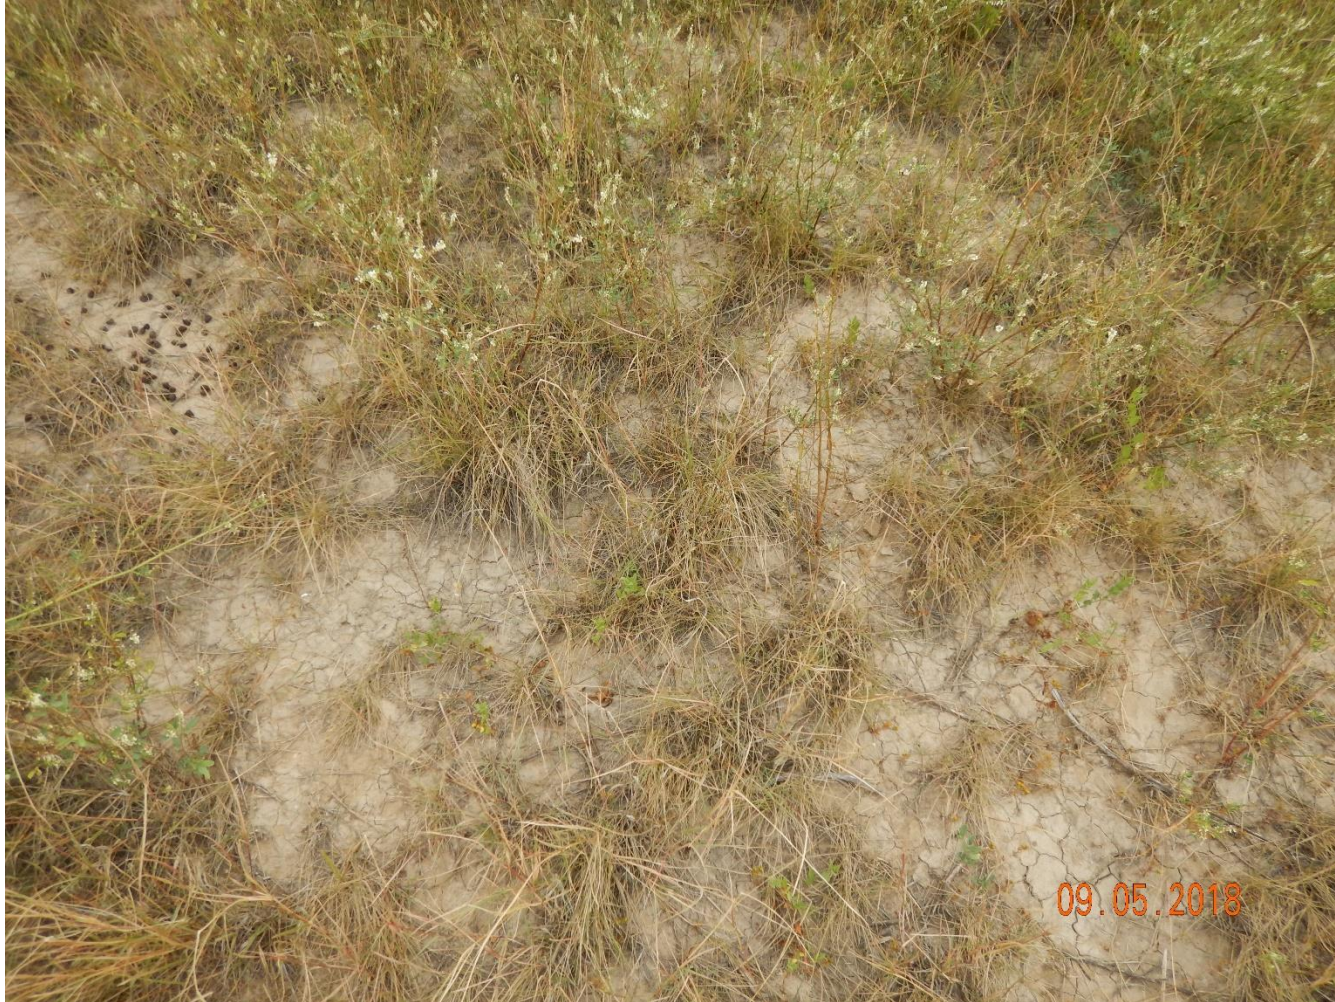
**Photo 45:** Photo taken from the adjacent lands. Photo shows dominant vegetation observed in this immediate area to be Sand Dropseed, Blue Grama and Yellow Sweet clover (white flower)

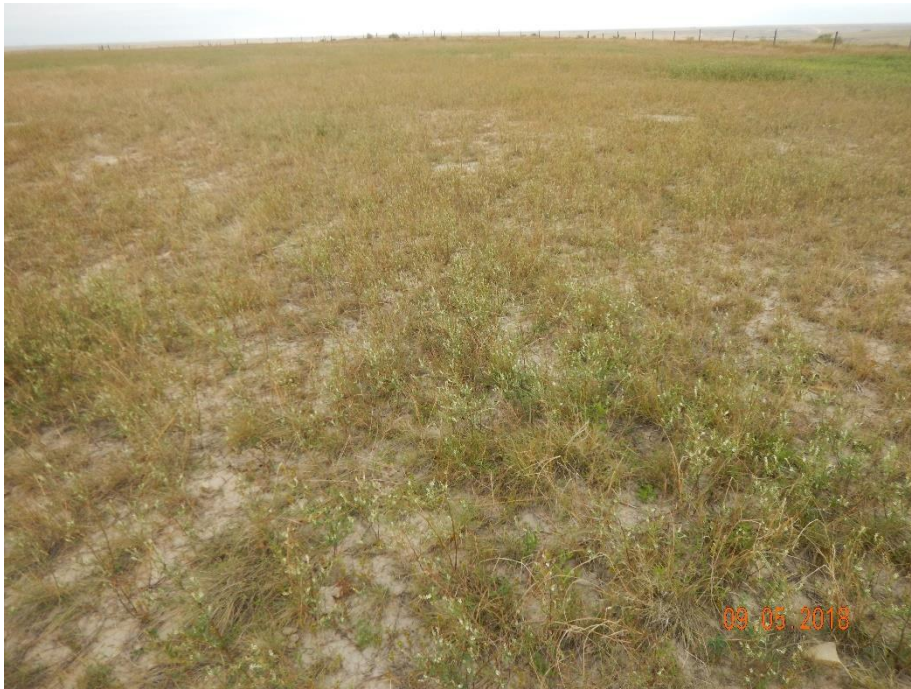
**Photo 47:** Photo taken from the adjacent lands, facing north. See photo 127 for additional details. Diffuse Knapweed was not observed in this area. Photo shows adjacent lands do not have the population densities of noxious weeds compared to areas within the locations and its immediate surrounding; noxious weed population densities decrease as the distance away from the locations increase.

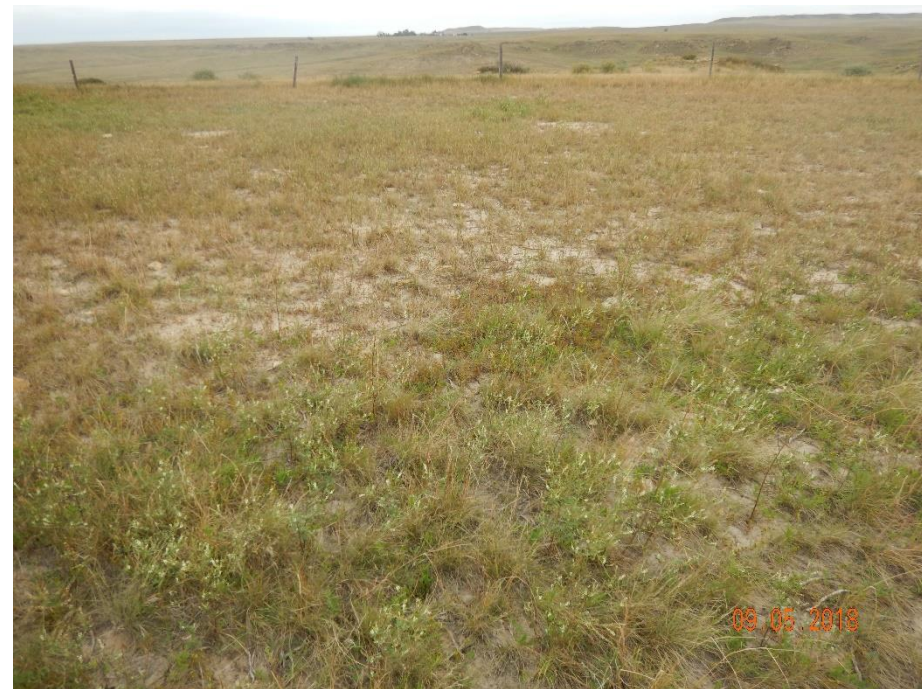
**Photo 48:** Photo taken from the adjacent lands, facing east. See comments under photo 47

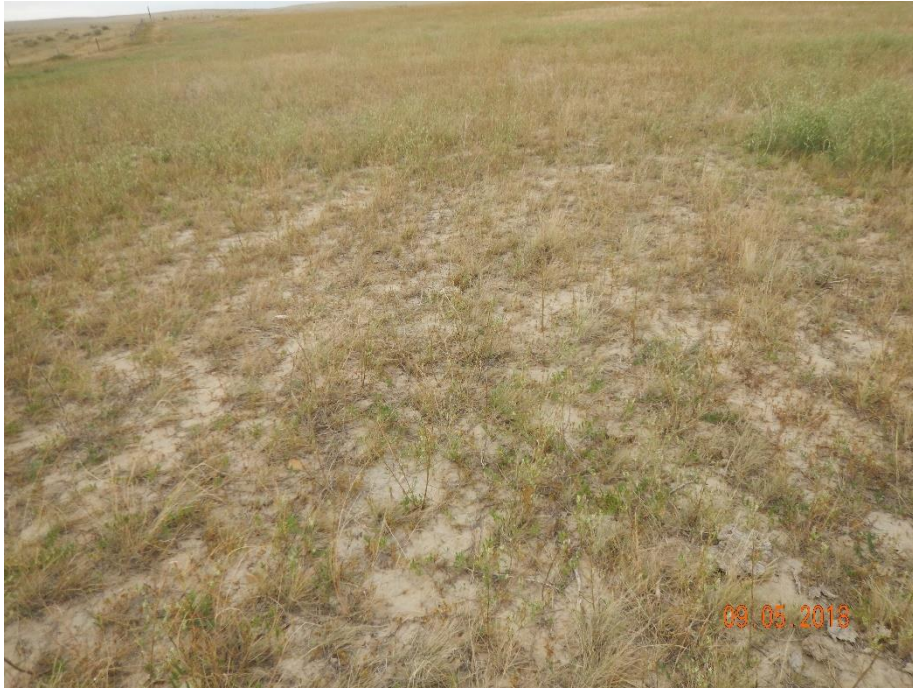
**Photo 49:** Photo taken from the adjacent lands, facing south. See comments under photo 47

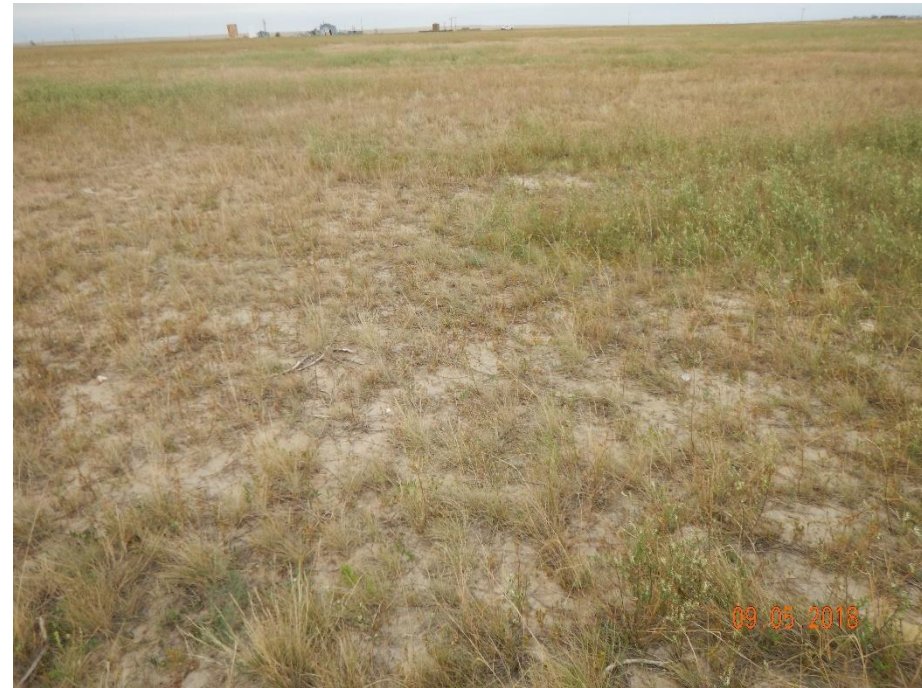
**Photo 50:** Photo taken from the adjacent lands, facing west. See comments under photo 47

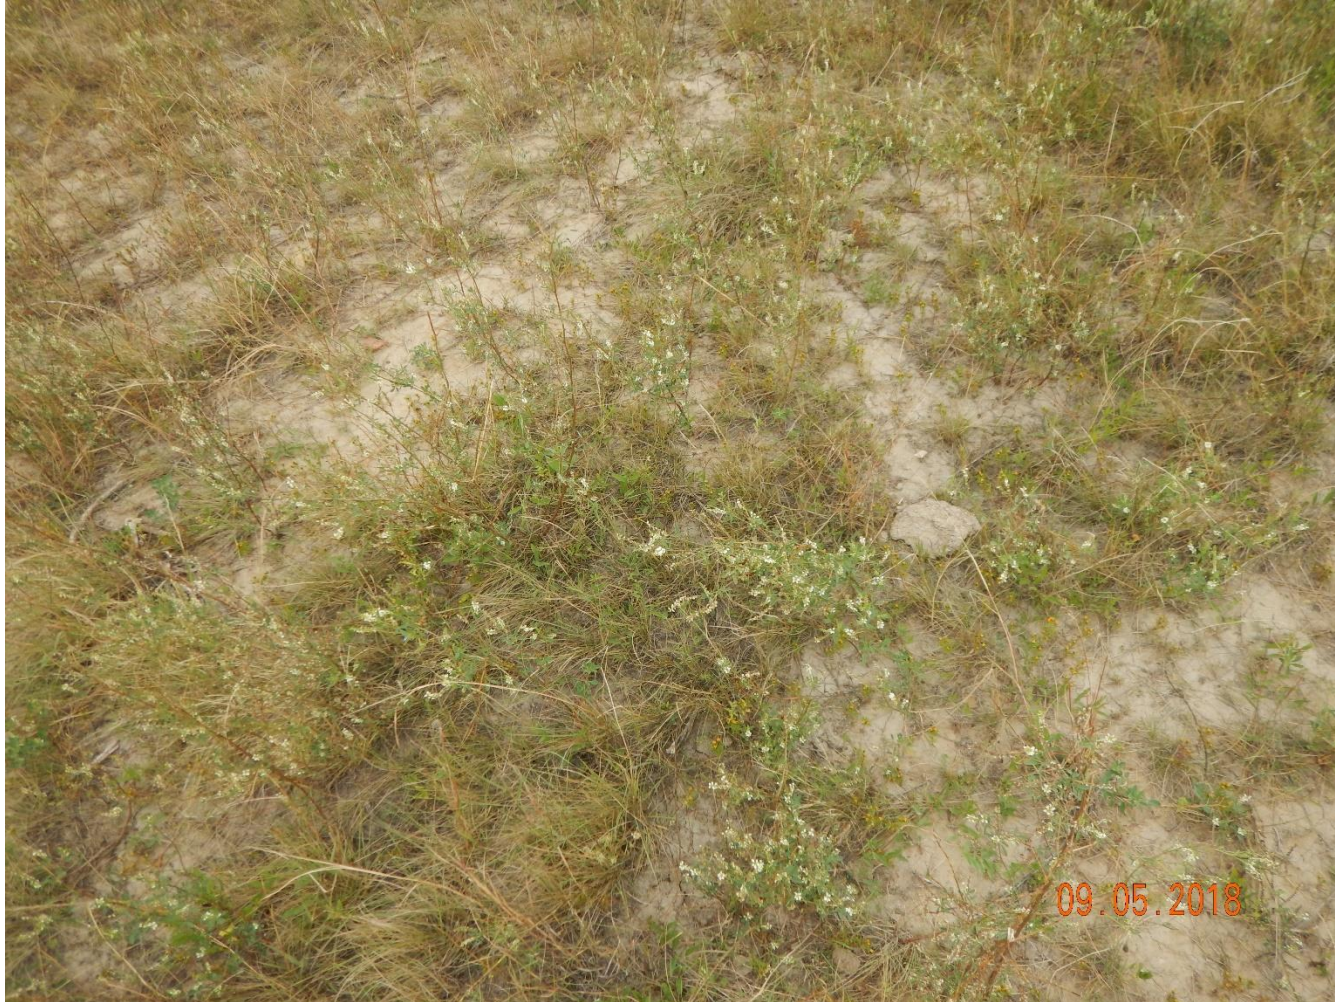
**Photo 51:** Photo taken from the adjacent lands. Photo shows dominant vegetation observed in this immediate area to be Sand Dropseed, Blue Grama and Yellow Sweet clover (white flower)

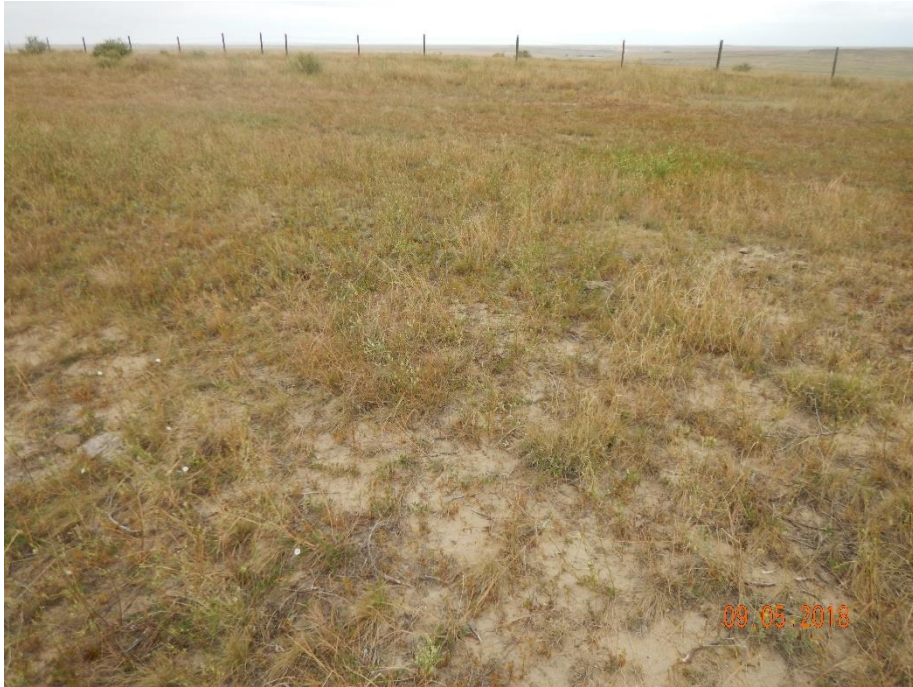
**Photo 52:** Photo taken from the adjacent lands, facing north. See photo 127 for additional details. Diffuse Knapweed **was not** observed in this area. Photo shows adjacent lands do not have the population densities of noxious weeds compared to areas within the locations and its immediate surrounding; noxious weed population densities decrease as the distance away from the locations increase.
