# Inspection Photos

Operator: FOUNDATION ENERGY  
MANAGEMENT LLC - 10112

Location ID: 447523

Inspection Doc. Number: 682503847  
Weld County, CO

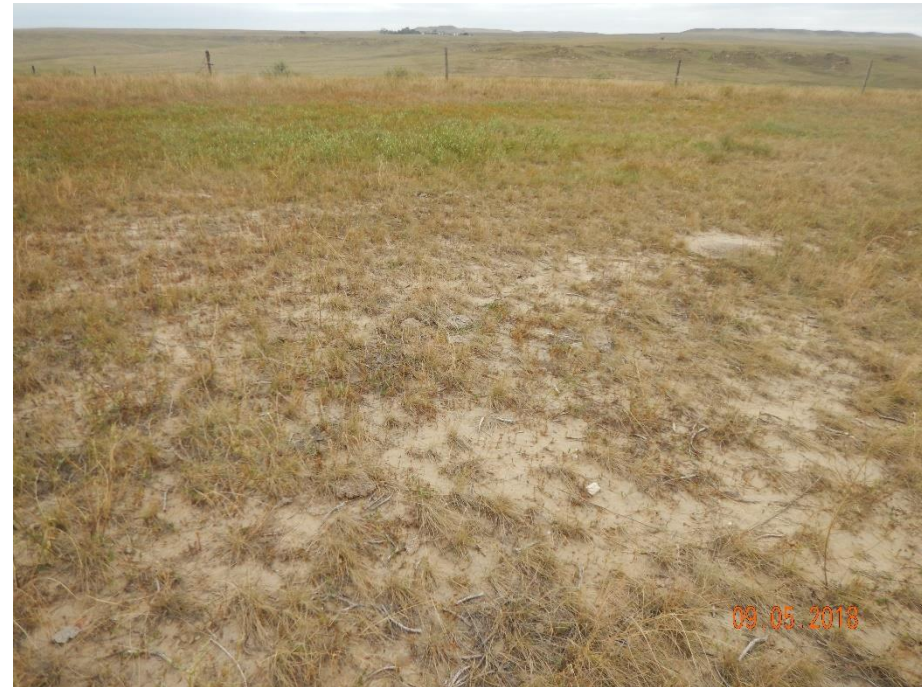
**Photo 52:** Photo taken from the adjacent lands, facing north. See photo 127 for additional details. Diffuse Knapweed **was not** observed in this area. Photo shows adjacent lands do not have the population densities of noxious weeds compared to areas within the locations and its immediate surrounding; noxious weed population densities decrease as the distance away from the locations increase.

**Photo 53:** Photo taken from the adjacent lands, facing east. See comments under photo 52

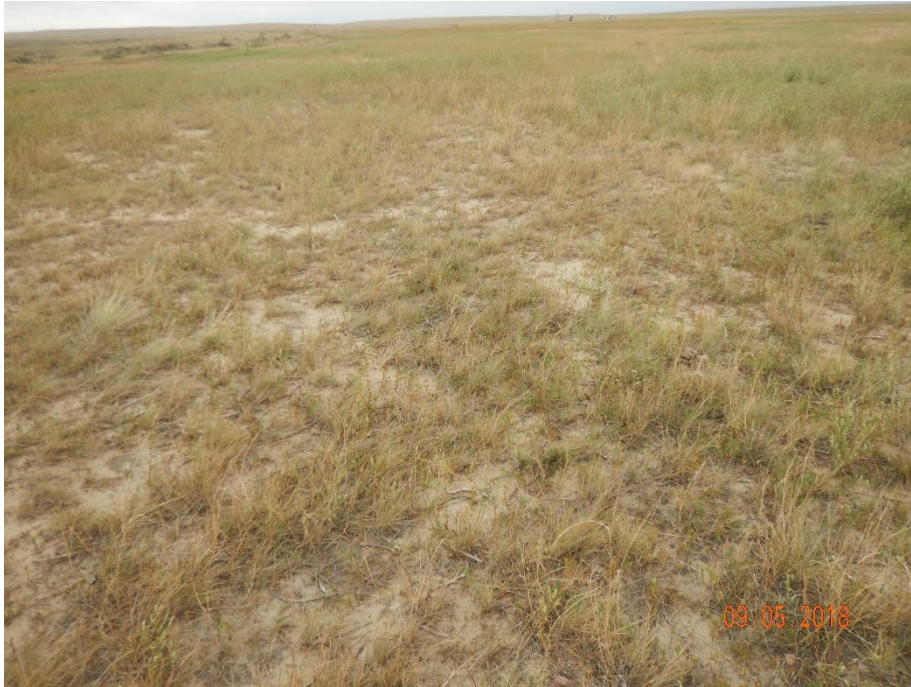
**Photo 54:** Photo taken from the adjacent lands, facing south. See comments under photo 52

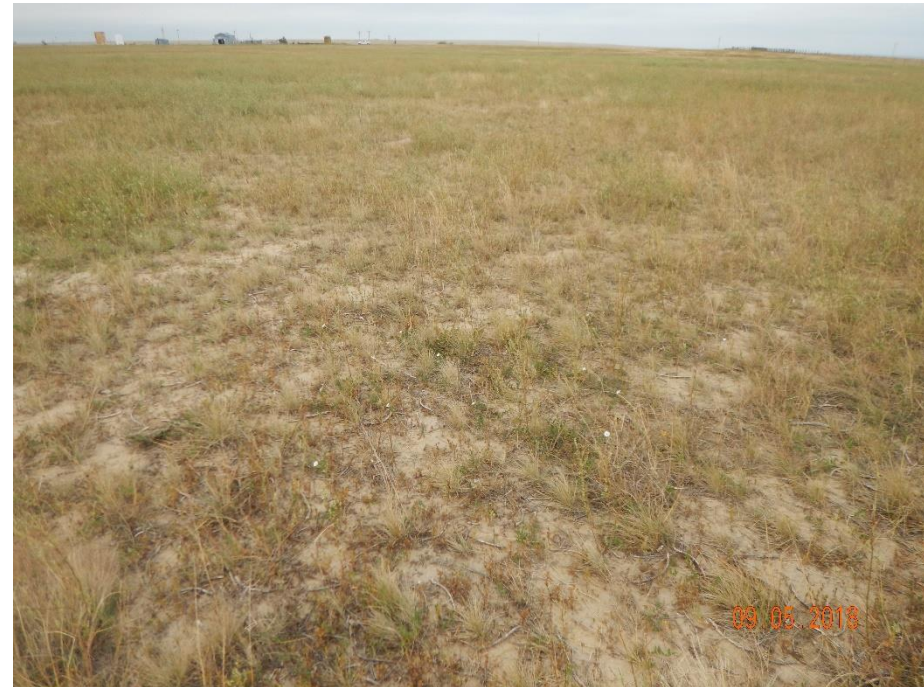
**Photo 55:** Photo taken from the adjacent lands, facing west. See comments under photo 52

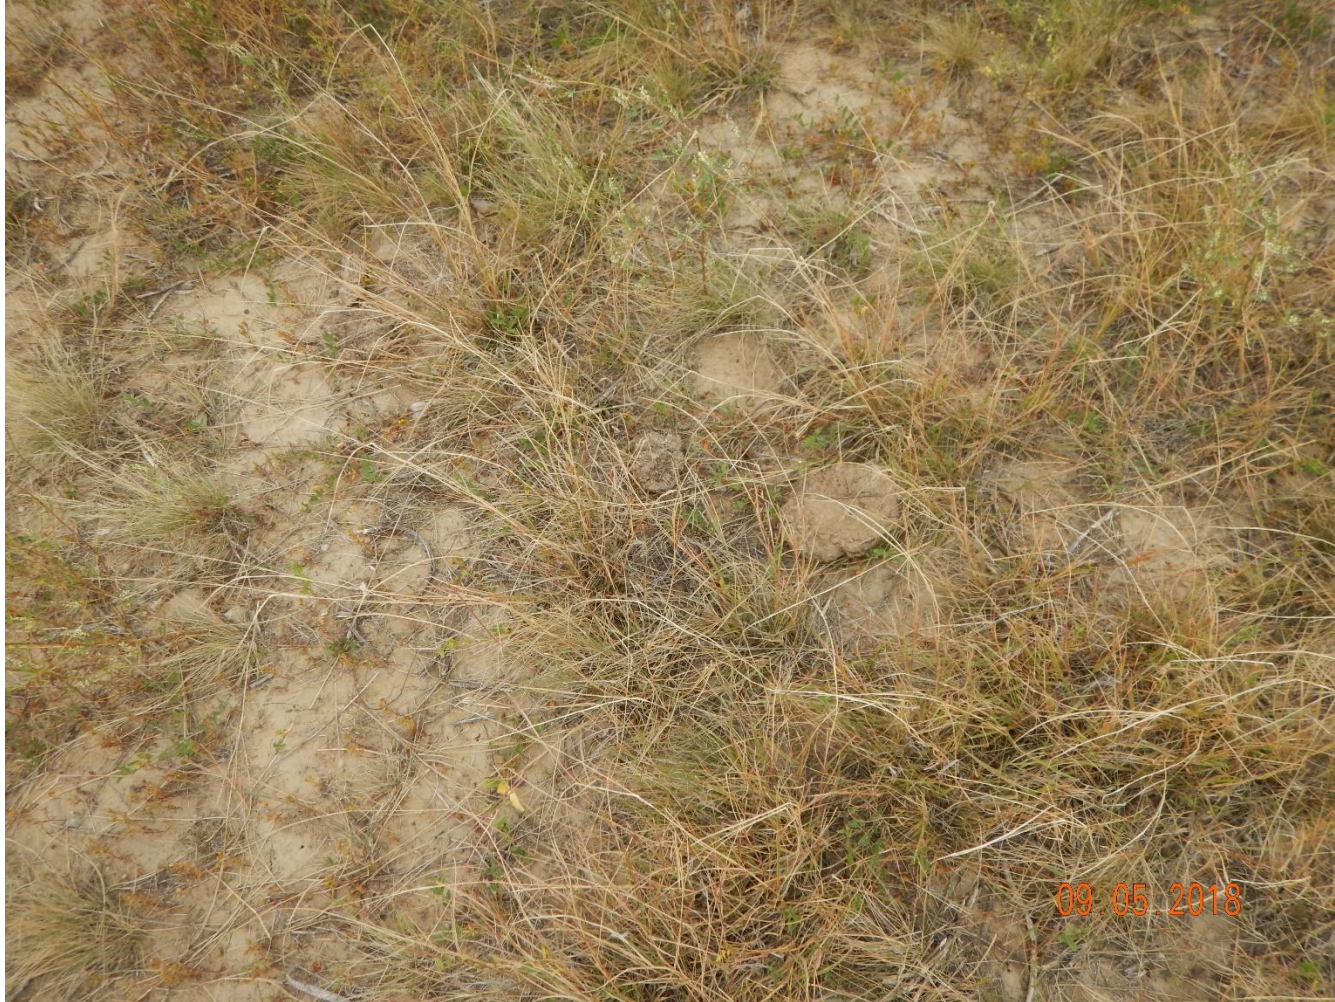
**Photo 56:** Photo taken from the adjacent lands. Photo shows dominant vegetation observed in this immediate area to be Sand Dropseed.

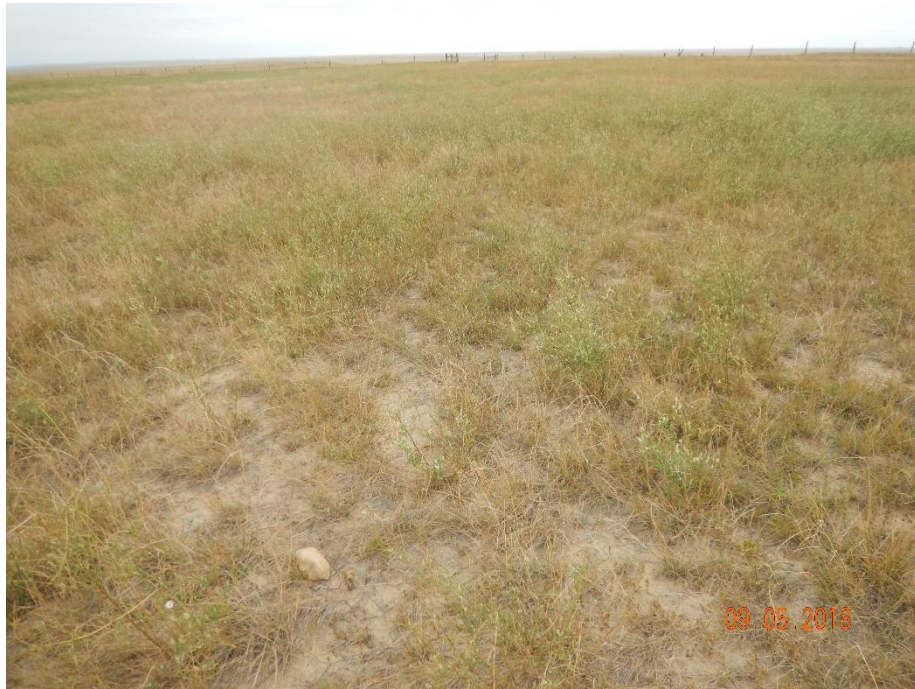
**Photo 57:** Photo taken from the adjacent lands, facing north. See photo 127 for additional details. Diffuse Knapweed was not observed in this area. Photo shows adjacent lands do not have the population densities of noxious weeds compared to areas within the locations and its immediate surrounding; noxious weed population densities decrease as the distance away from the locations increase.

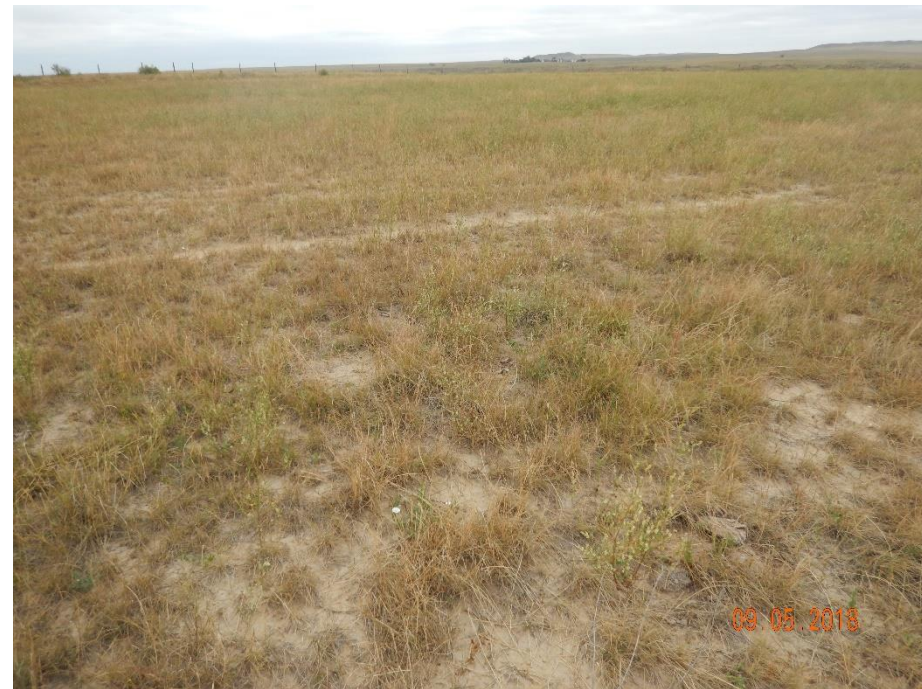
**Photo 58:** Photo taken from the adjacent lands, facing east. See comments under photo 57

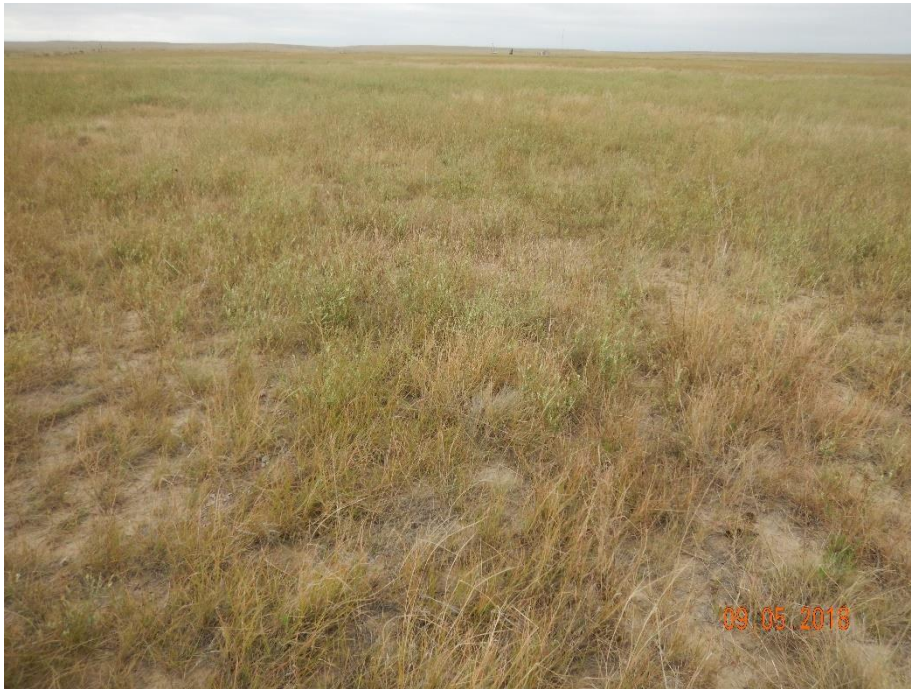
**Photo 59:** Photo taken from the adjacent lands, facing south. See comments under photo 57

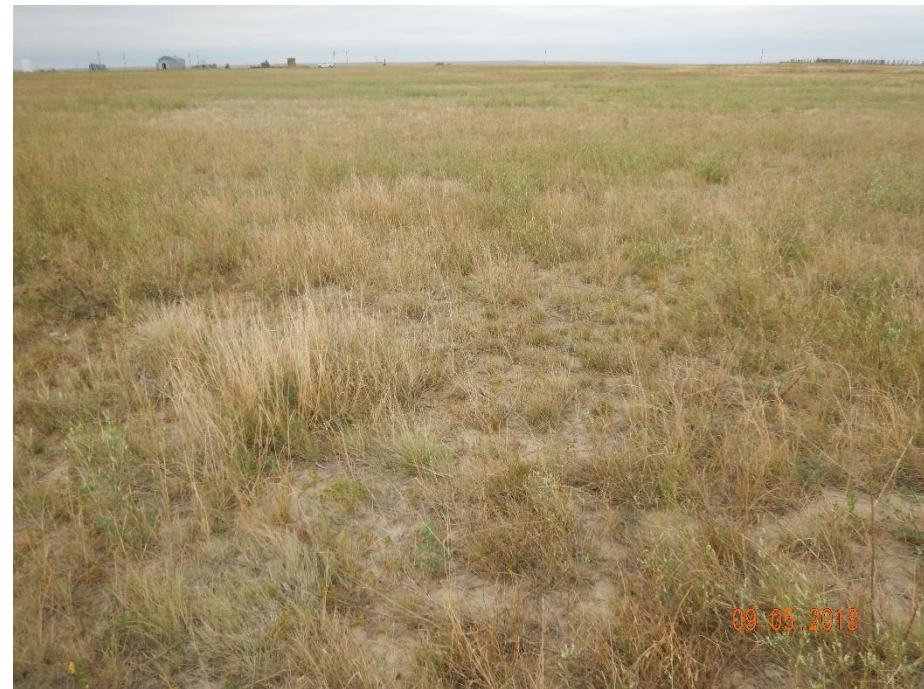
**Photo 60:** Photo taken from the adjacent lands, facing west. See comments under photo 57

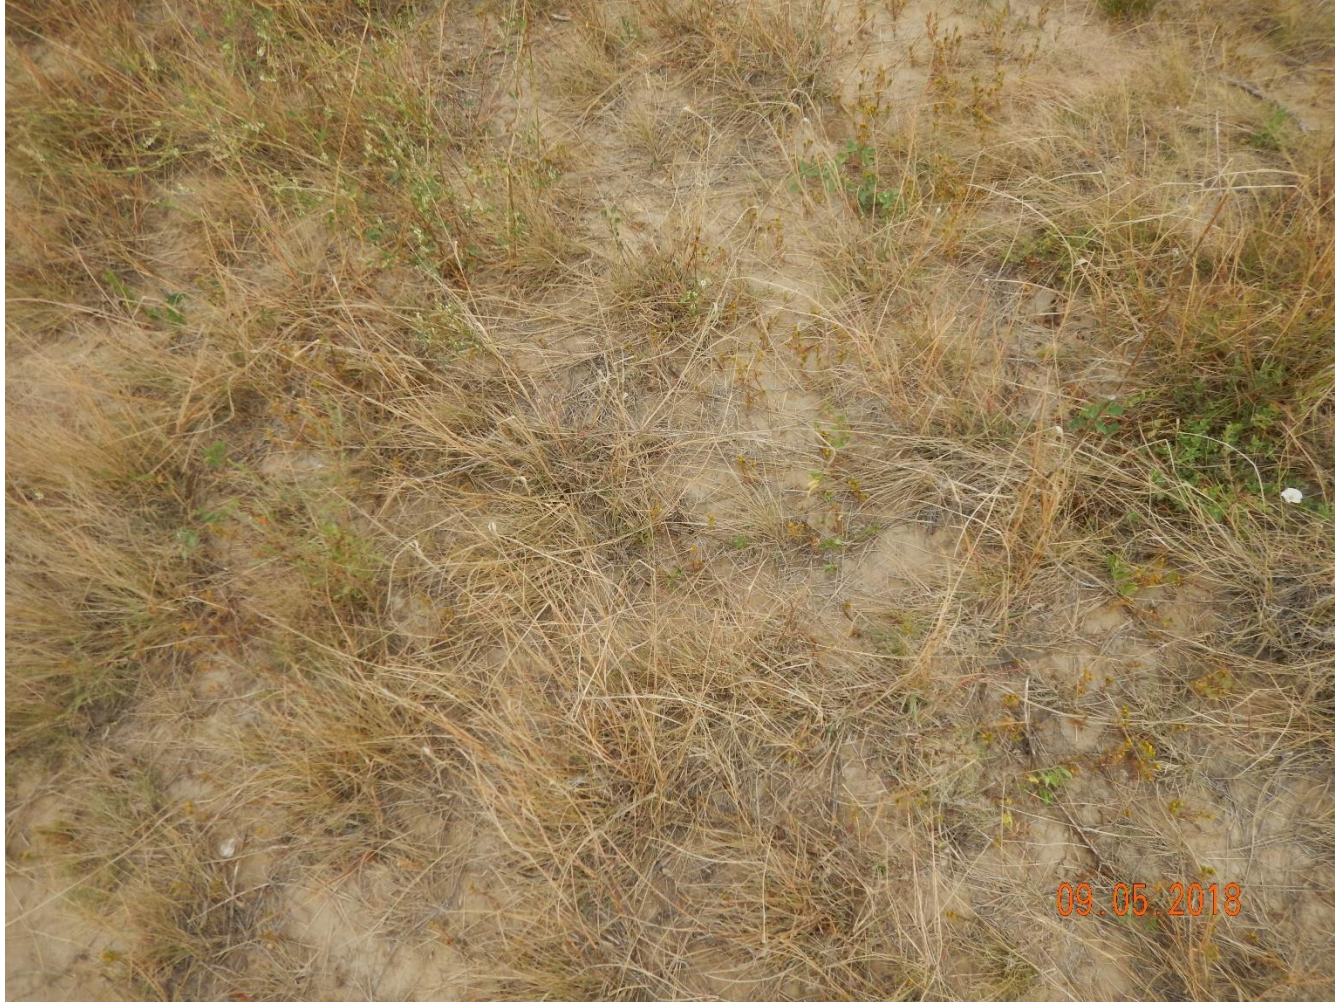
**Photo 61:** Photo taken from the adjacent lands. Photo shows dominant vegetation observed in this immediate area to be Sand Dropseed, Blue Grama and Yellow Sweet clover (white flower, top left)

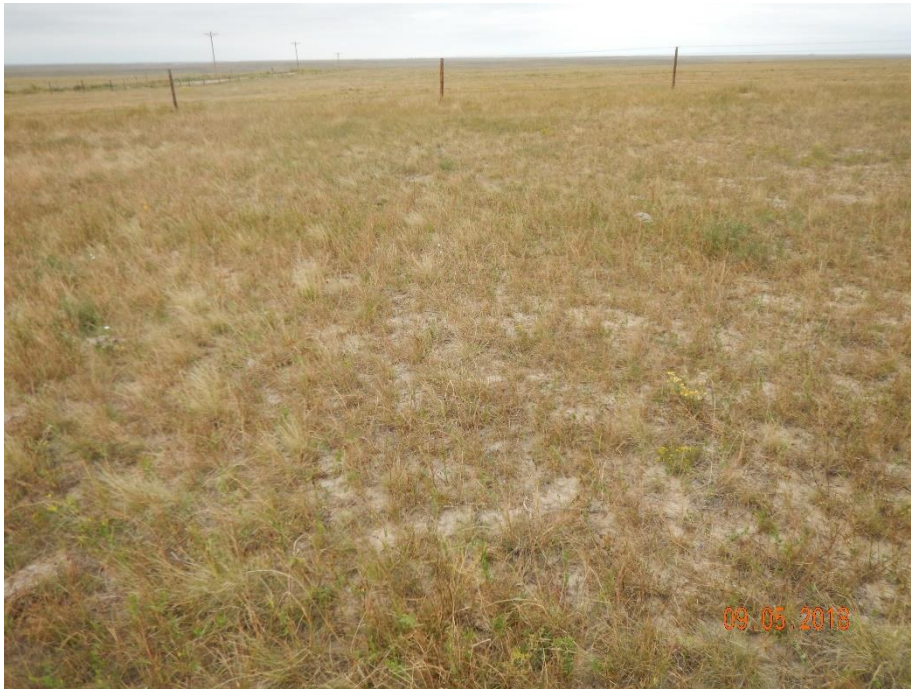
**Photo 63:** Photo taken from the adjacent lands, facing north. See photo 127 for additional details. Diffuse Knapweed was not observed in this area. Photo shows adjacent lands do not have the population densities of noxious weeds compared to areas within the locations and its immediate surrounding; noxious weed population densities decrease as the distance away from the locations increase.

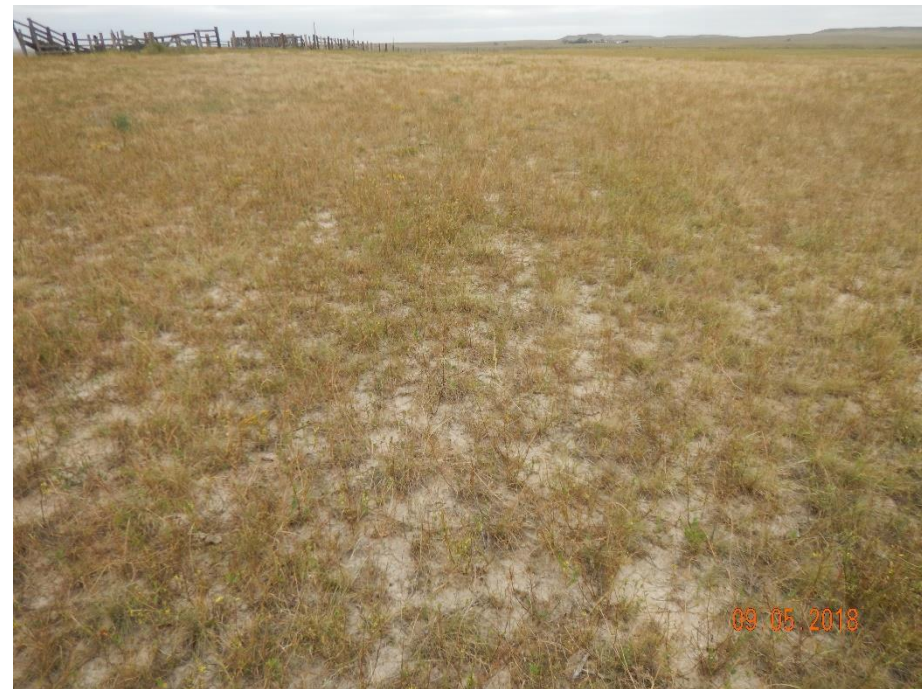
**Photo 64:** Photo taken from the adjacent lands, facing east. See comments under photo 63

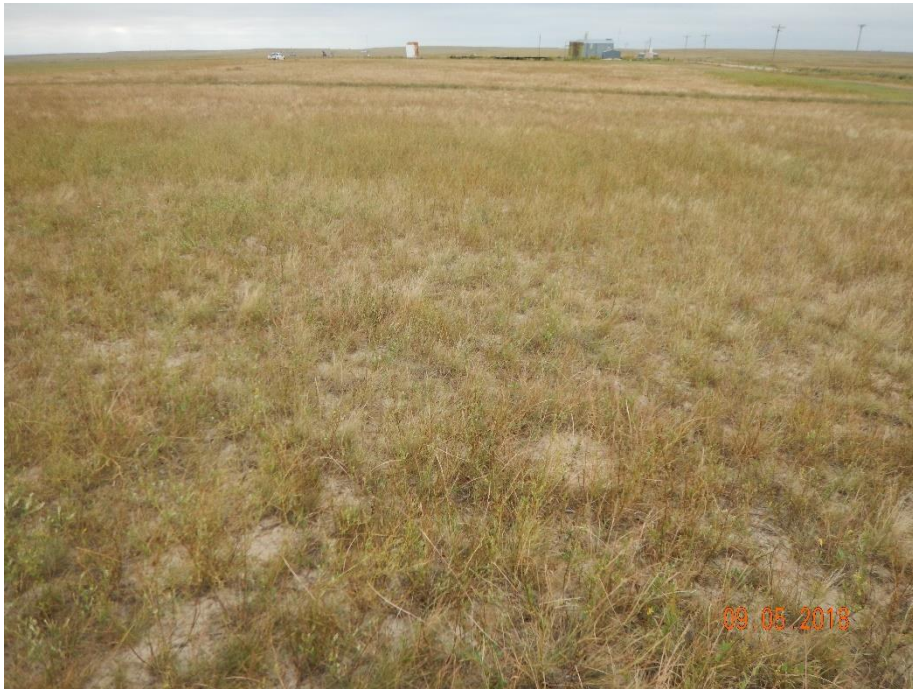
**Photo 65:** Photo taken from the adjacent lands, facing south. See comments under photo 63

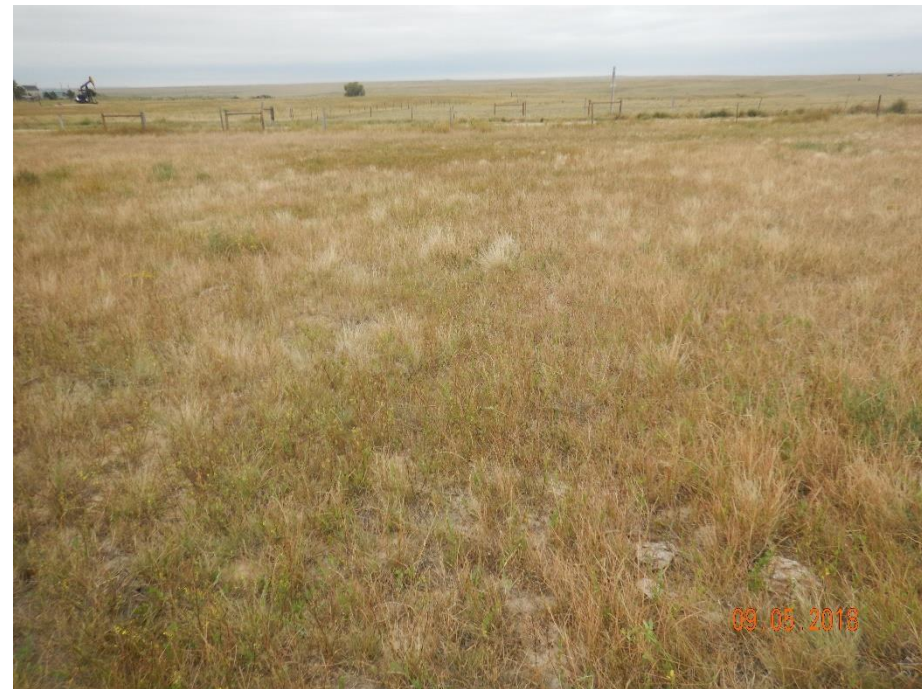
**Photo 66:** Photo taken from the adjacent lands, facing west. See comments under photo 63

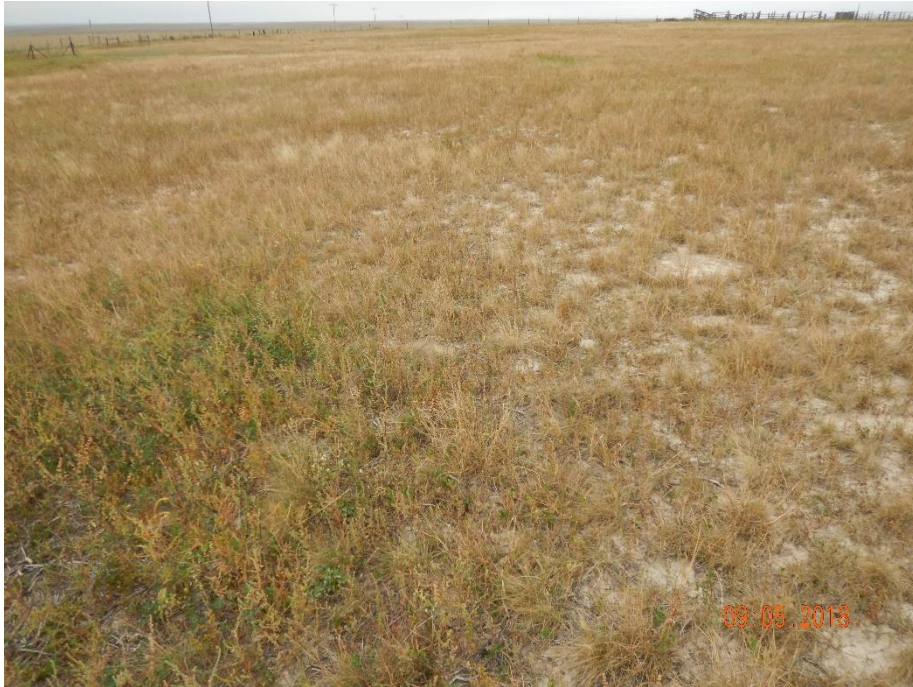
**Photo 67:** Photo taken from the adjacent lands, facing north. See photo 127 for additional details. Diffuse Knapweed **was not** observed in this area. Photo shows adjacent lands do not have the population densities of noxious weeds compared to areas within the locations and its immediate surrounding; noxious weed population densities decrease as the distance away from the locations increase.

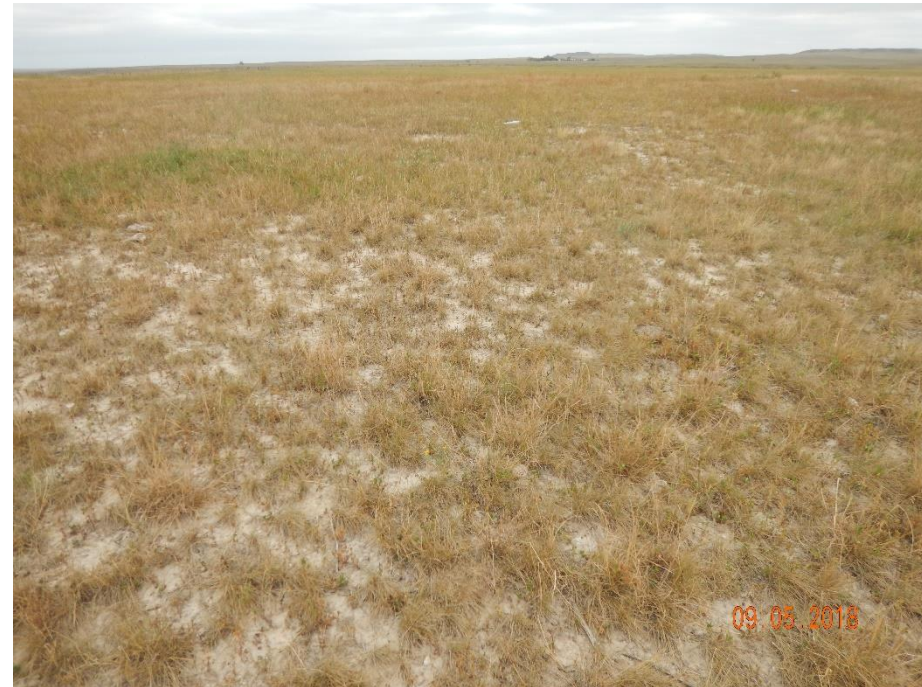
**Photo 68:** Photo taken from the adjacent lands, facing east. See comments under photo 67

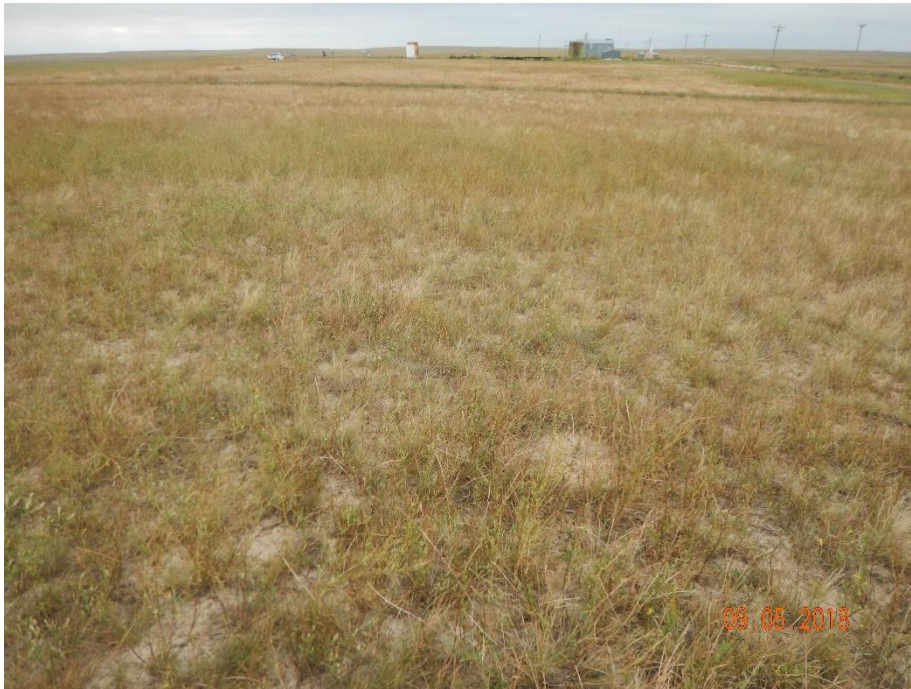
**Photo 69:** Photo taken from the adjacent lands, facing south. See comments under photo 67

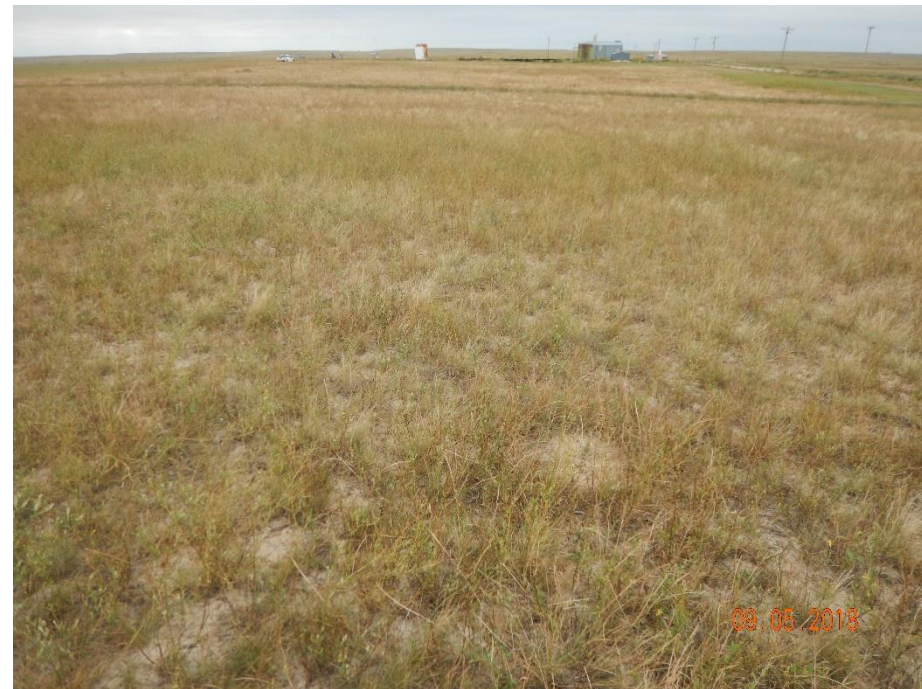
**Photo 70:** Photo taken from the adjacent lands, facing west. See comments under photo 67

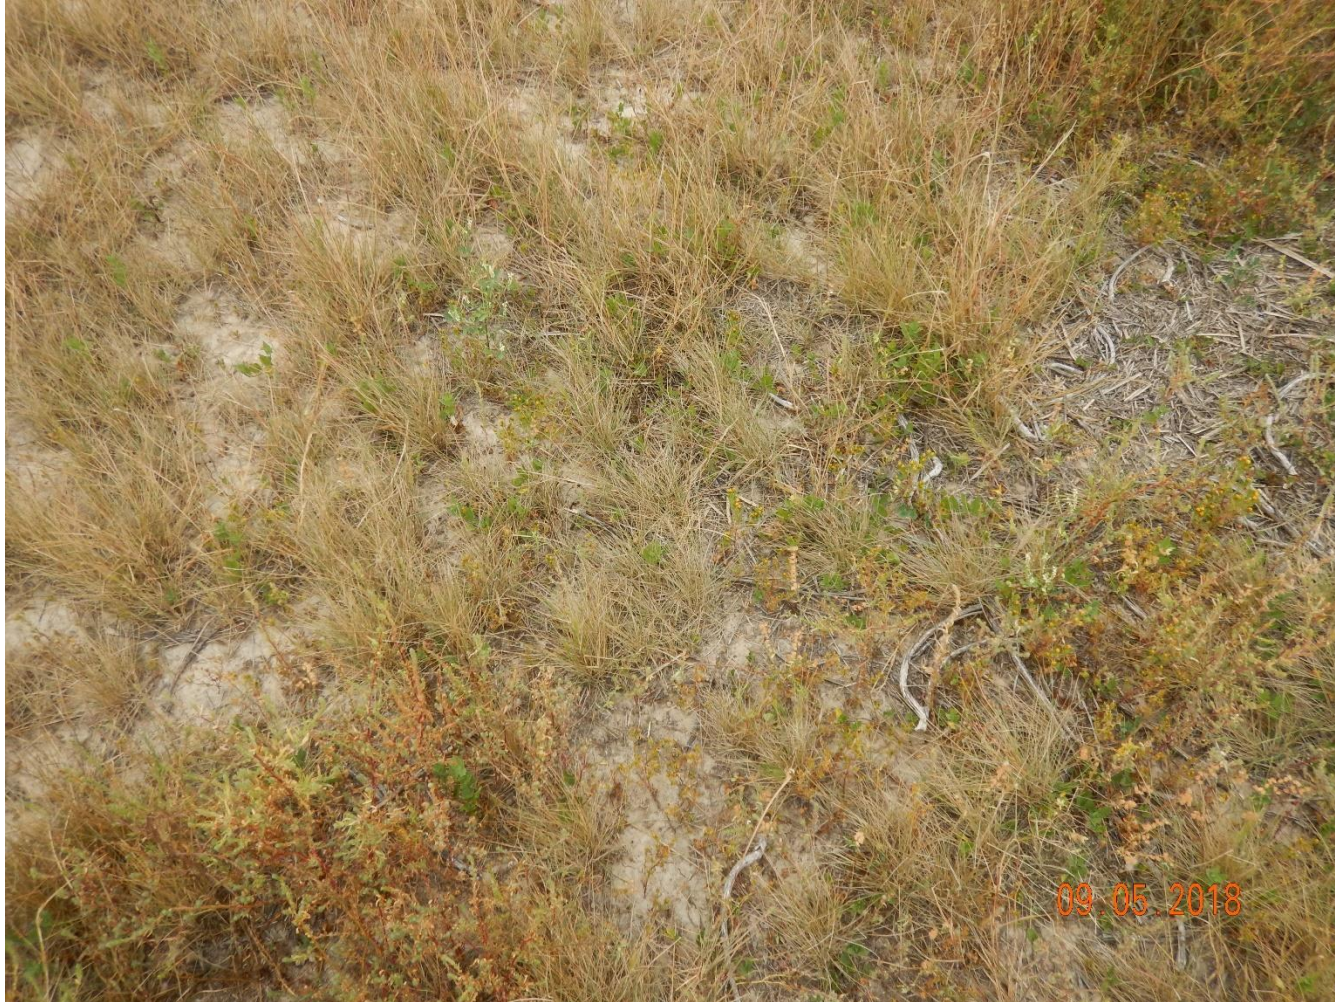
**Photo 71:** Photo taken from the adjacent lands. Photo shows dominant vegetation observed in this immediate area to be Sand Dropseed, Blue Grama and Yellow Sweet clover (white flower) and Russian Thistle
